U.S. Department  
of Transportation  
**Federal Railroad  
Administration**

RR 20-03 | February 2020

## FULL-SCALE SHELL IMPACT TEST OF A DOT-113 TANK CAR

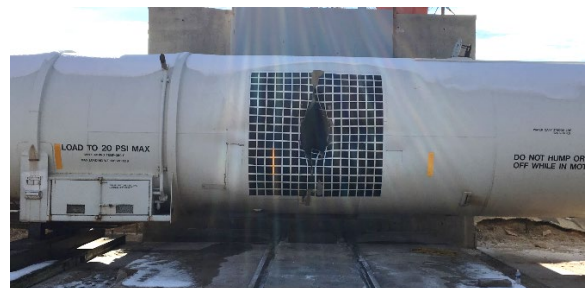
**Figure 2. Post-test Photo of the Punctured Shell**

The tank was punctured after an indentation of ~47 inches, at a force of ~750 thousand pounds. Review of the test measurements showed that the impactor had slowed to ~8.4 mph when puncture occurred, corresponding to a residual kinetic energy of ~0.7 million foot-pounds. The residual kinetic energy corresponded to approximately 25 percent of the initial kinetic energy of the ram car. [Figure 2](#) shows the punctured tank car outer shell.

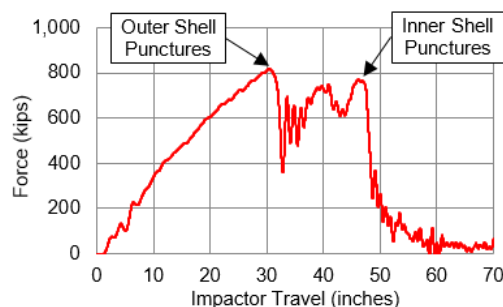
**Figure 4. Test Force-displacement Results at 16.7 mph (CFC-60)**

The impact occurred at 16.7 mph and resulted in puncture of the inner and outer tanks. The force-displacement results from the test are shown in Figure 4, along with annotations denoting where the outer and inner shells punctured. The force/acceleration results are taken from the average of four of the five longitudinal accelerometers on the ram. A CFC-60 filter was used on these results in accordance with the Society of Automotive Engineers (SAE) J211-1 standard. Examination of the test data revealed that the outer tank punctured after ~31 inches of impactor travel and the inner tank punctured after ~47 inches. The impactor continued to penetrate the inner tank after puncture.

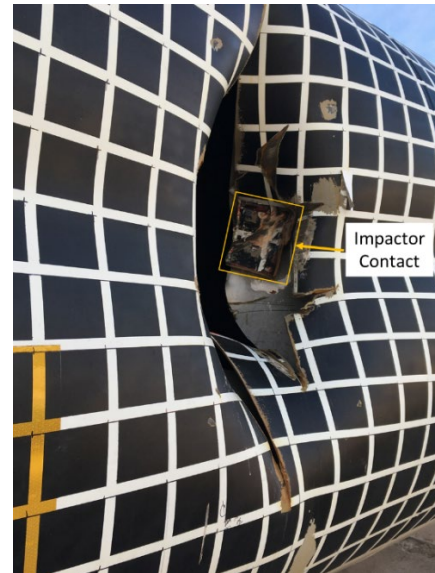
**Figure 5. Post-test Tear in Outer Tank**

Figure 5 shows the tear in the outer shell after the removal of the ram car. The tear appears to have initiated under a corner of the impactor and propagated vertically, which is consistent with previous tests and pre-test FEA for this test. No welds were involved in tearing of the outer tank. Red paint transfer from the impactor's tip is highlighted in this image as evidence of impactor contact.

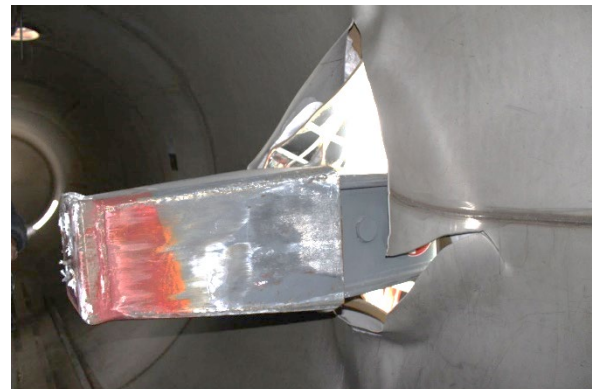
**Figure 6. Post-test Tear in Inner Tank**

Figure 6 shows the tear on the inner tank from the inside of the tank, prior to the ram's removal. Vertical tears are visible above the head of the impactor and a longitudinal tear is visible on the right of the image. The tear ran close to but did not open a stainless steel longitudinal weld seam in the inner tank.
