# Arecibo Observatory: *Failure Event Sequence*

Presentation Requested by  
*The Committee on Analysis of Causes of Failure and Collapse of the  
305-Meter Telescope at the Arecibo Observatory*

January 25, 2022

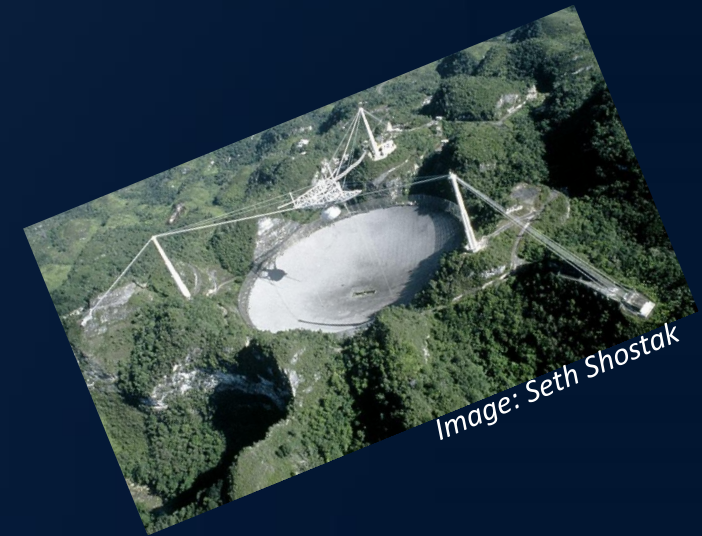
Backstay with ~2 inch  
slippage

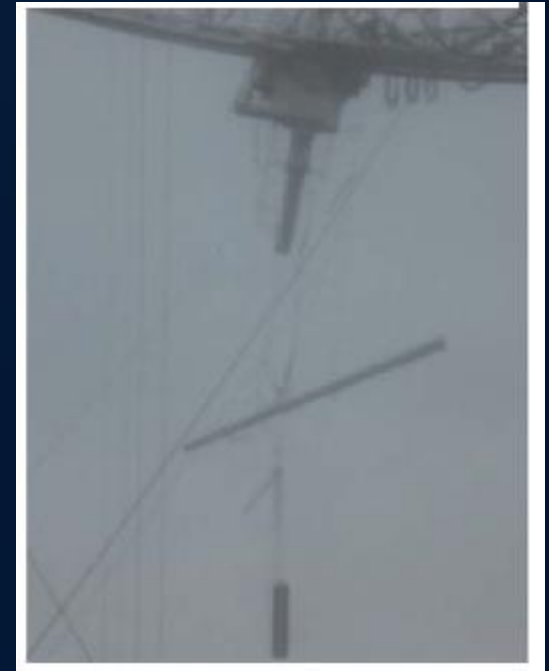
- **Tower 8 main cable:**
  - Only cable-related repair noted in post-Maria evaluation and funding requests; project execution plan prioritized highest-risk (replacing spliced cable)
  - Structural analysis, Main cable replacement design, and assistance in the cable replacement and construction administration to be overseen by WSP (acquired Louis Berger who acquired Ammann & Whitney)
  - Note a temporary fix had been performed in 2014 after another Earthquake

*Hindsight 20/20: this splice was still intact after the collapse*

*Significant winds:  
line feed broke  
off! Catwalk  
required  
significant  
repairs.*

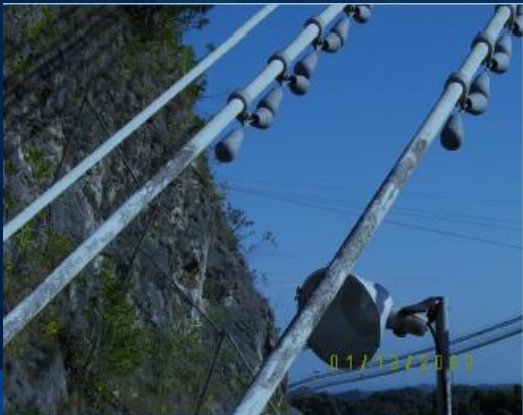
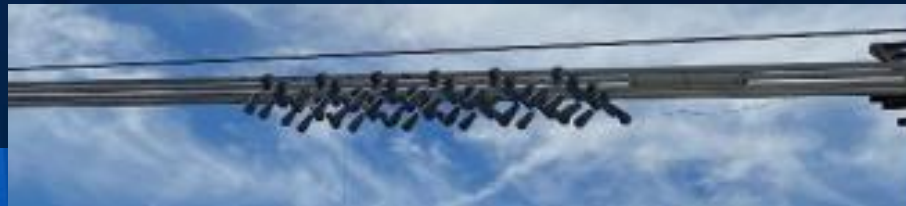
- Initial report (January 27, 2020) noted damage to vibration dampers, tie down blocks and slabs, potential for cracked platform steel components, and cracks in concrete buildings. Also concerns noted about site power infrastructure, and the need for more safety and inspection equipment, and structural analysis and modeling for resiliency
- \$3.325M proposal submitted 2020 and awarded included tasks for acquisition and installation of new vibration dampers; purpose of dampers is to reduce vibration caused by external forces (wind or seismic events)
  - Existing dampers were damaged (bent) during earthquakes
  - Dampers on all main cable suspension locations (between platform and tower, and between tower and tower anchors)

*Straight dampers (left);  
bent dampers (below)*

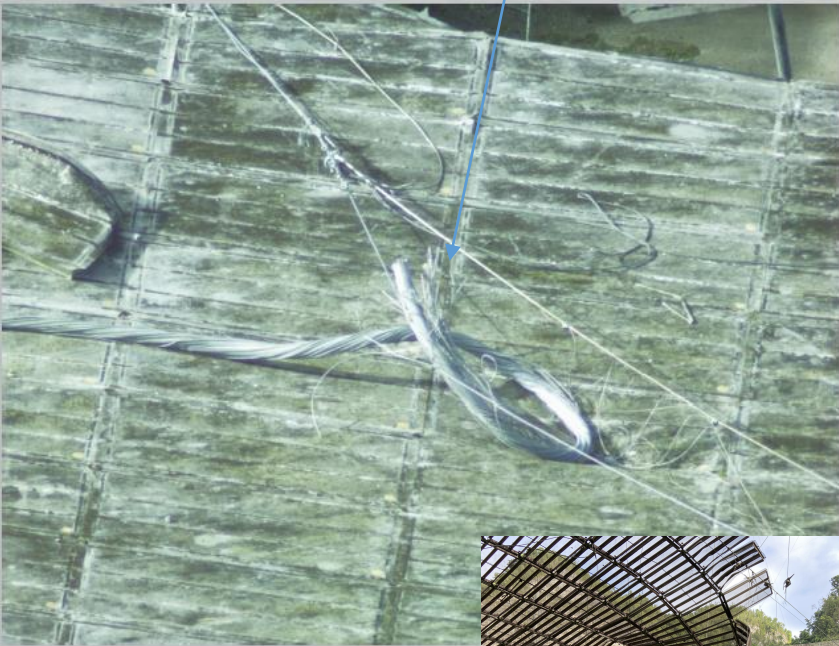
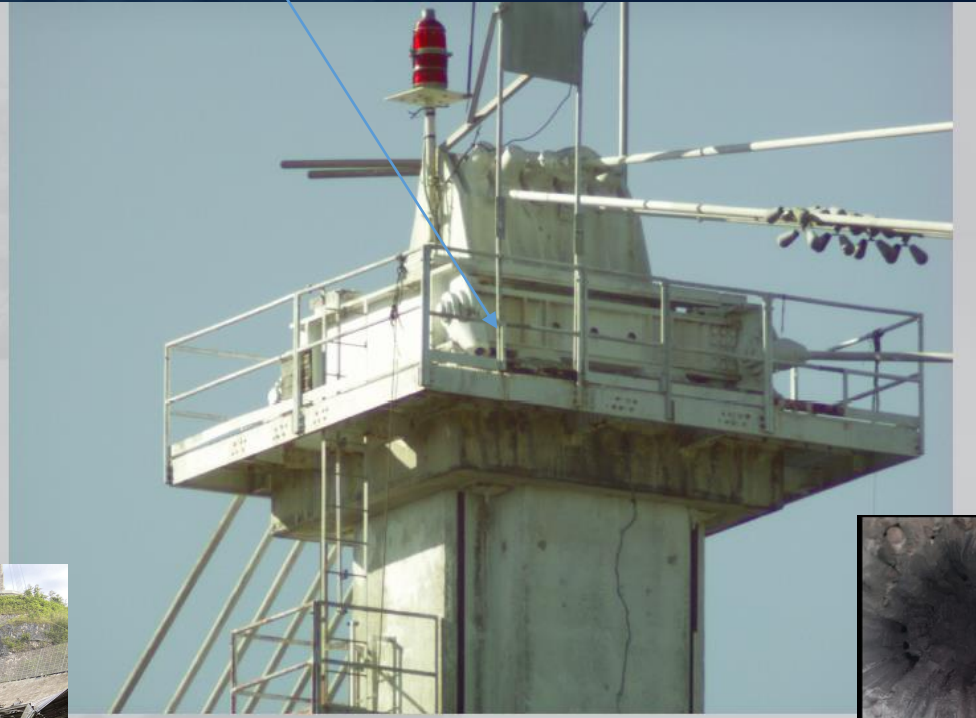
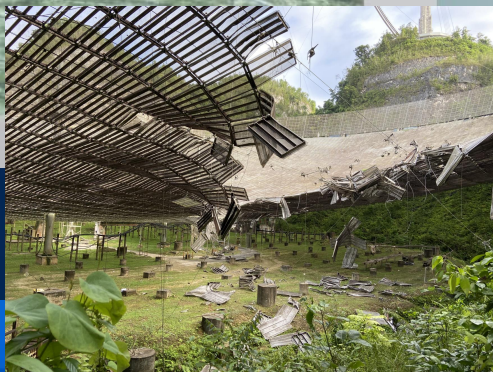
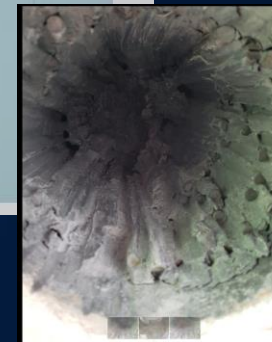
Failed  
socket

-described by  
structural  
engineers to  
have failed  
“suddenly and  
without  
warning”

- Focused evaluation on failed socket/cable from August 10th failure
- Found failure was “primarily due to cumulative damage caused by initially low structural design margins and a high percentage of sustained load, resulting in zinc creep deformation, progressive internal socket wire damage, and eventual loss of joint capacity”
- No further hardware provided as after collapse, mission shifted from forensic evaluation to implement a stabilization and repair to a full forensic evaluation (to be led by Engineer of Record, TT)

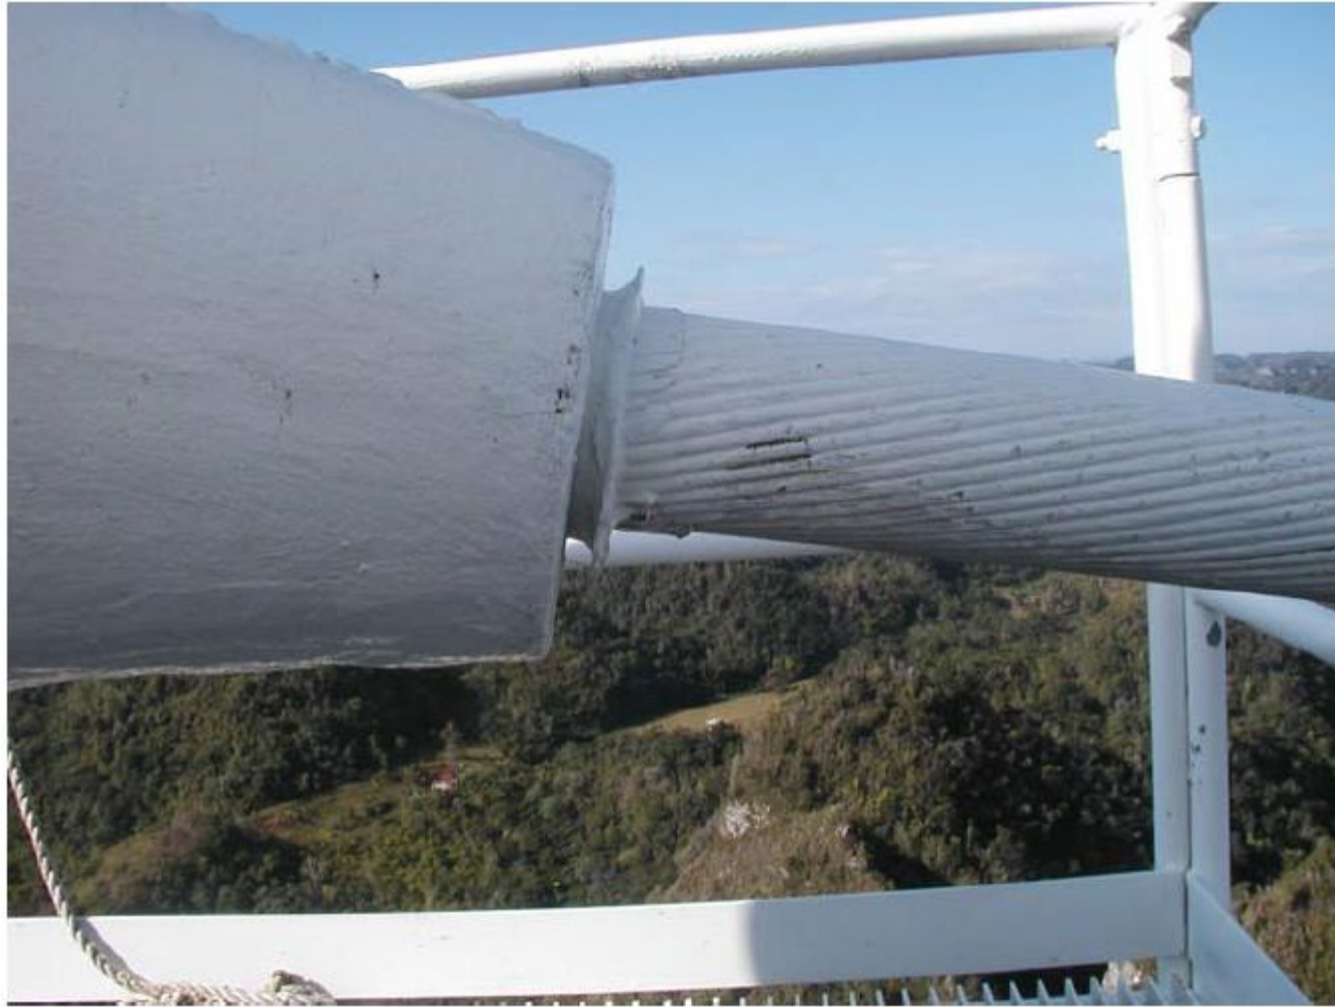
3.2.4 – P1: Auxiliary cable end socket as viewed from the top of tower T4. The cast zinc has separated from the leading edge of the end socket. This condition was observed at all the upgrading cables and is believed to have occurred during fabrication or proof loading.

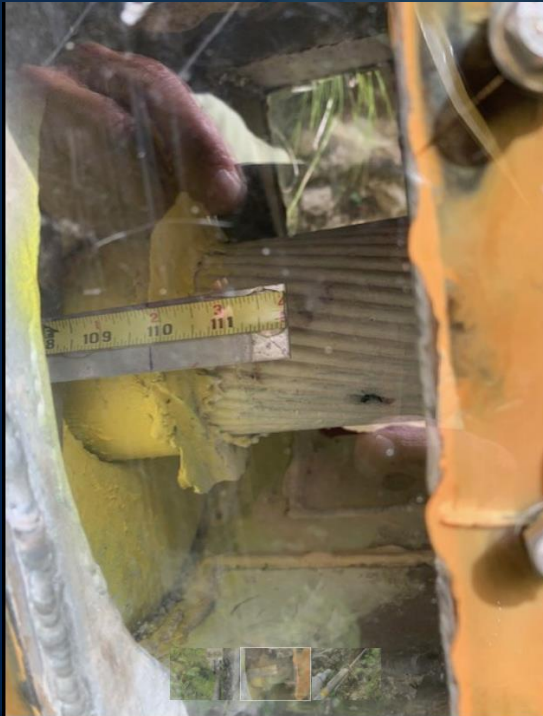
# Tower 12 – backstay auxiliary – ~2" separation

Many of the auxiliary cables and auxiliary backstay cables are showing more than  $\frac{1}{2}$ " separation (cast zinc from leading edge of socket); from  $\frac{3}{4}$ " to 2" in the worst case

Immediate Concern: Another cable will pull loose from its socket

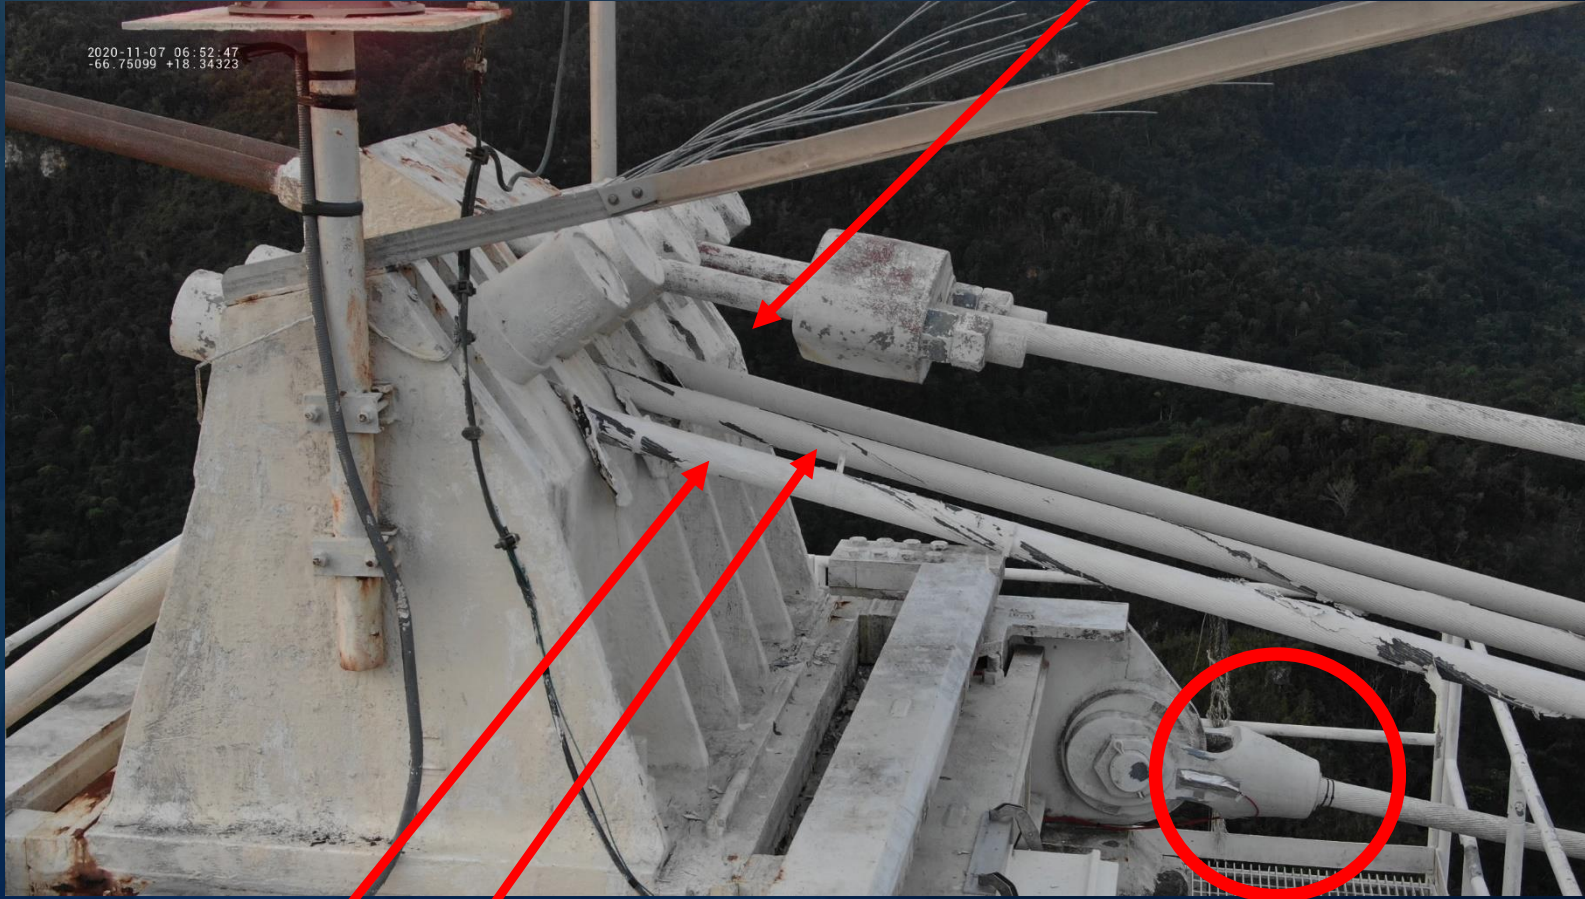
Failed main cable

New broken wires on M4-1 (4)  
and M4-2 (2)

Aux South – no  
observed change

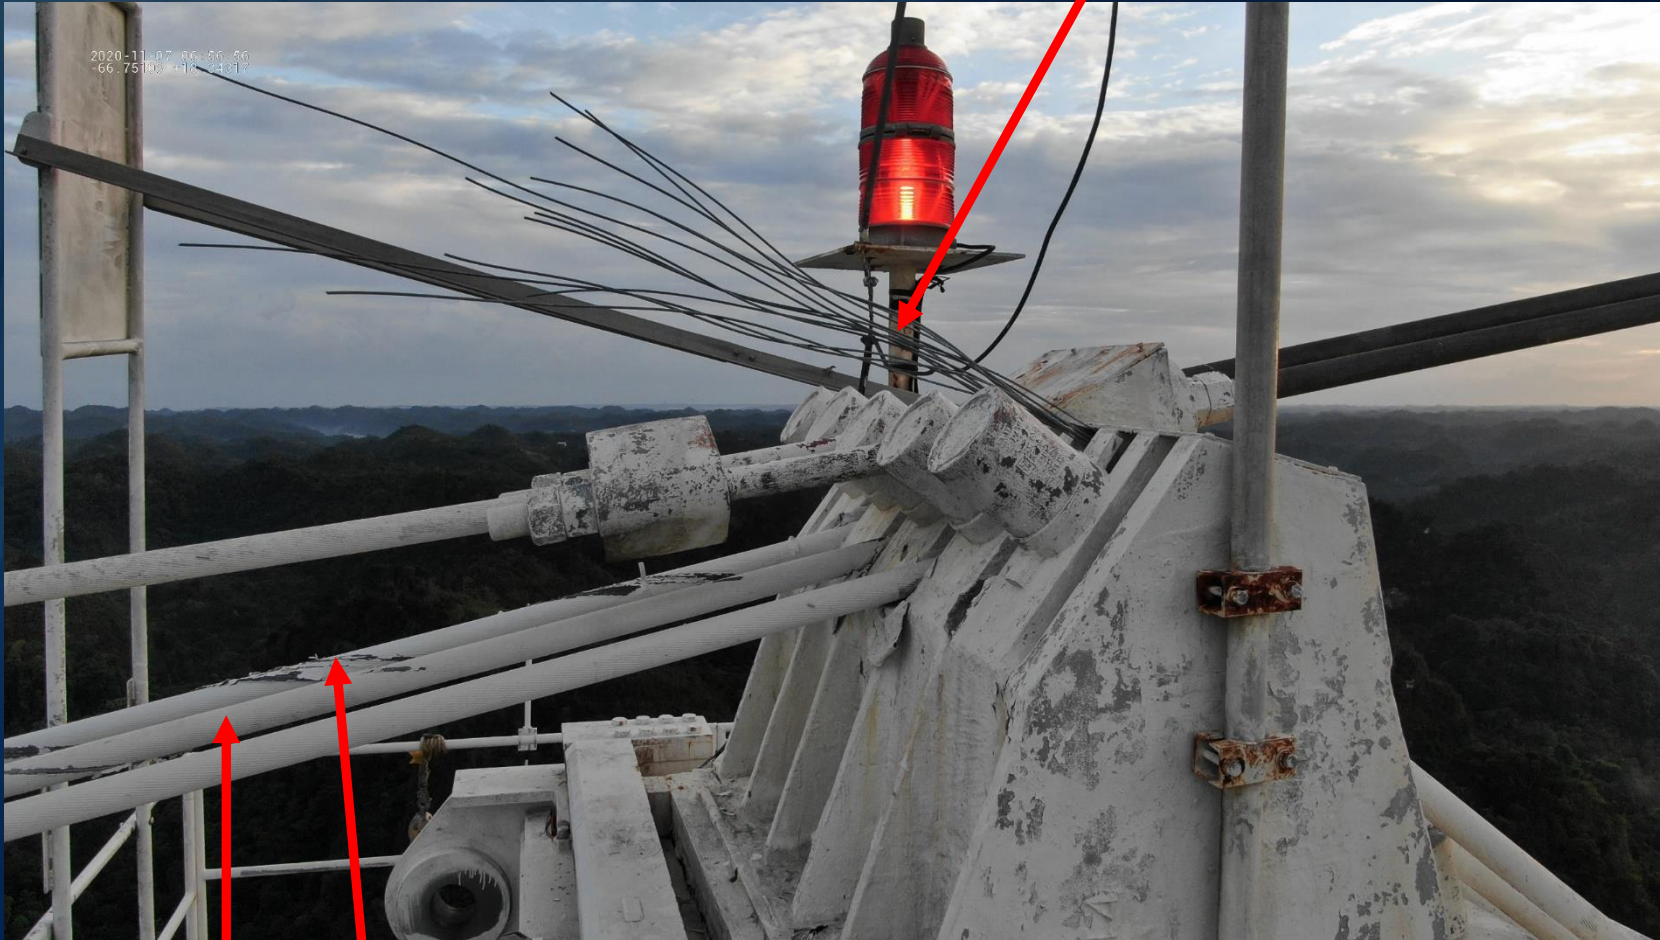
Failed main cable wires

New broken wires on M4-1 (4)  
and M4-2 (2)

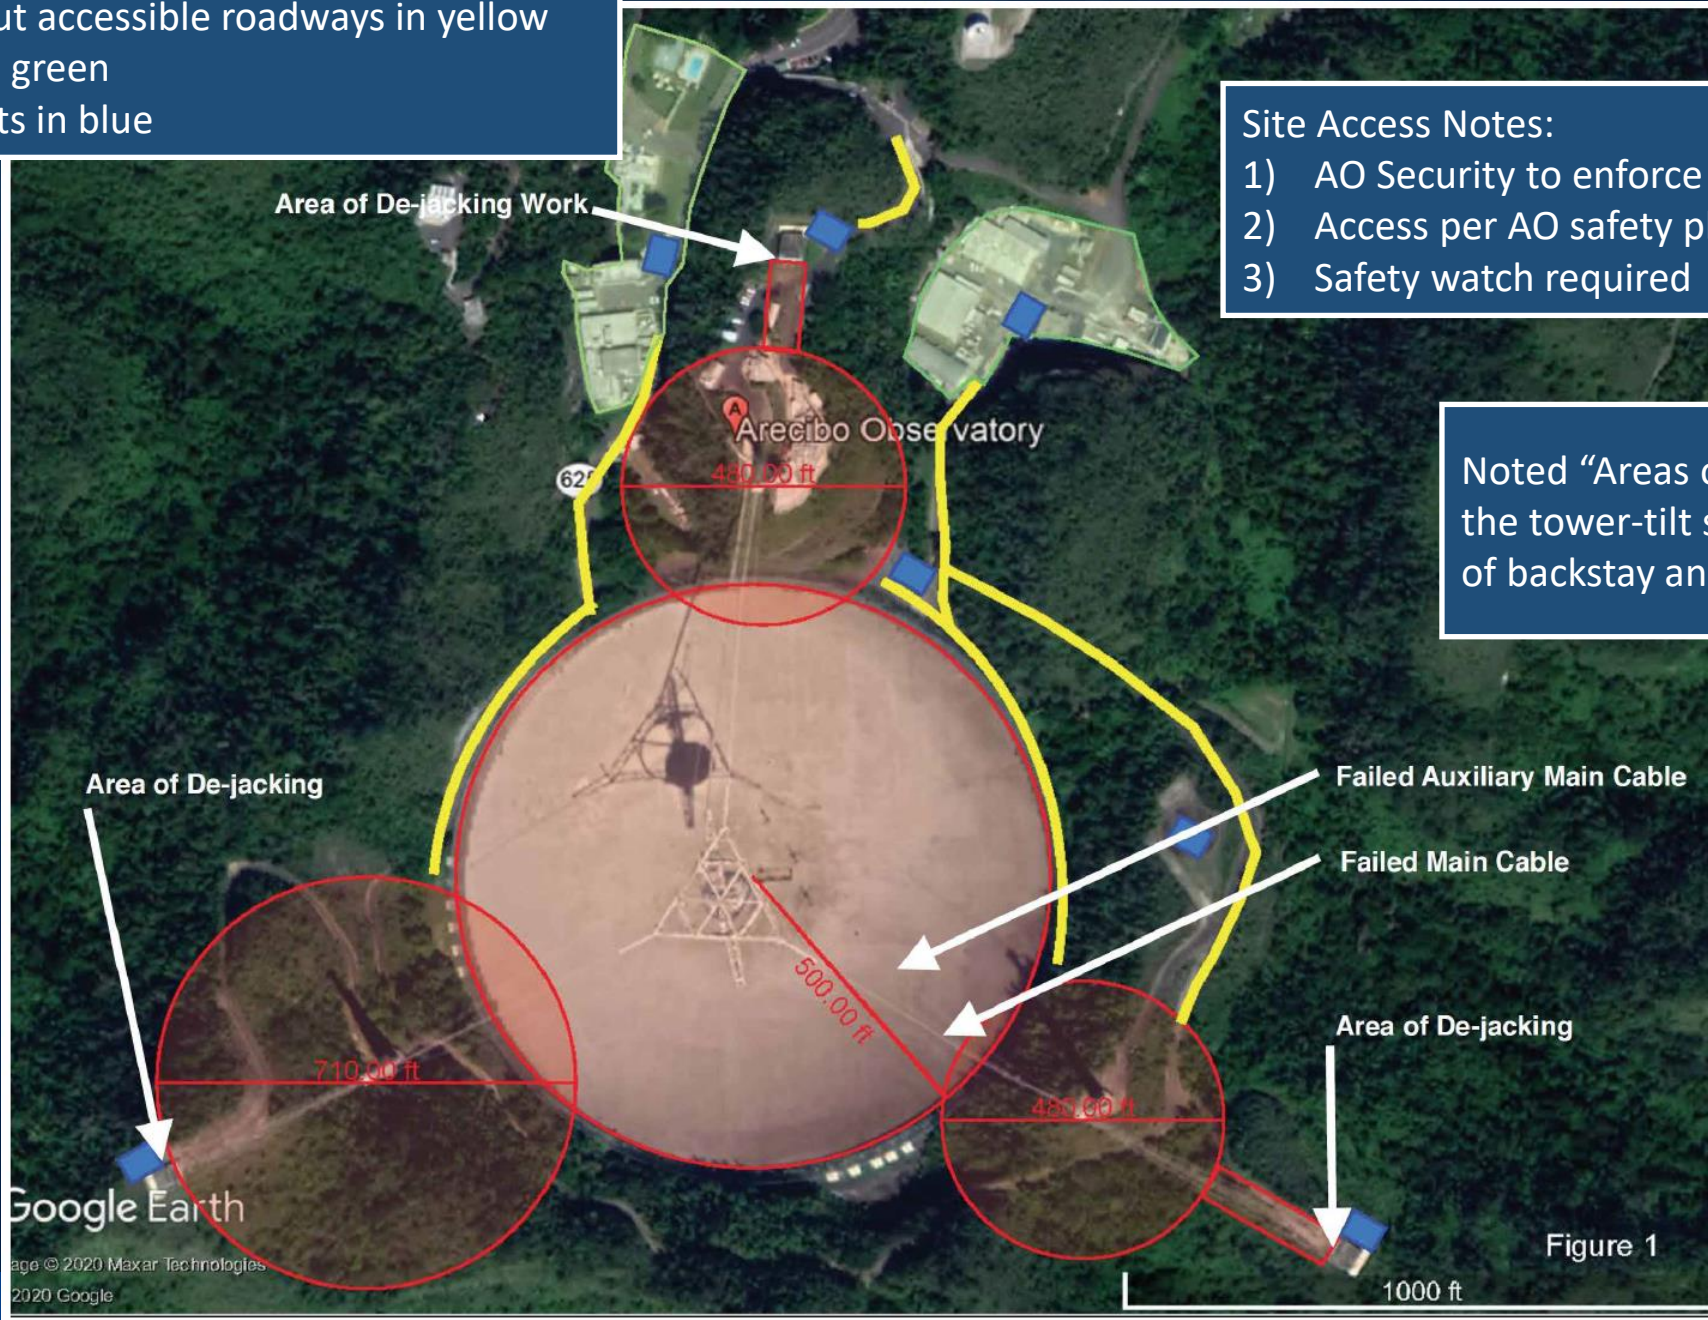
Noted "Areas of De-jacking" were proposed for the tower-tilt strategy: these are the locations of backstay anchorages

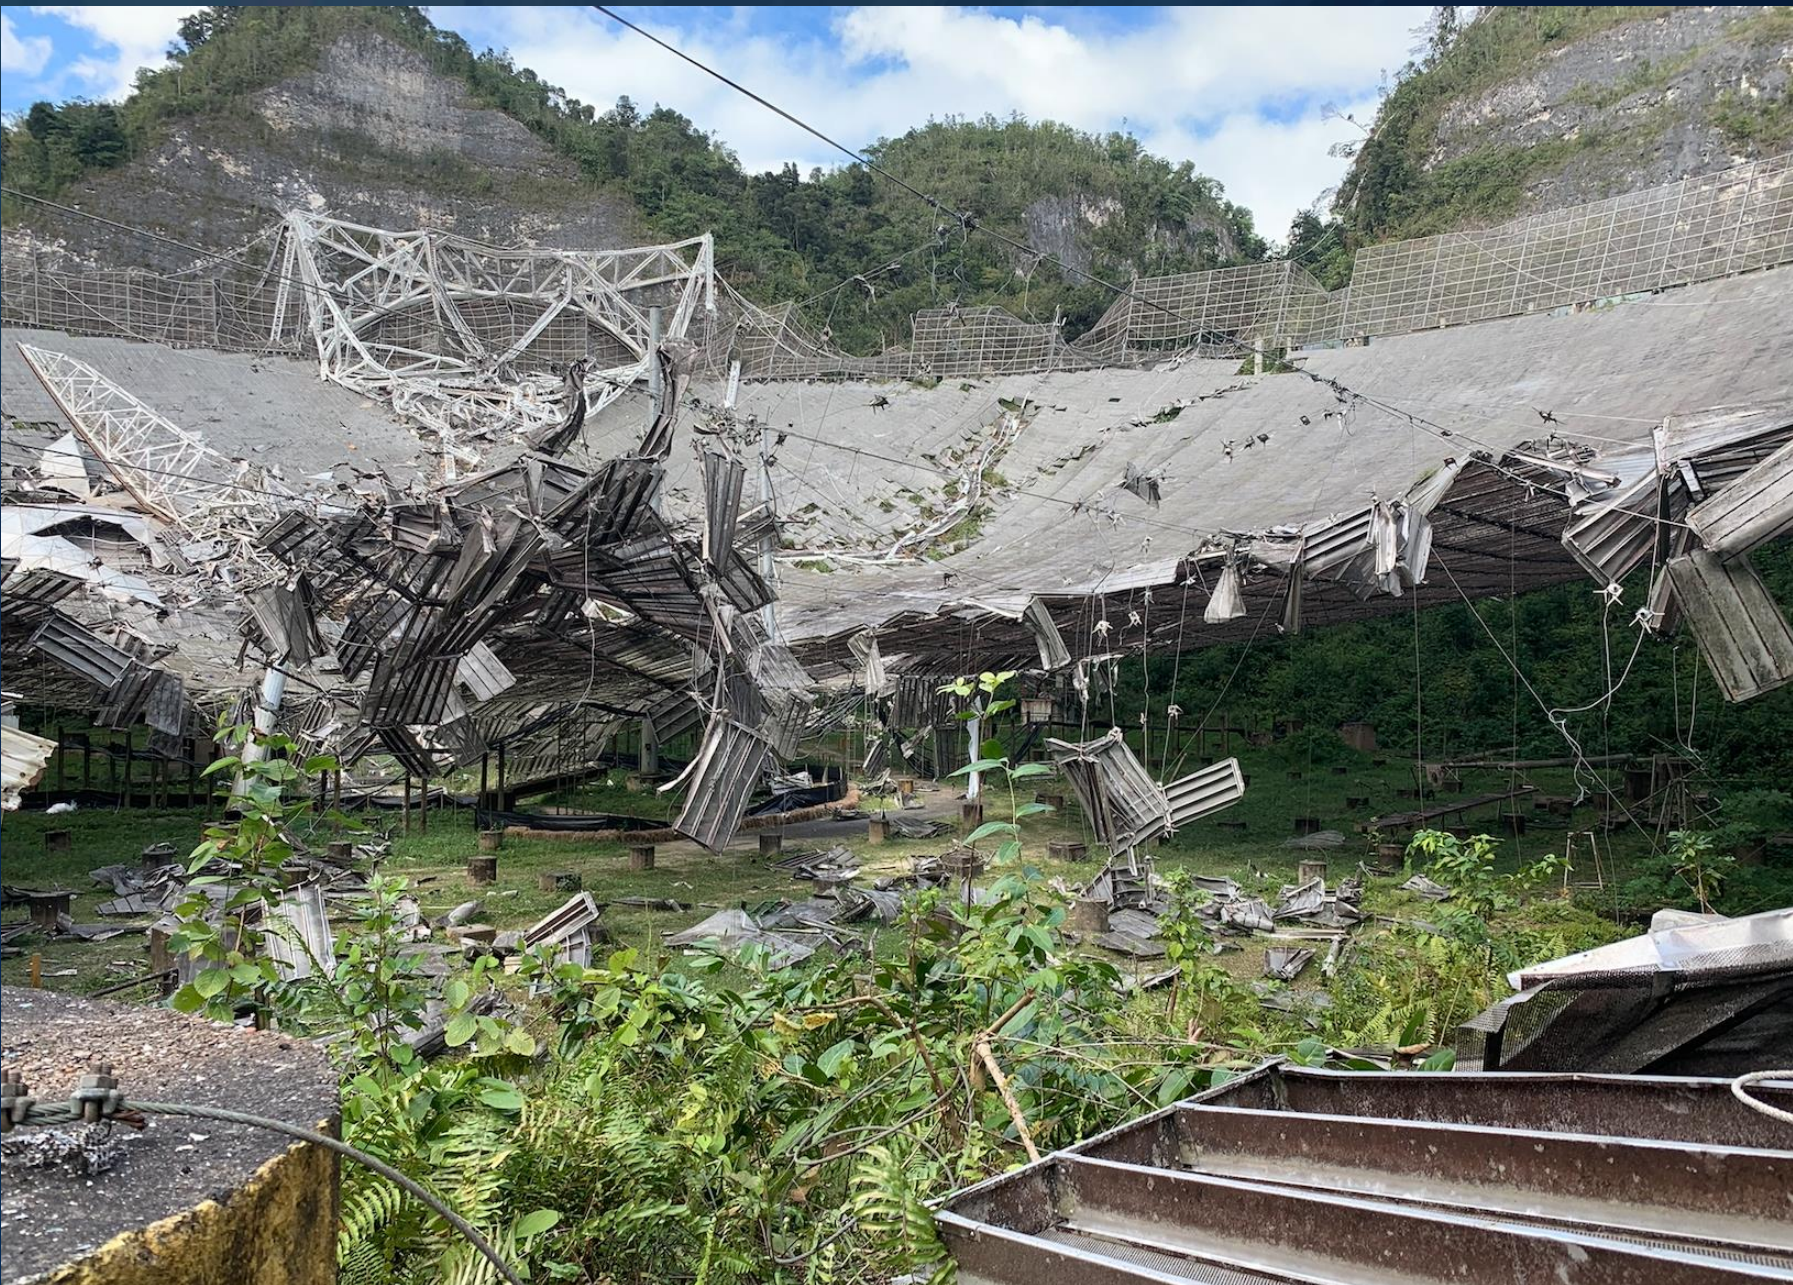
- Drone footage of collapse taken by very adept AO staff provides us a precise sequence of events for the final collapse
- Loads were exceeded and it was a cascading failure

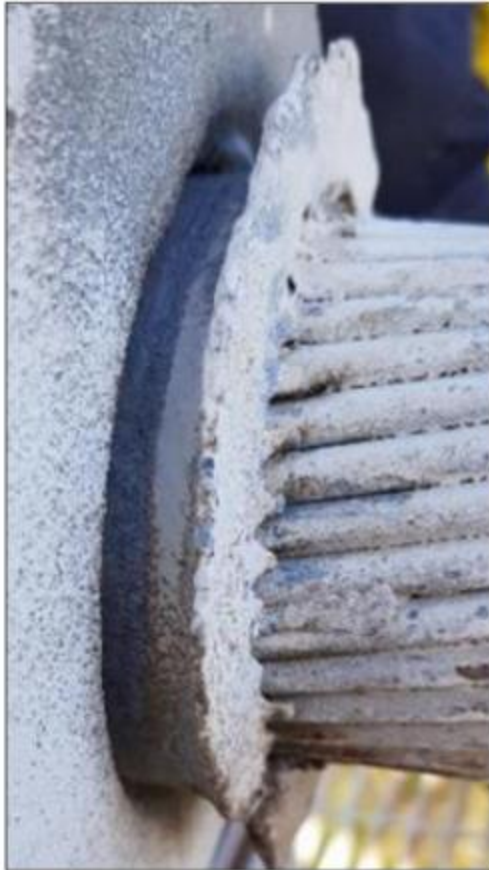
Socket M8N\_T exhibited  
3/4" cable slip.

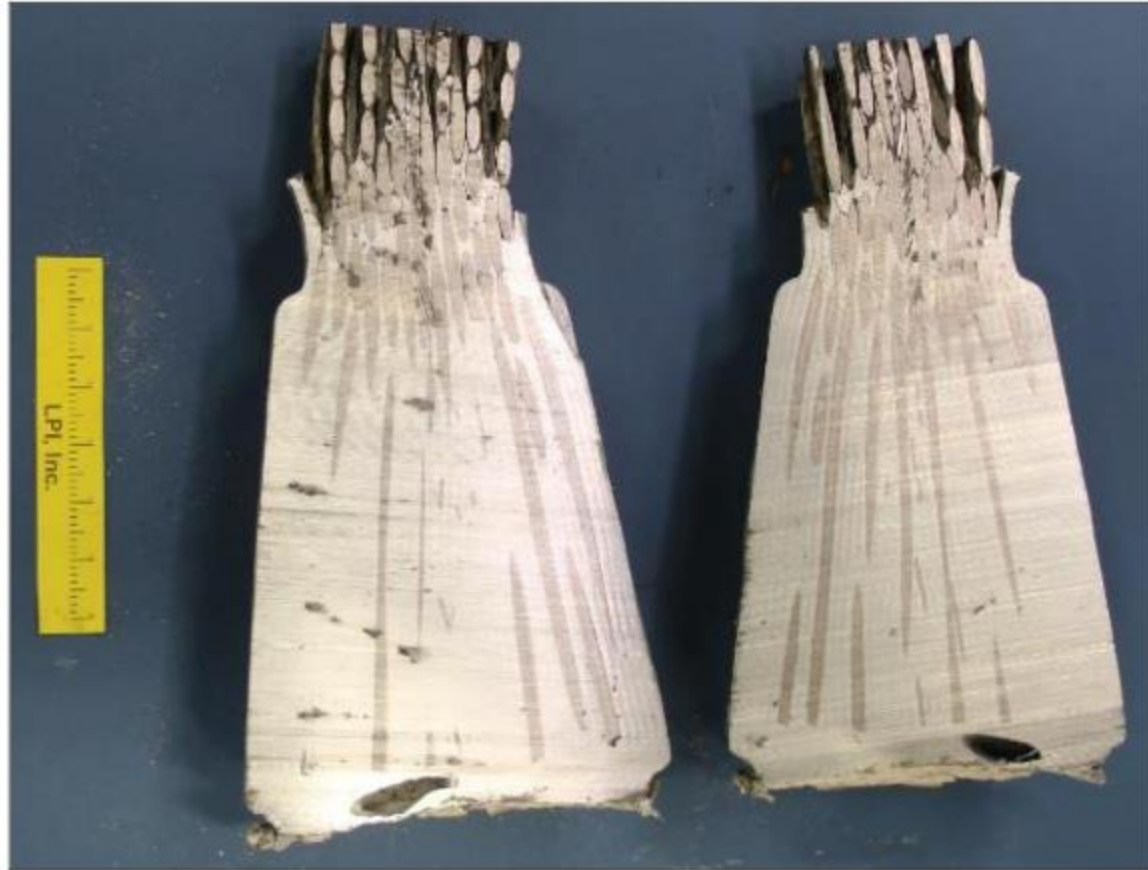
Zinc casting was cut open and macroetched  
to reveal zinc grain and/or flow structure.
