WHY MINE WASTE IMPOUNDMENTS EXPERIENCE STABILITY FAILURES

**Committee on Geological and Geotechnical Engineering
Board on Earth Sciences and Resources
National Academies of Sciences, Engineering, and Medicine**

September 5, 2019

W. Allen Marr

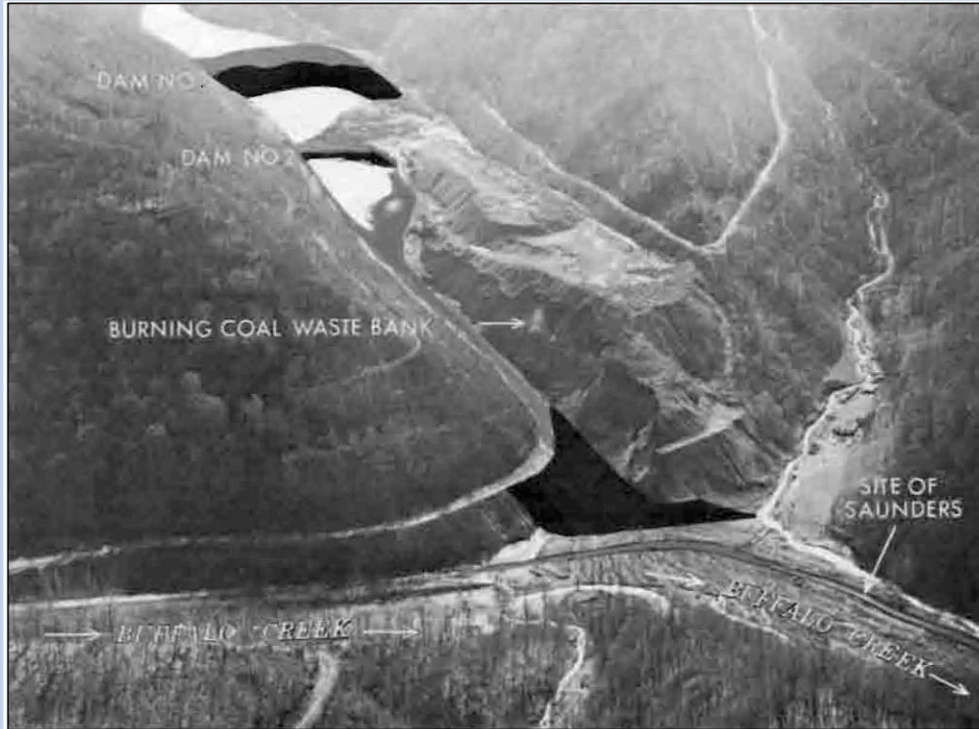
Figure 61. Reconstructed view of the damsite.
Source: U.S. Geological Survey, Circular 667

Date:	Feb 26, 1972, sudden, no warning
Type:	14 m embankment of coal waste built on coal refuse slurry retaining coal wash tailings for coal mine
Failure Mode:	Collapse of dam by slumping and sliding of downstream after heavy rain (<u>water flow through the dam</u>)
Volume Spilled:	500,000 cubic meters
Consequences:	Tailings traveled 27 km downstream average 2 m/sec, 125 people died, 1121 injuries , 507 homes destroyed, 30 businesses. Property and highway damage exceeded \$65 million. Led to US Dam Safety Act giving US Army Corps of Engineers responsibility to conduct nationwide safety inspections of dams.

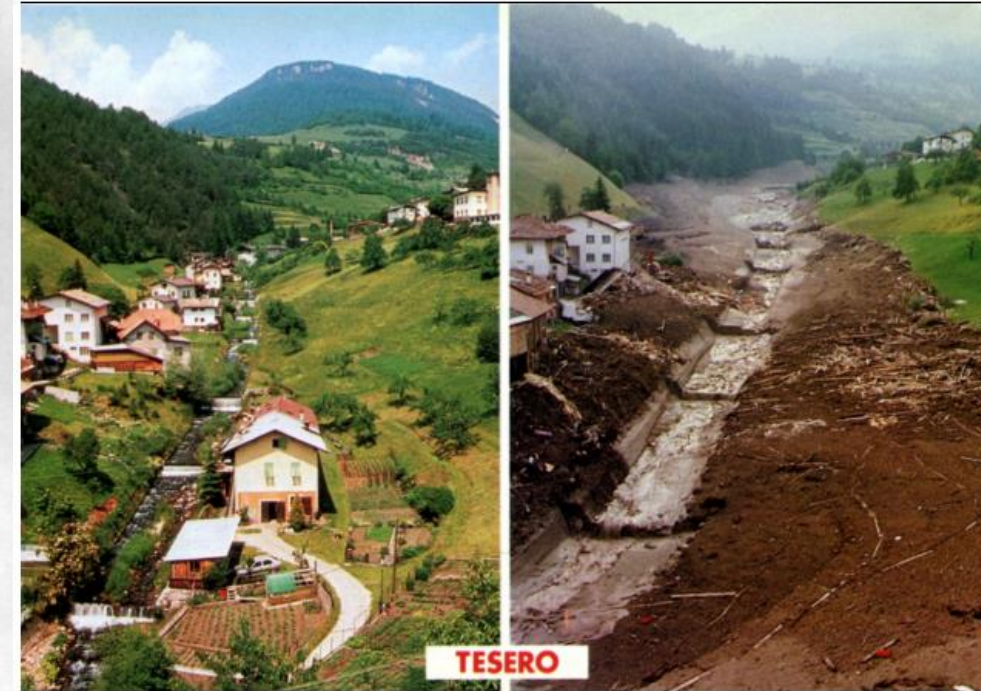
Fig. 13. Before and after the passage of the mudflow in the Tesero village at section 20 in Fig. 8 (postcard – Foto Trettel, P., edited by: Artesan, Tesero).

Date:	July 19, 1985, sudden, no warning
Type:	30 m upstream tailings dam for fluorite mine
Failure Mode:	<u>Failure through silt foundation</u> followed by mud flow
Volume Spilled:	200,000 cubic meters of liquefied tailings flowed 4.2 km at 25 m/sec
Consequence:	Mud flows killed 268 people, destroyed 82 buildings

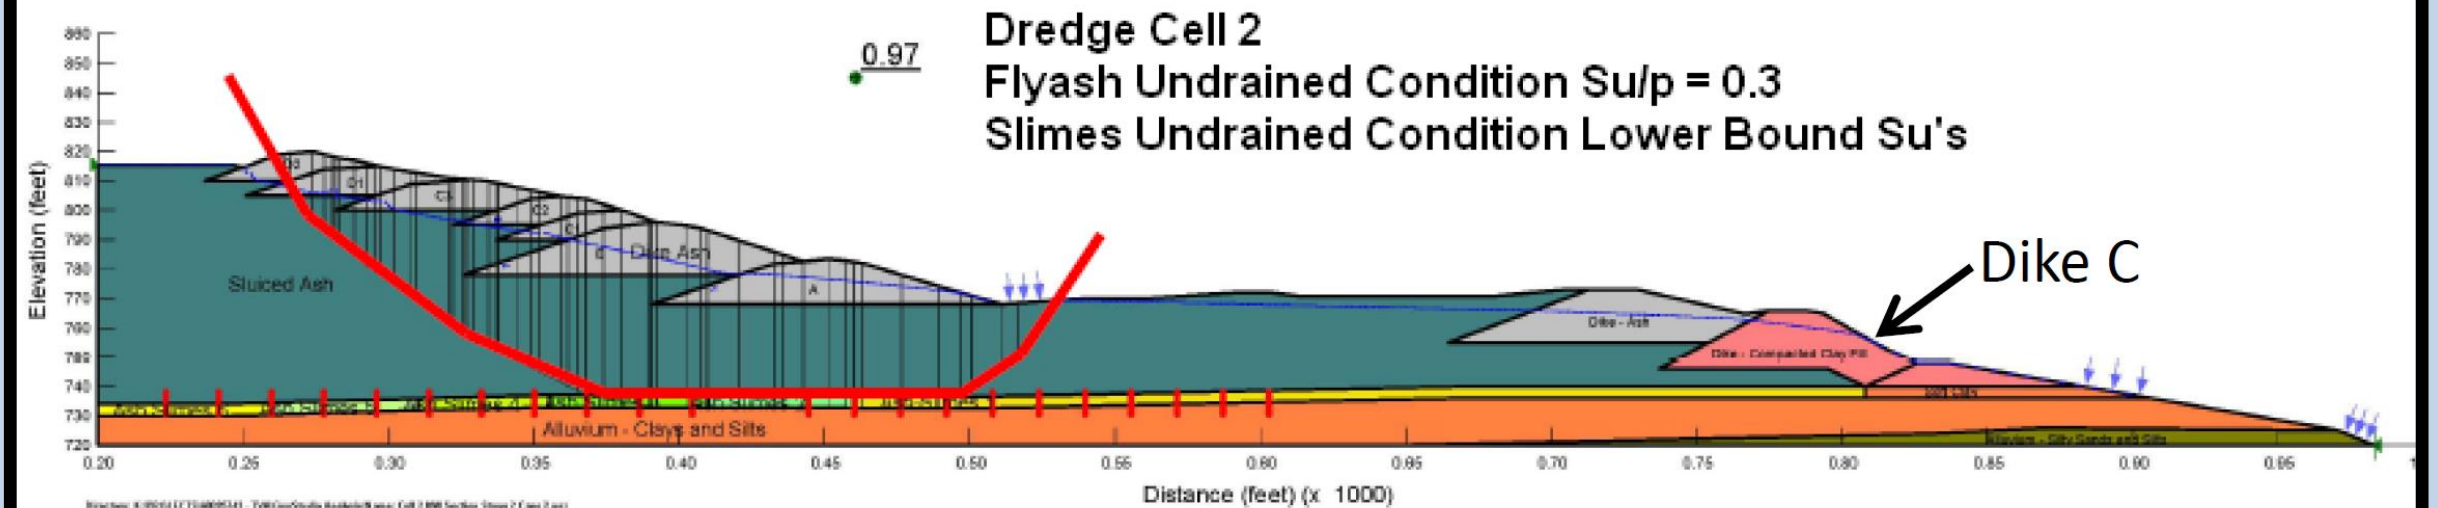
Factor of Safety = 1.0

Undrained creep shear failure of 6" layer of interbedded silt, clay and slimes at high water content with load being added. Triggered shear slide then liquefaction of the sluiced ash tailings.

Date:	Dec 22, 2008 sudden no warning, inspected day before
Type:	30 m upstream method dam for coal ash at power plant
Failure Mode:	<u>Undrained failure through thin weak foundation layer</u> , leading to liquefaction of stored ash, followed by mud flow
Volume Spilled:	4.1 million cubic meters of liquefied ash flowed 7 km, initially at ??? m/sec
Consequence:	Mud flows >180 properties damaged \$1.2+ Billions of dollars paid by TVA in cleanup, unknown other damage payments

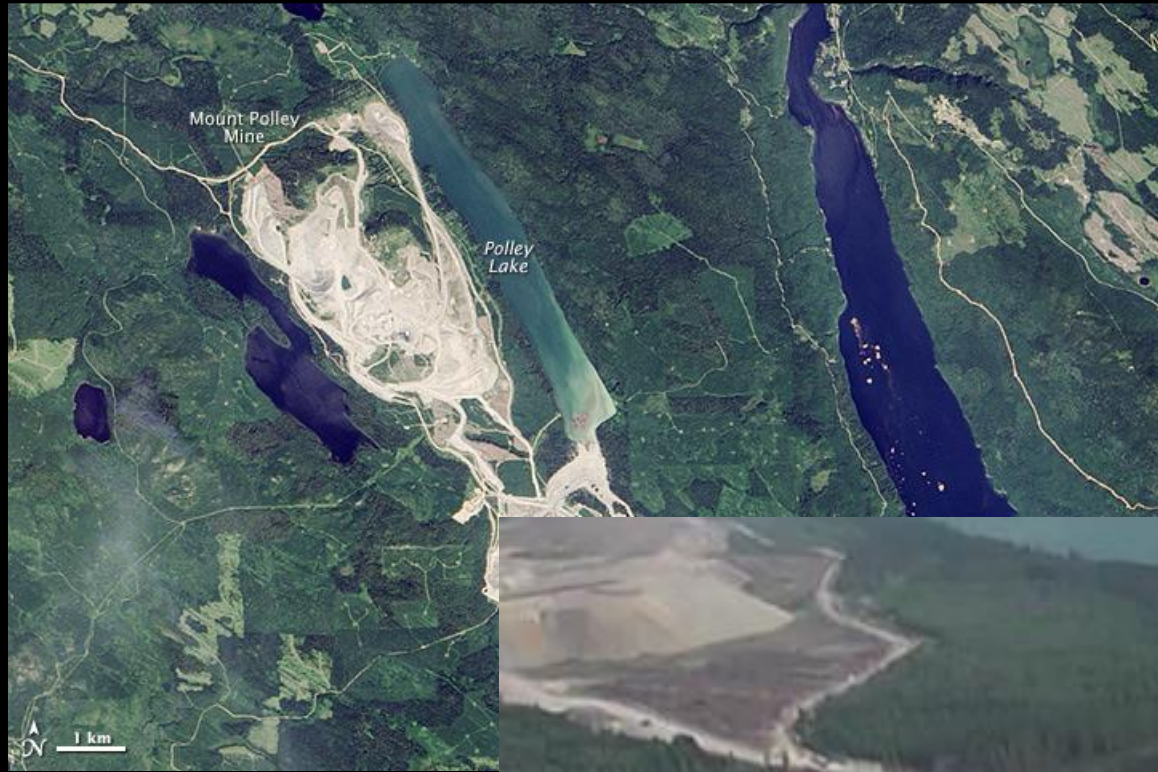
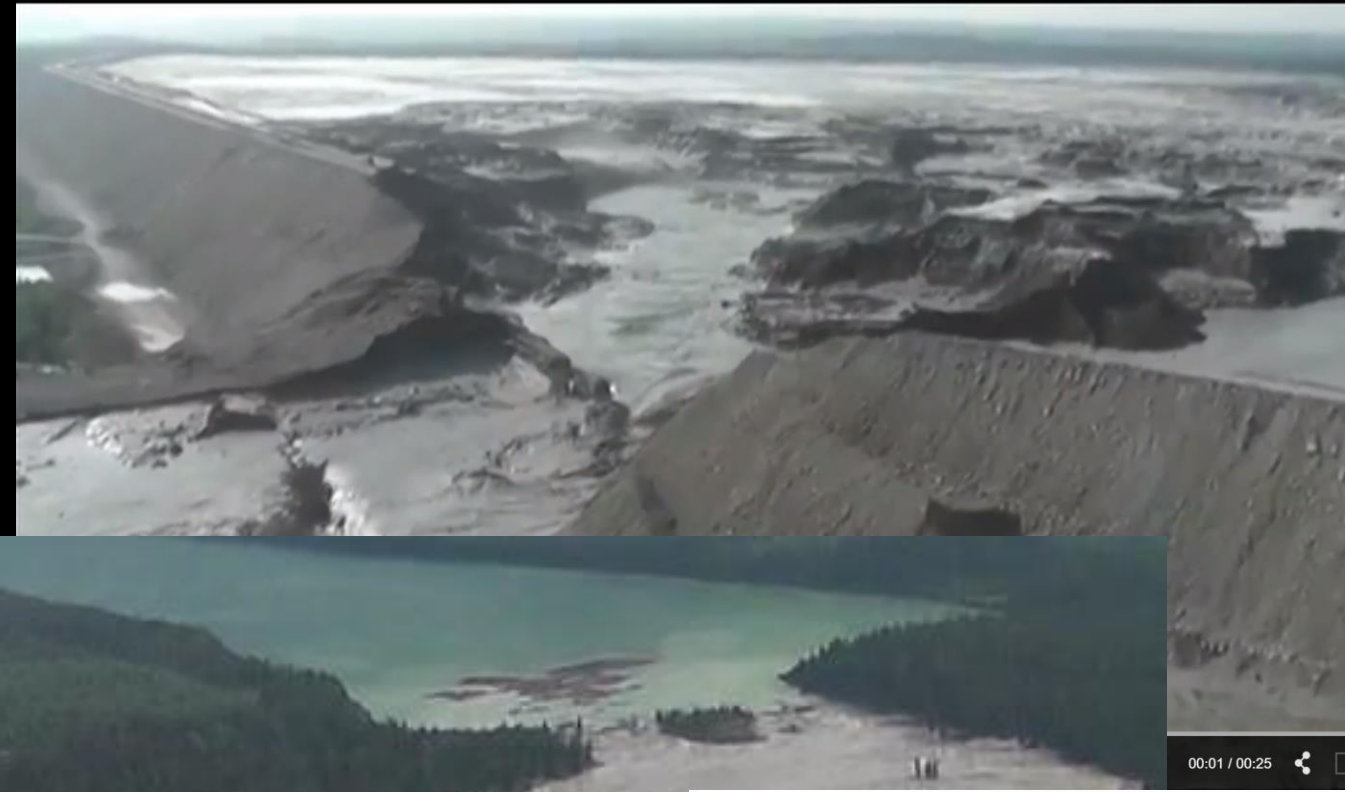
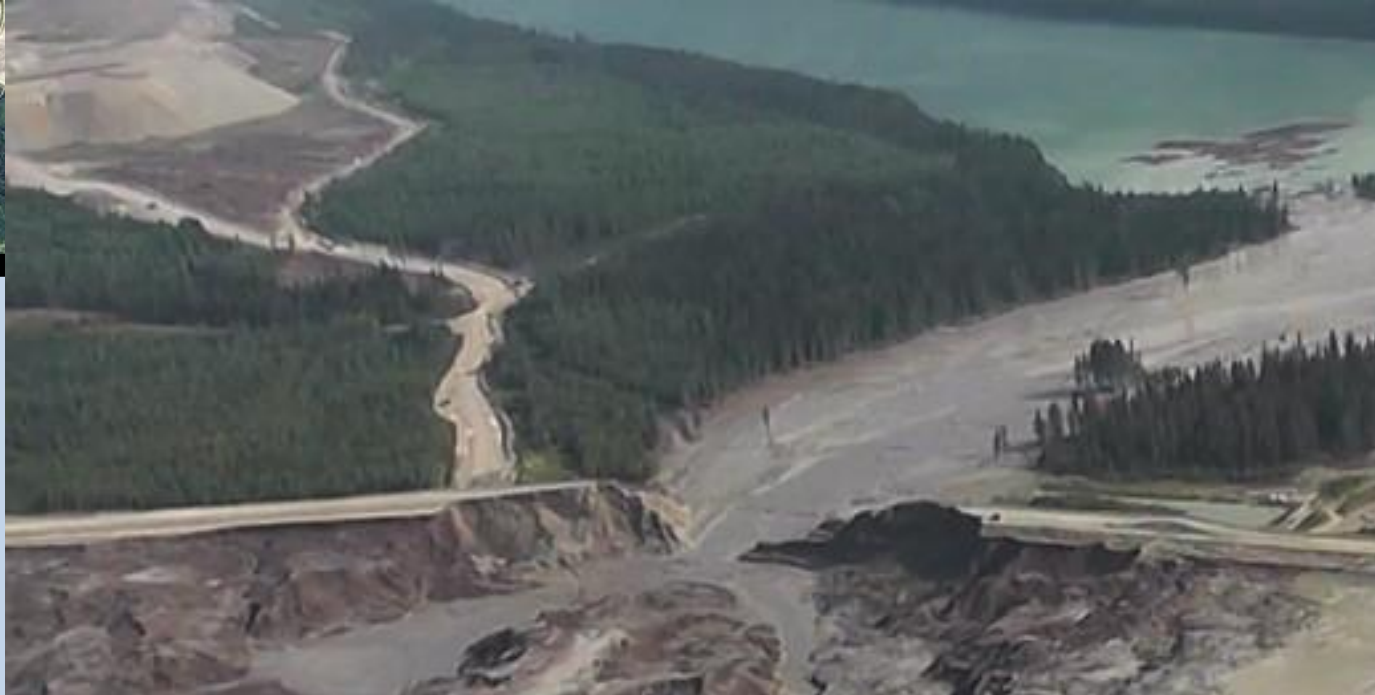
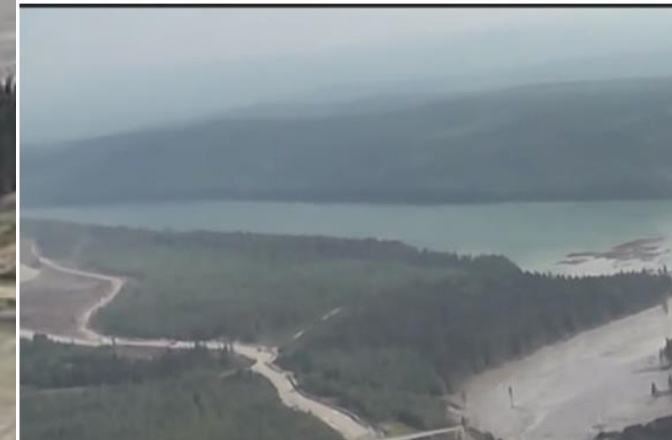
FIGURE 4.1.1: SIMPLIFIED CROSS-SECTION OF THE MOUNT POLLEY DAM

- ...indicate that the foundation [GLU] was brought to failure under **fully drained** conditions, until the undrained strength was reached...

Date:	Aug 4, 2014, sudden failure, no warning
Type:	40 m modified centerline dam for tailings from gold and copper mine
Failure Mode:	<u>Undrained stability failure through foundation</u> of containment dam built over varved clay, leading to liquefaction of stored tailings, followed by mud flow
Volume Spilled:	24.4 million cubic meters of liquefied tailings and water flowed into 600 km long Fraser River over 4 days
Consequences:	Mud flows created one of the biggest environmental disasters in modern Canadian history Estimated \$68 million in clean up cost. >100 jobs lost. Design engineering firms paid \$108 million to settle out. APEGBC charged the responsible engineers with negligence or unprofessional conduct.

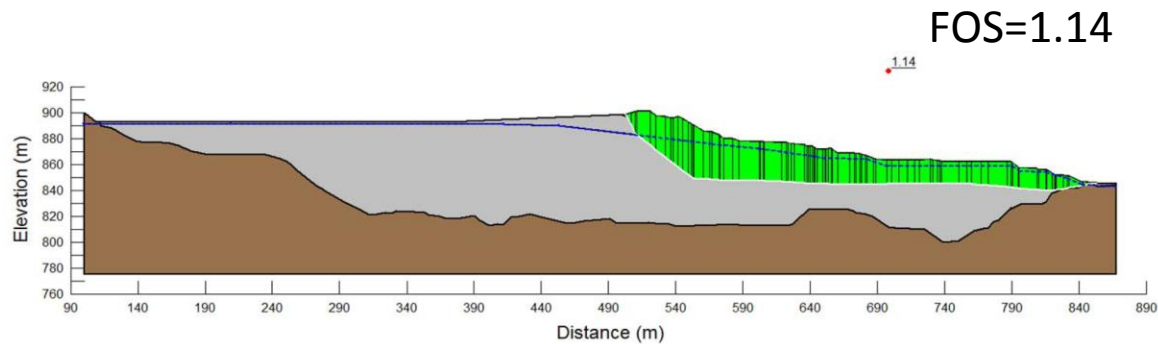
PROJECT
Fundão Tailings Dam Review Panel
TITLE
ESA above WT / USA Heterogeneous below WT
Left Abutment – Section 01
Field Data
November 5, 2015
FIGURE NO.
H.H1-10A

High pore pressures in the tailings from filling lowered the stability of the dam

Date:	Nov 15, 2015 sudden no warning, inspected shortly before
Type:	39-100 m upstream method dam tailings from iron ore
Failure Mode:	<u>Undrained failure of containment dam built over tailings from rapid filling</u> , leading to liquefaction of stored tailings, followed by mud flow
Volume Spilled:	43.7 million cubic meters of liquefied tailings flowed 620 km, initially at 11 m/sec
Consequence:	Mud flows killed 19 people, destroyed 375 homes, other structures. Worst environmental disaster in Brazilian history to that time. Damages and lawsuits of billions of dollars against owners.

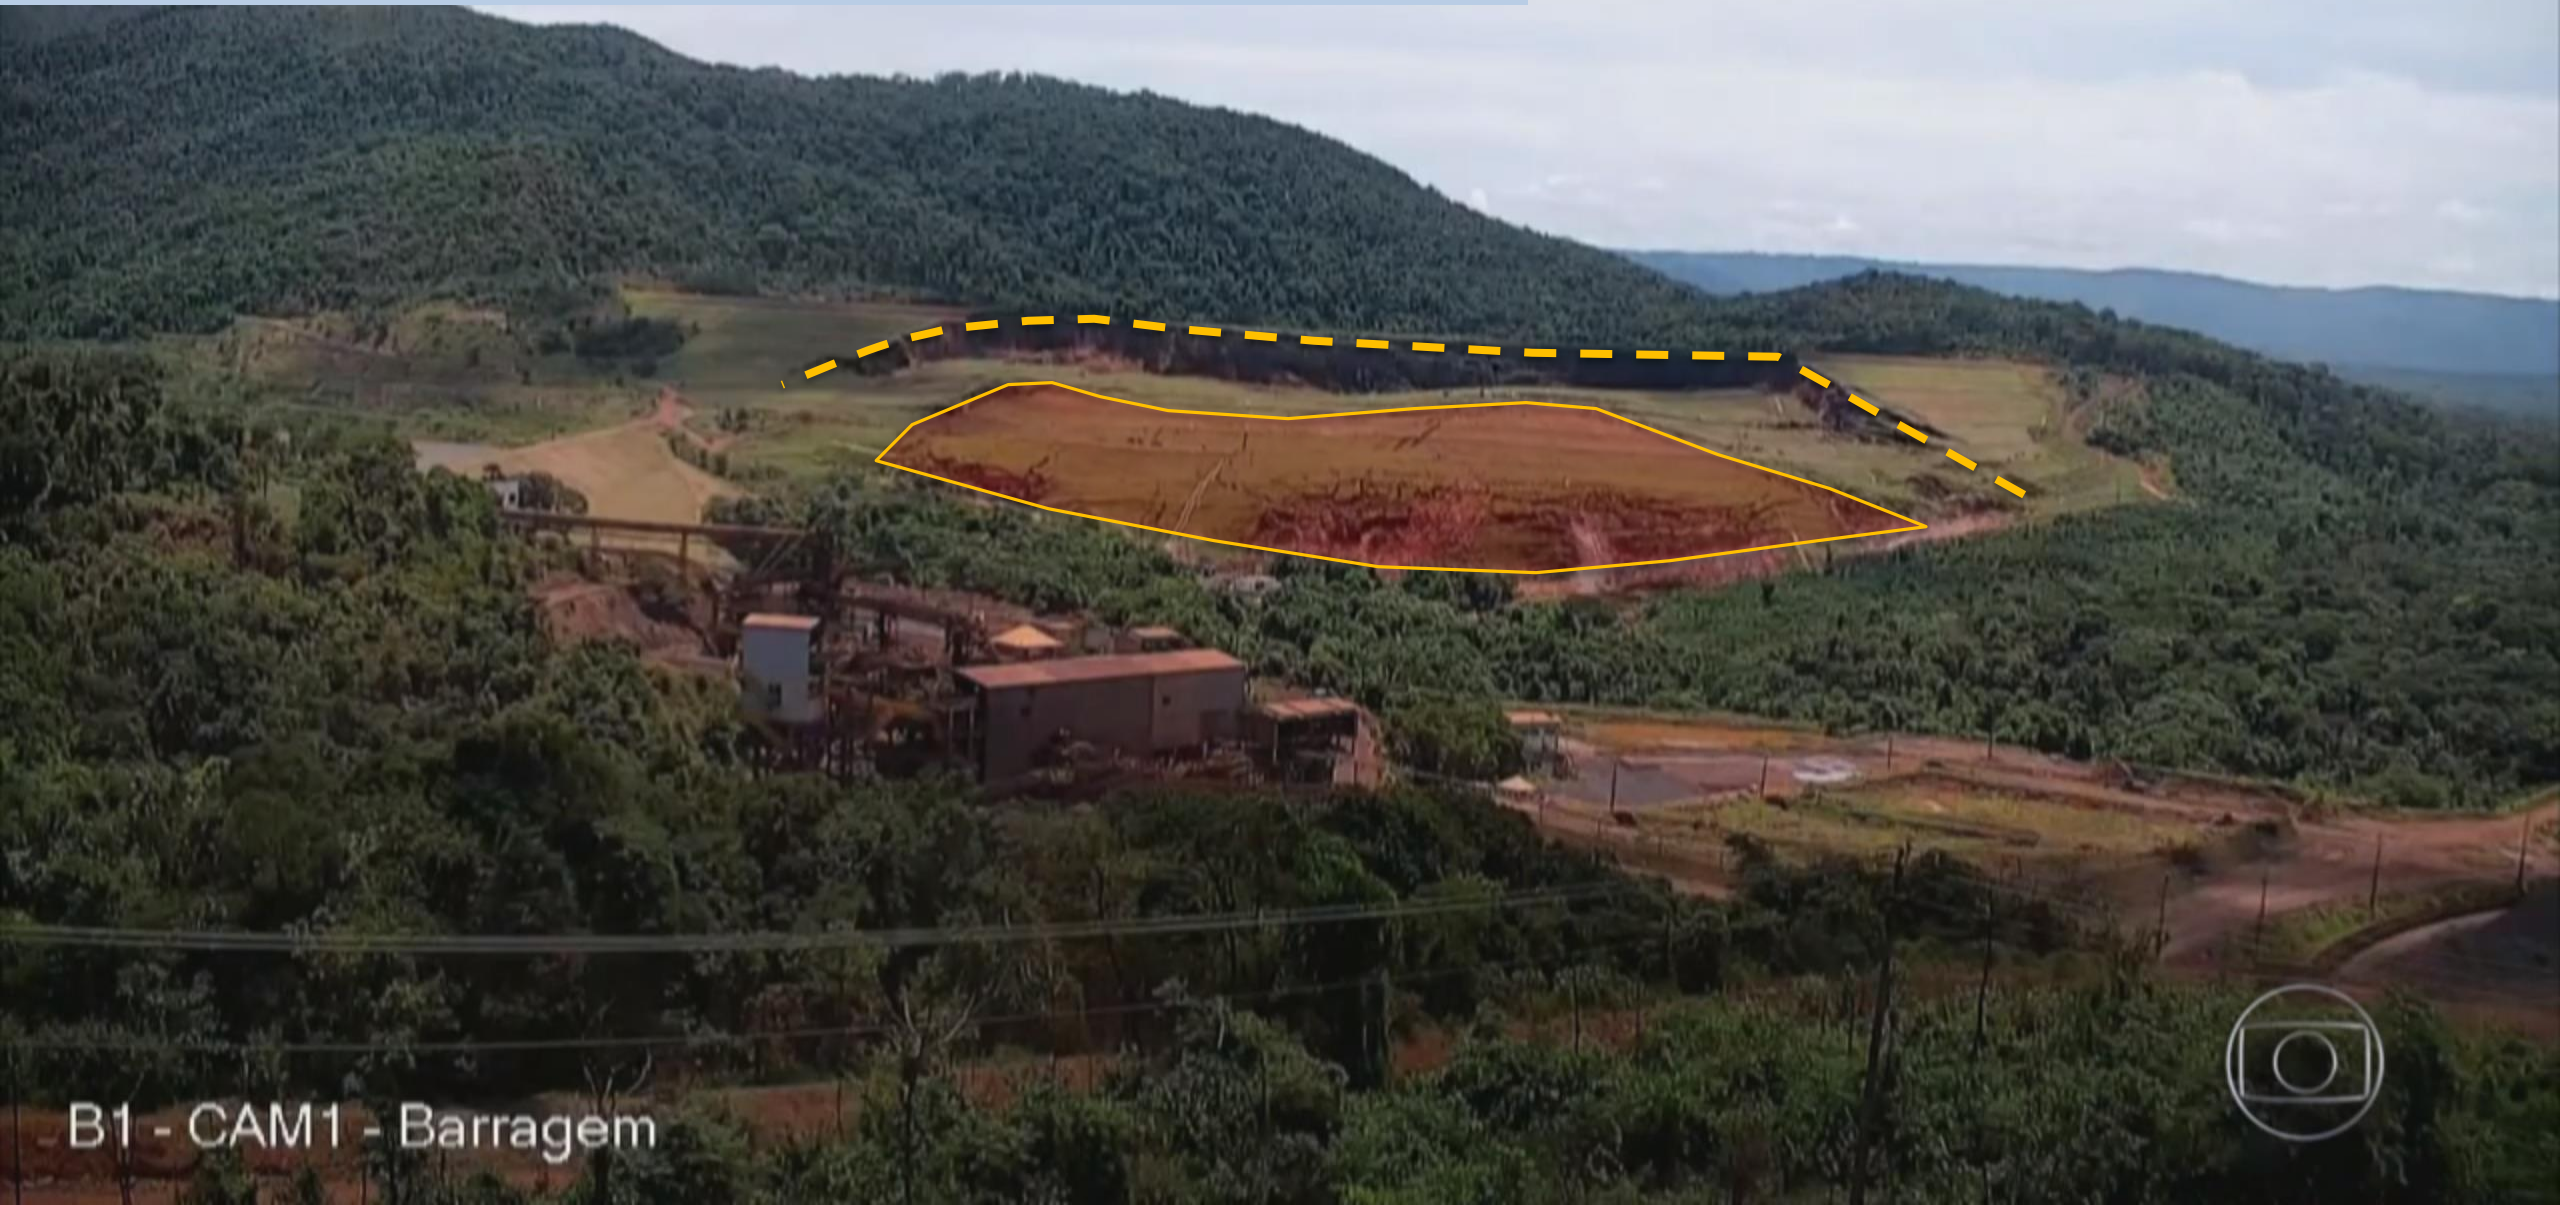
B1 - CAM1 - Barragem

Date:	Jan 22, 2019, sudden, no warning
Type:	86 m upstream method tailings dam for iron mine, no filling for 3 years prior to failure
Failure Mode:	--to be determined--
Volume Spilled:	12 million cubic meters of liquefied tailings flowed 5 miles to Paraopeda River at average rate of 1 m/sec
Consequences:	Mud flow killed 248+ people, 22 missing, financial consequences will be in billions of dollars, individuals arrested. Owner stock valuation fell \$19 Billion in single day
