Atlantic Croaker at the Coastal Virginia Offshore Wind Farm

NASEM Standing Committee on Offshore Wind
Energy and Fisheries Winter Meeting 2024

Coastal Virginia Offshore Windfarm (CVOW)

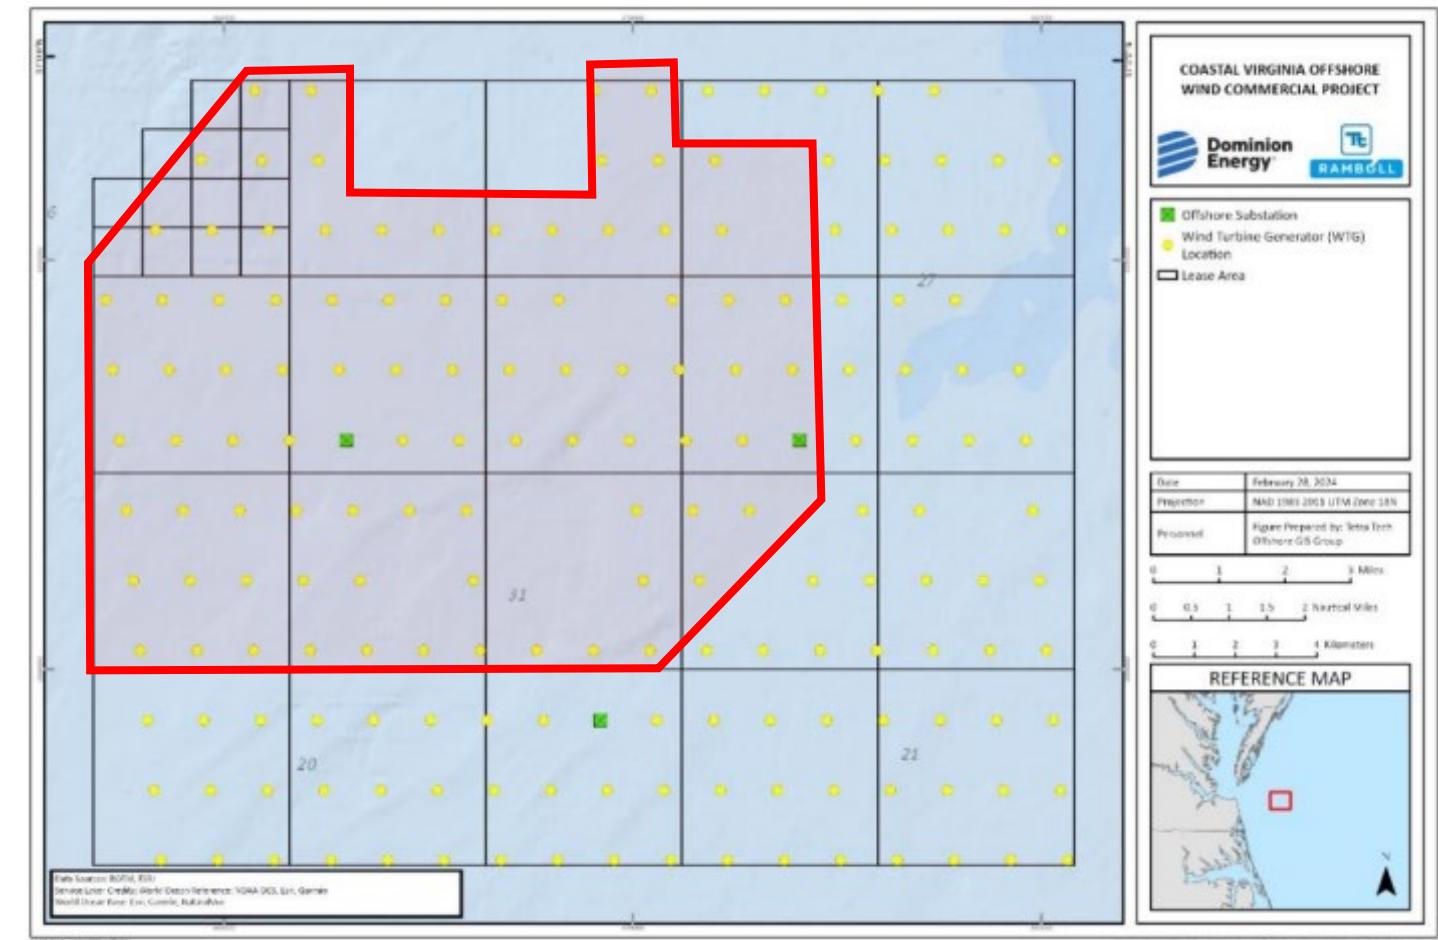
Observations of Deceased Croaker at CVOW

- 39 observations at 24 foundation locations
 - Average is 450 fish per observation
 - Observations occurred at ~ 30% of the installed foundations
 - No observations in July or September

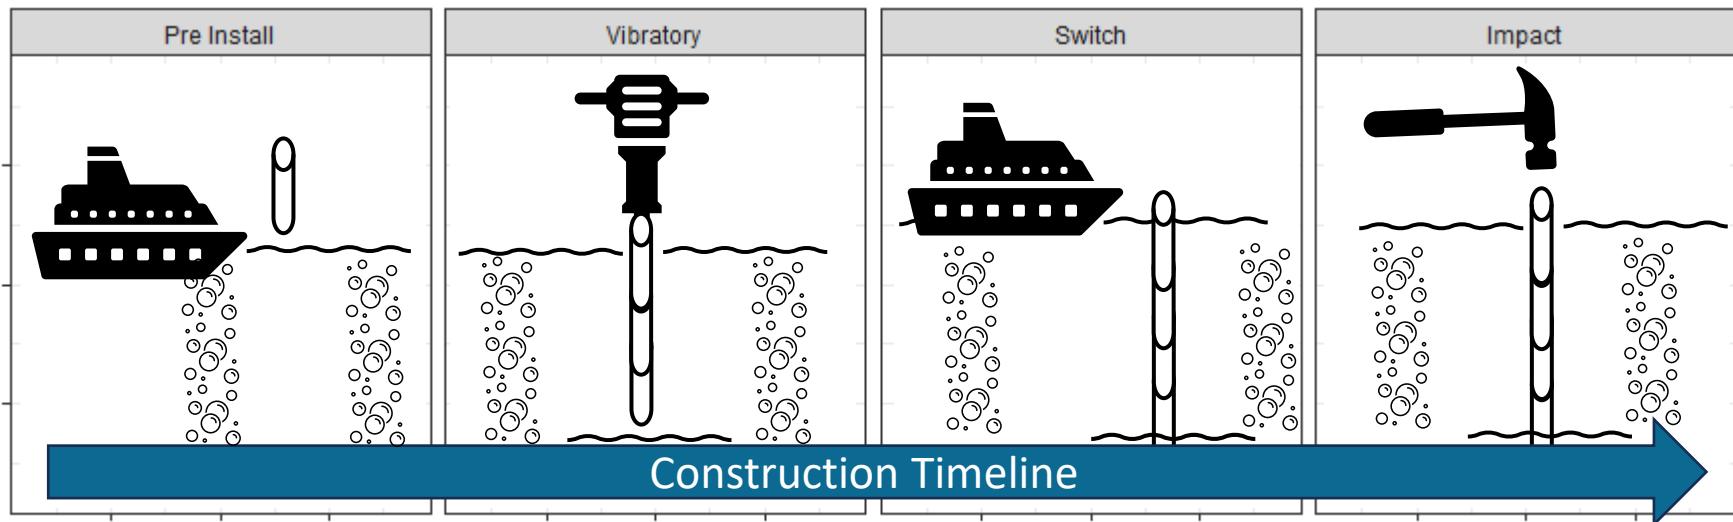
Construction Event	Mean Distance from Pile (m)	Mean Num. of Fish Observed	Total Fish	Num. of Observations	Percent of Observed Fish	Percent of Observations
No Construction	2,420	690	3,450	5	19%	13%
Pre-install	487	716	10,740	15	59%	38%
Vibratory piling	99	194	970	5	5%	13%
Post vibratory, pre impact ("switch")	606	163	1,792	11	10%	28%
Impact piling	3038	383	1,150	3	6%	8%
				18,102	39

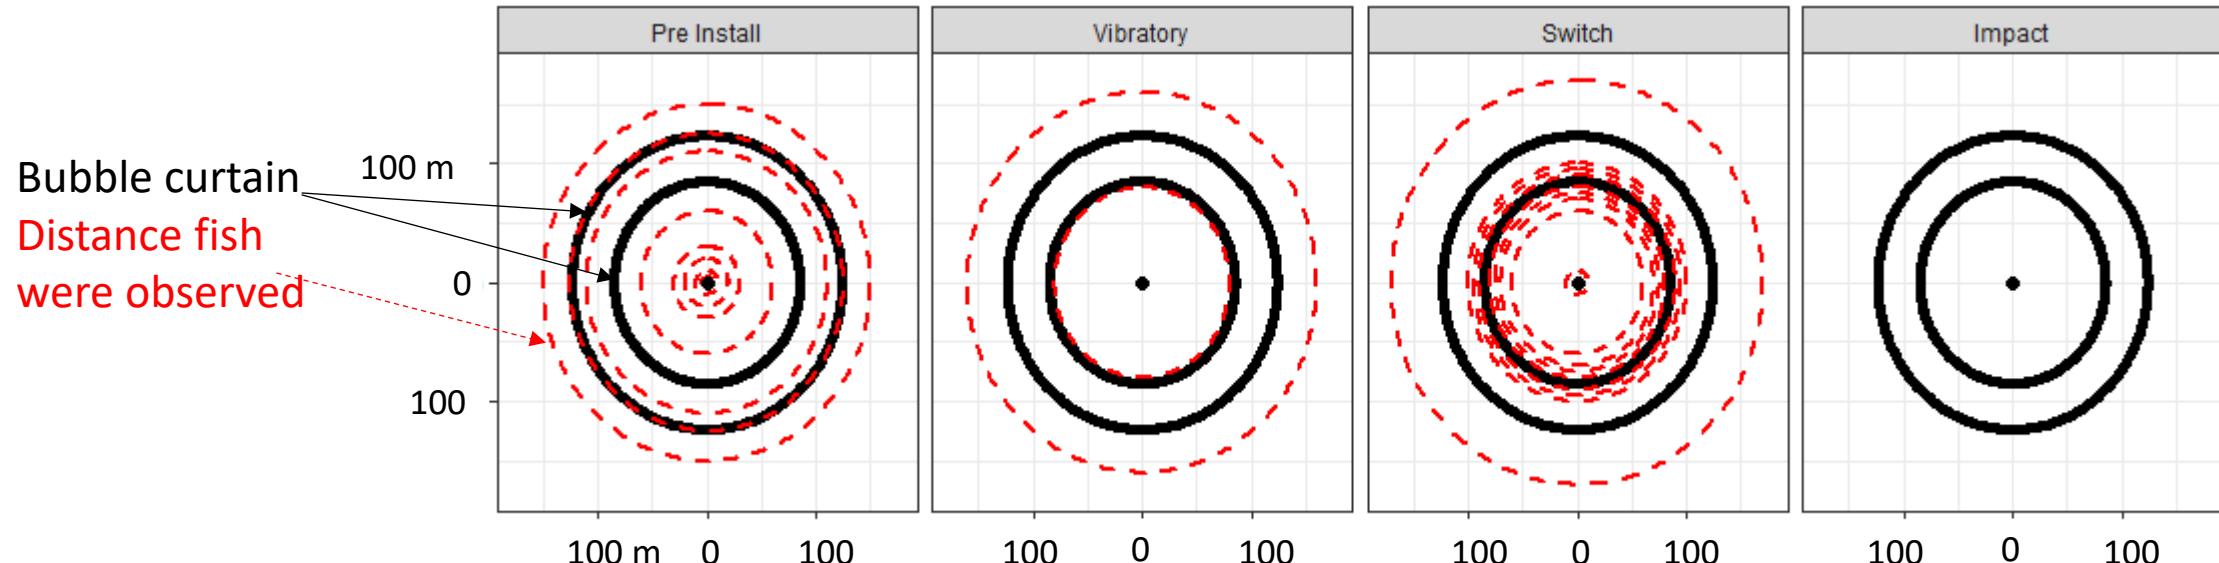
Construction Event	Mean Distance from Pile (m)	Mean Num. of Fish Observed	Total Fish	Num. of Observations	Percent of Observed Fish	Percent of Observations
No Construction	2,420	690	3,450	5	19%	13%
Pre-install	487	716	10,740	15	59%	38%
Vibratory piling	99	194	970	5	5%	13%
Post vibratory, pre impact ("switch")	606	163	1,792	11	10%	28%
Impact piling	3038	383	1,150	3	6%	8%
			18,102	39

25% of observations occurred greater than 1 km away from the pile

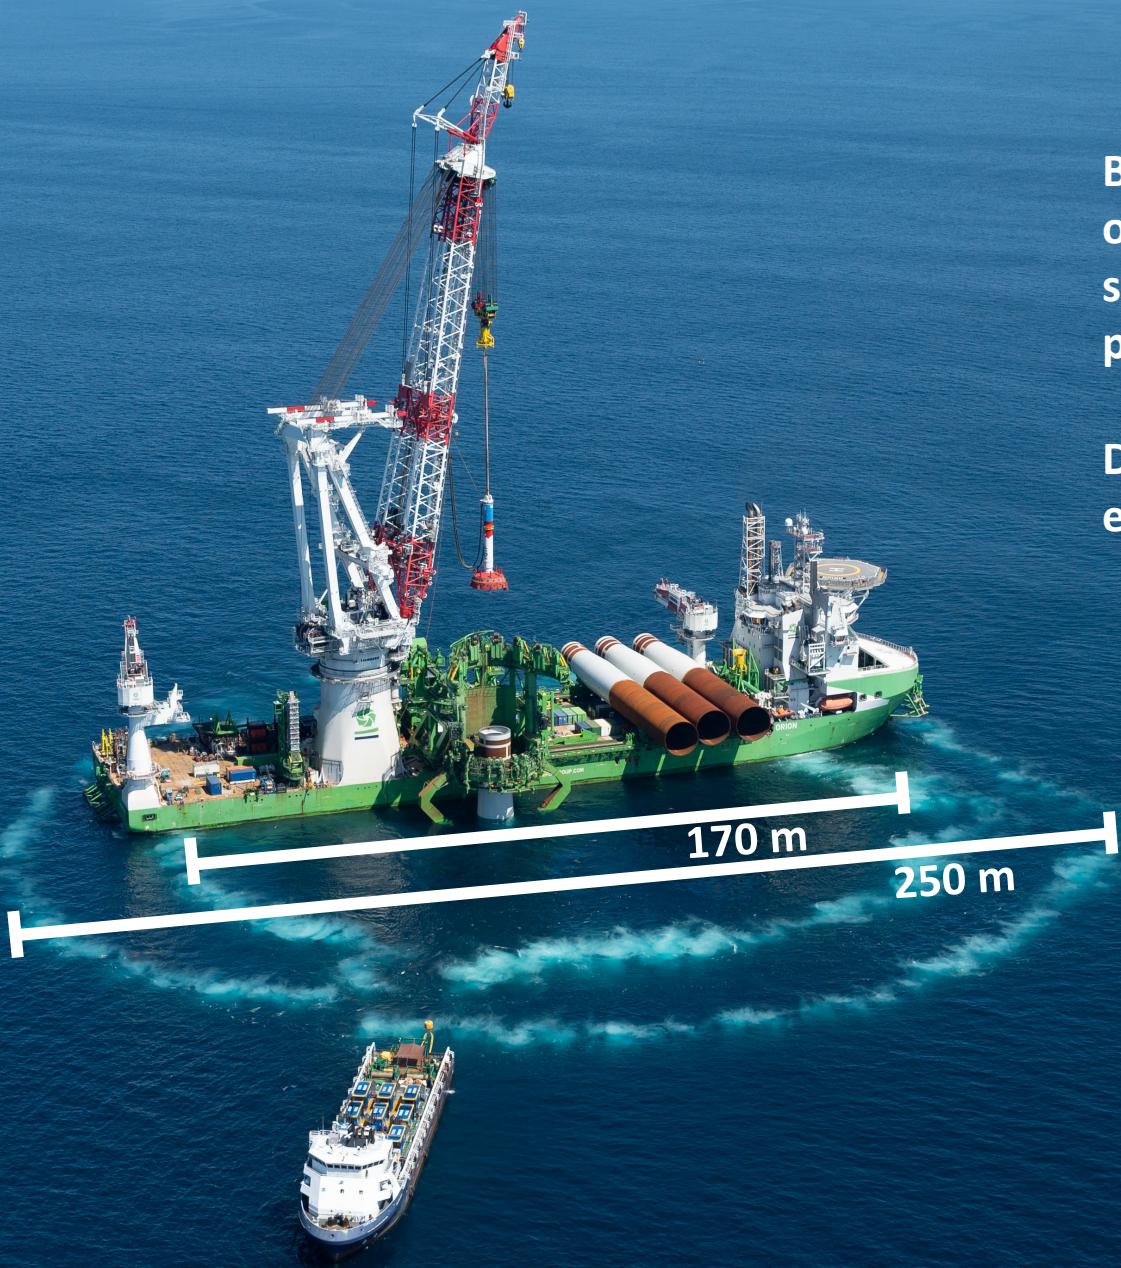
Bubble curtains are used during installation of monopile foundations to attenuate sound, thereby reducing noise impacts for protected species & fish

Double bubble curtains can reduce sound energy level by 90 %
