National Research Council's Resilient America Roundtable April 22, 2015

Michael L. Bobby
Acting Superintendent

Seismic Evaluations of Six Charleston County Schools

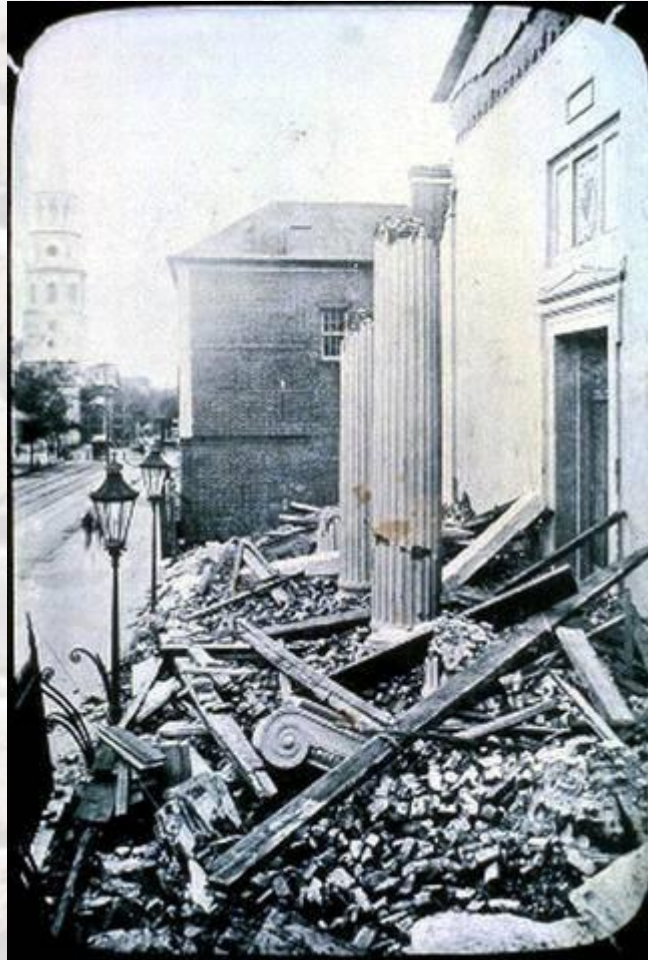
- *Damaged or destroyed many buildings and killed somewhere between 60 and 124 people (depending on sources)*
- *Property damage was estimated at \$5-\$6 million (1886 dollars) and damage impacted thousands of buildings*

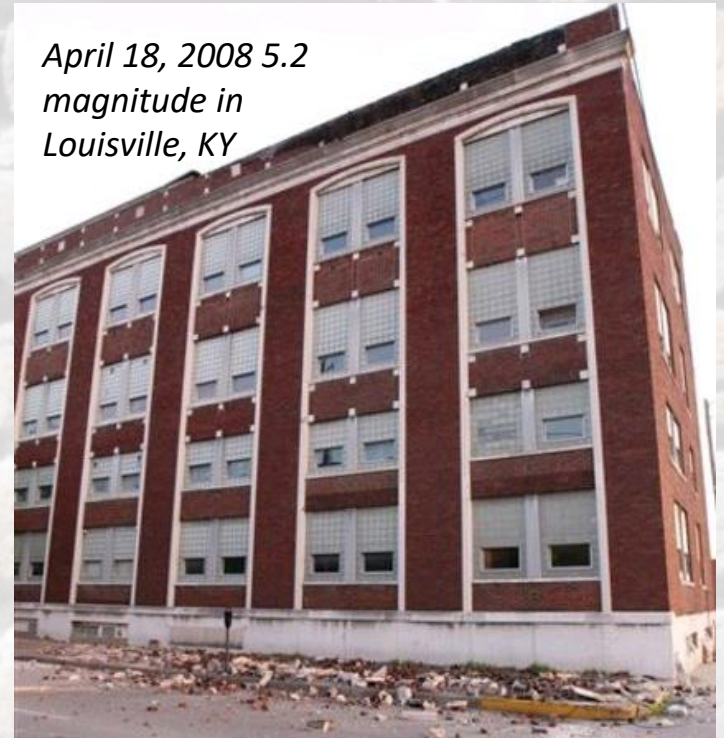
FEMA 310:
significant damage, but margin against either partial or total collapse remains

Injuries may occur, but the level of risk for life-threatening injury and entrapment is low

April 18, 2008 5.2
magnitude in
Louisville, KY

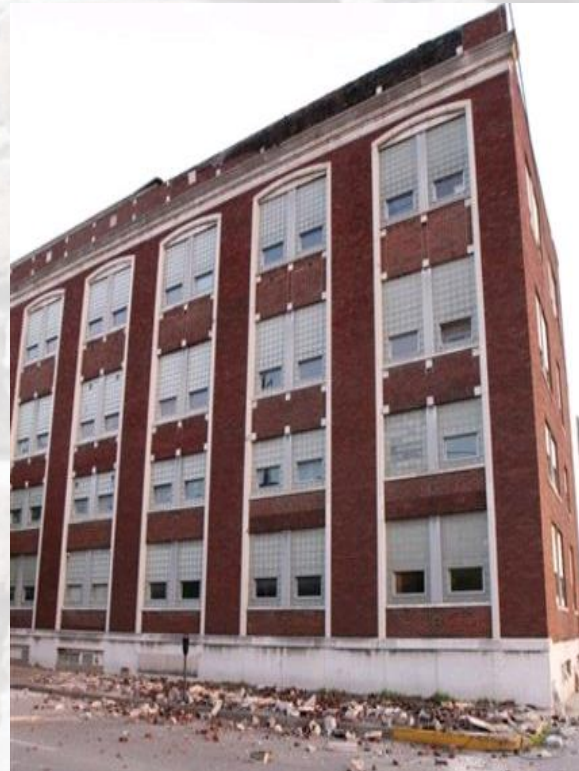
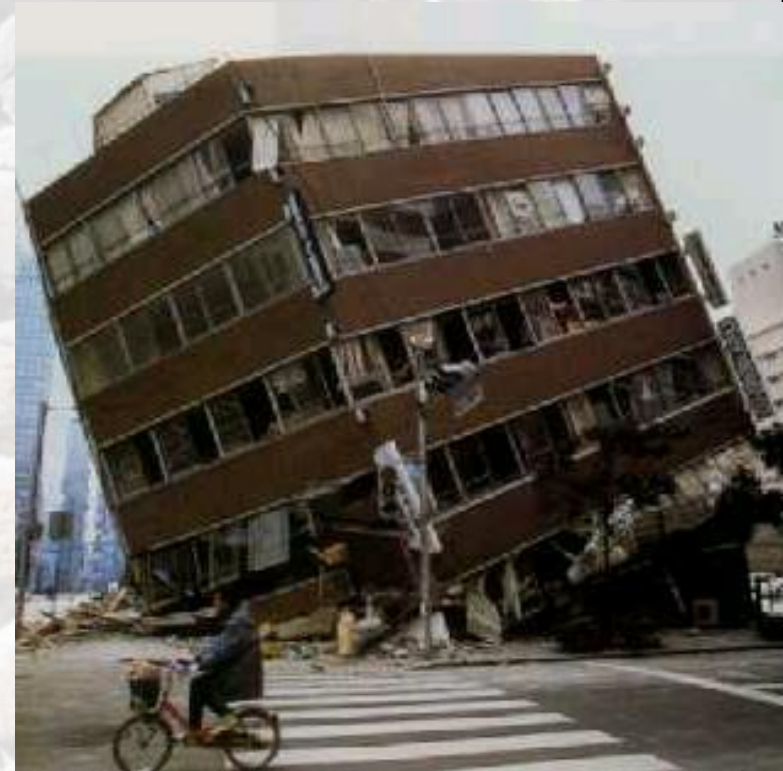
You get building on left vs. building on the right.

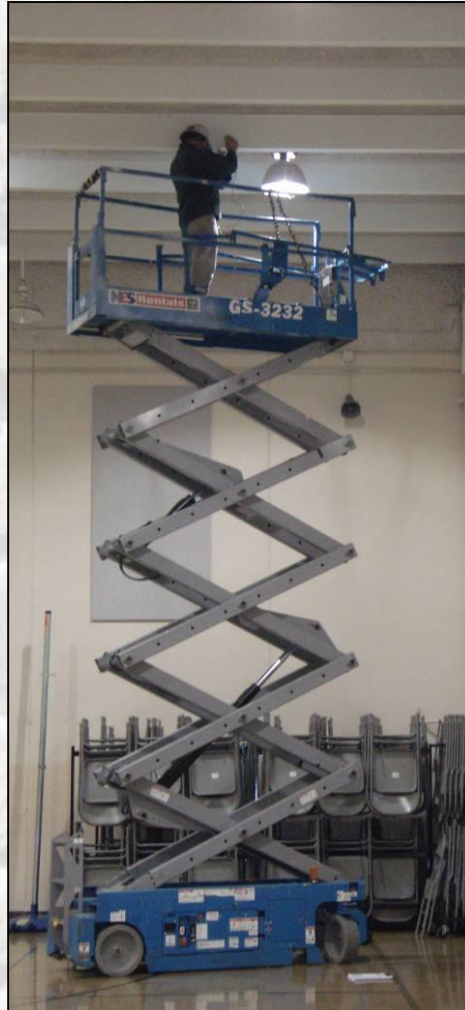
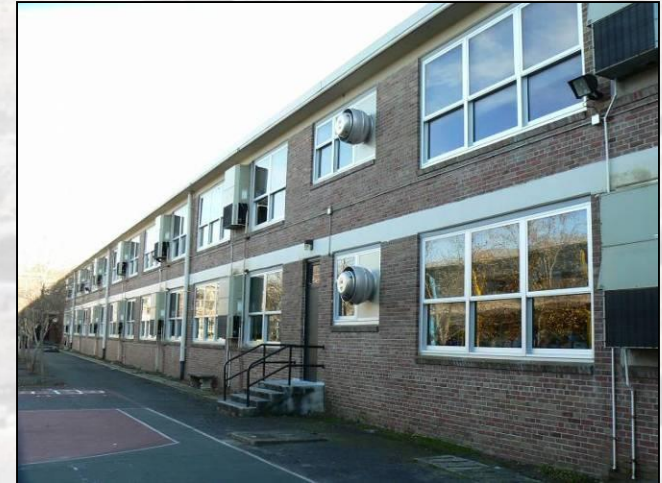
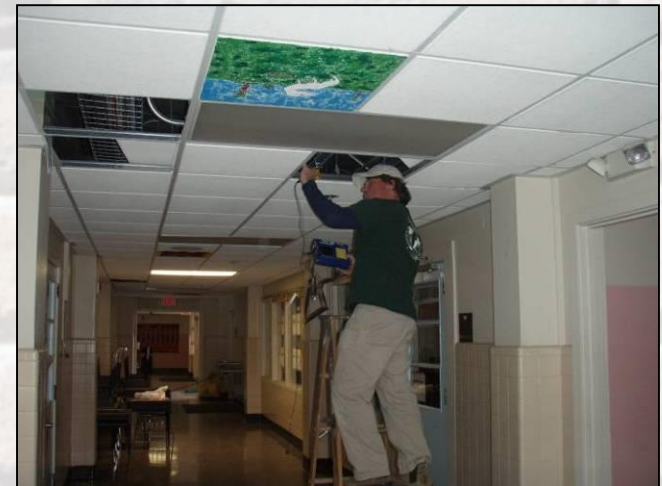
IV. CHARLESTON PROGRESSIVE

- A. Main Building
- B. Annex
- C. Addition
- D. Gymnasium

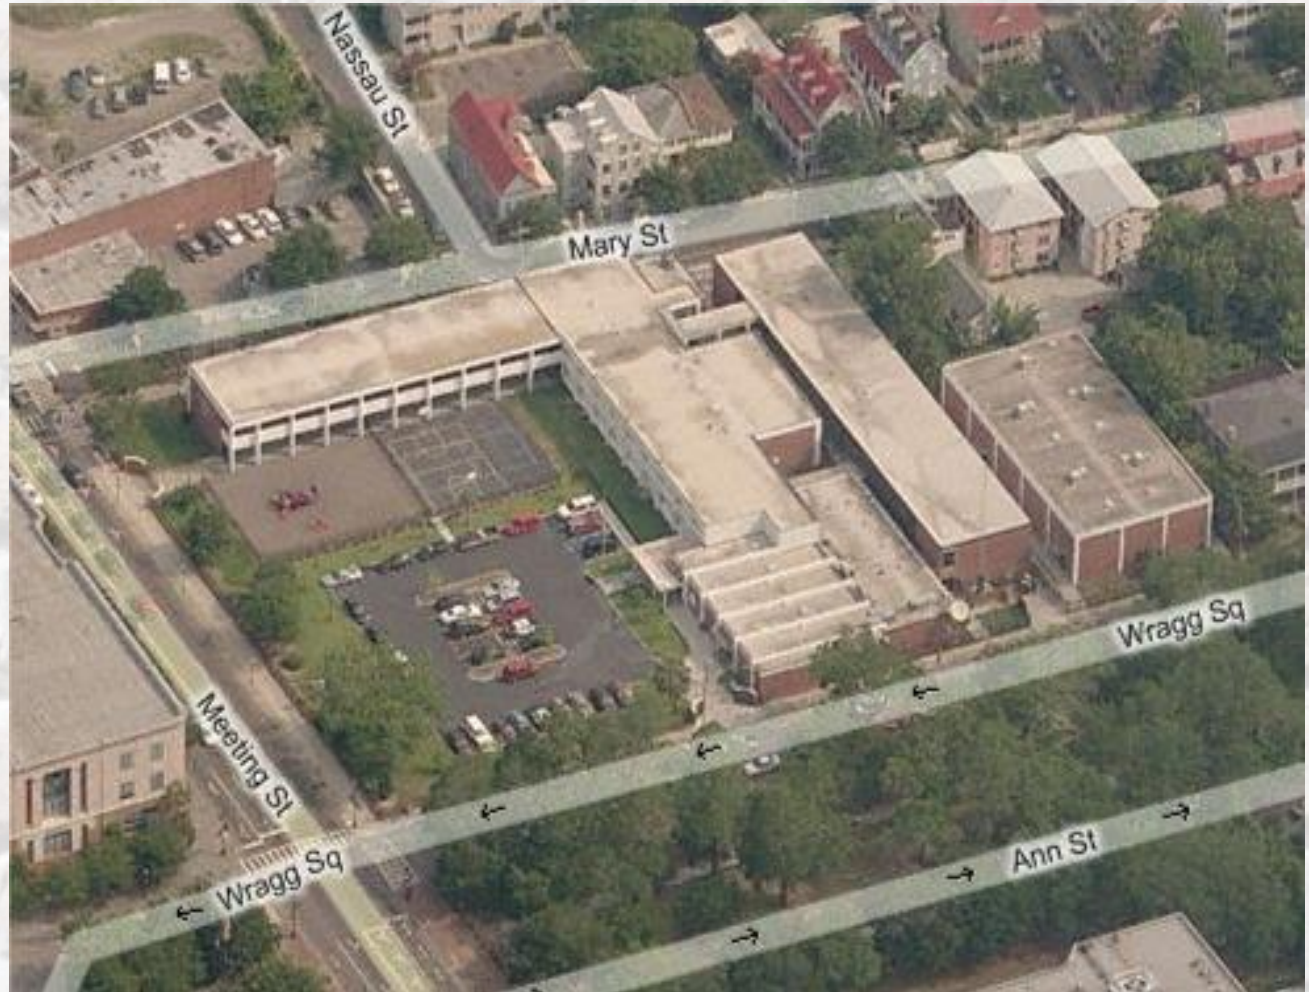
TIER 1 & 2 Deficiencies – Non-Structural

A. Adjacent Elements

B. Narrow Contents

C. Attached Equipment

D. Flexible

E. Glazing

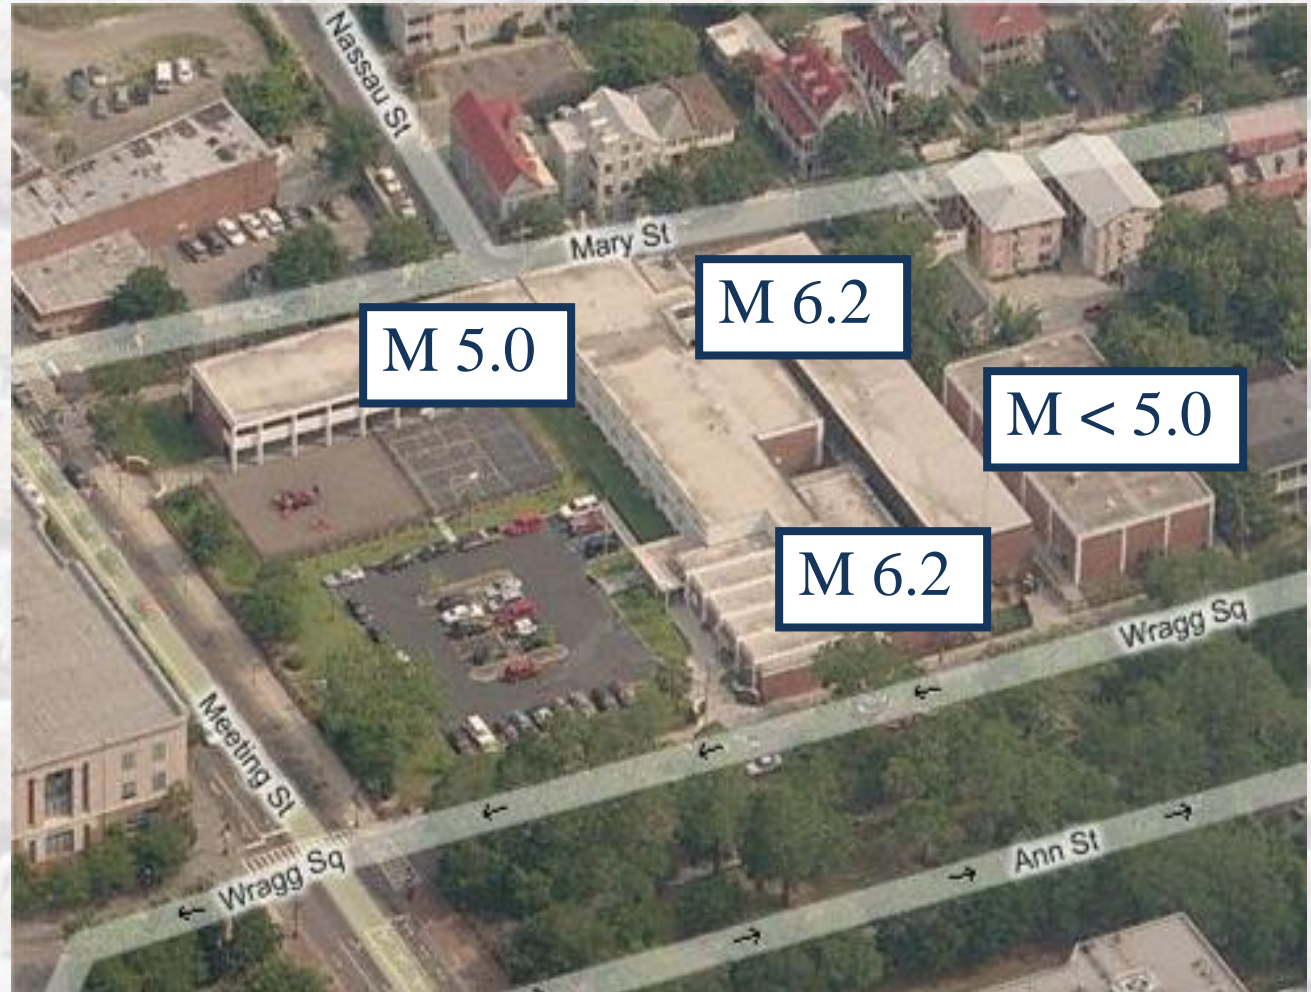
Proposed Retrofit Measures

- A. New Shear Wall
- B. Wall Strengthen Shotcrete
- C. Wall Strengthen FRP
- D. Create Loadpath
- E. Earthquake Drains

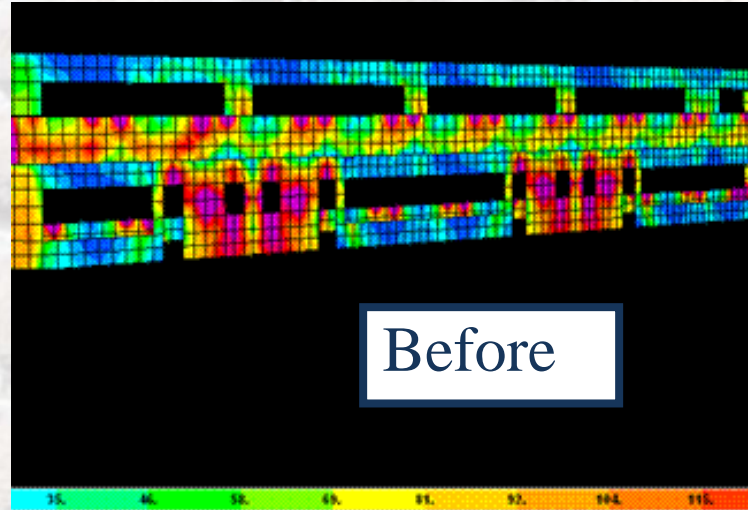
- A. New Shear Wall
- B. Wall Strengthen Shotcrete
- C. Wall Strengthen FRP
- D. Create Loadpath
- E. Earthquake Drains

Reduces stress in walls, and reduces load in concrete frame
