Enbridge Oil Spill

July 2010 Enbridge Line 6B Crude Oil Release – Marshall, Michigan

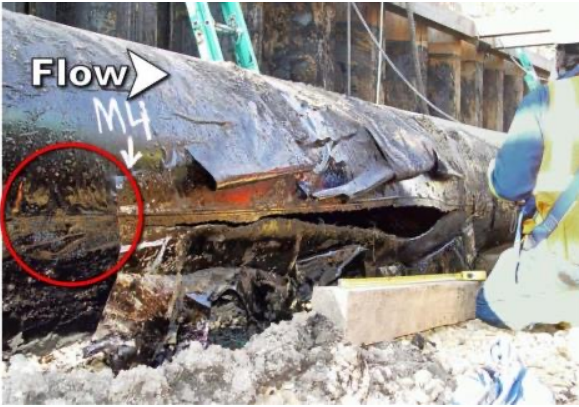
Source NTSB (2012)

- July 25, 2010 pipeline rupture
- 843,000 gallons of diluted bitumen (dilbit) released over 17 hours
- Wetland to Talmadge Creek to 38 miles Kalamazoo River
- 80 miles upstream from Lake Michigan

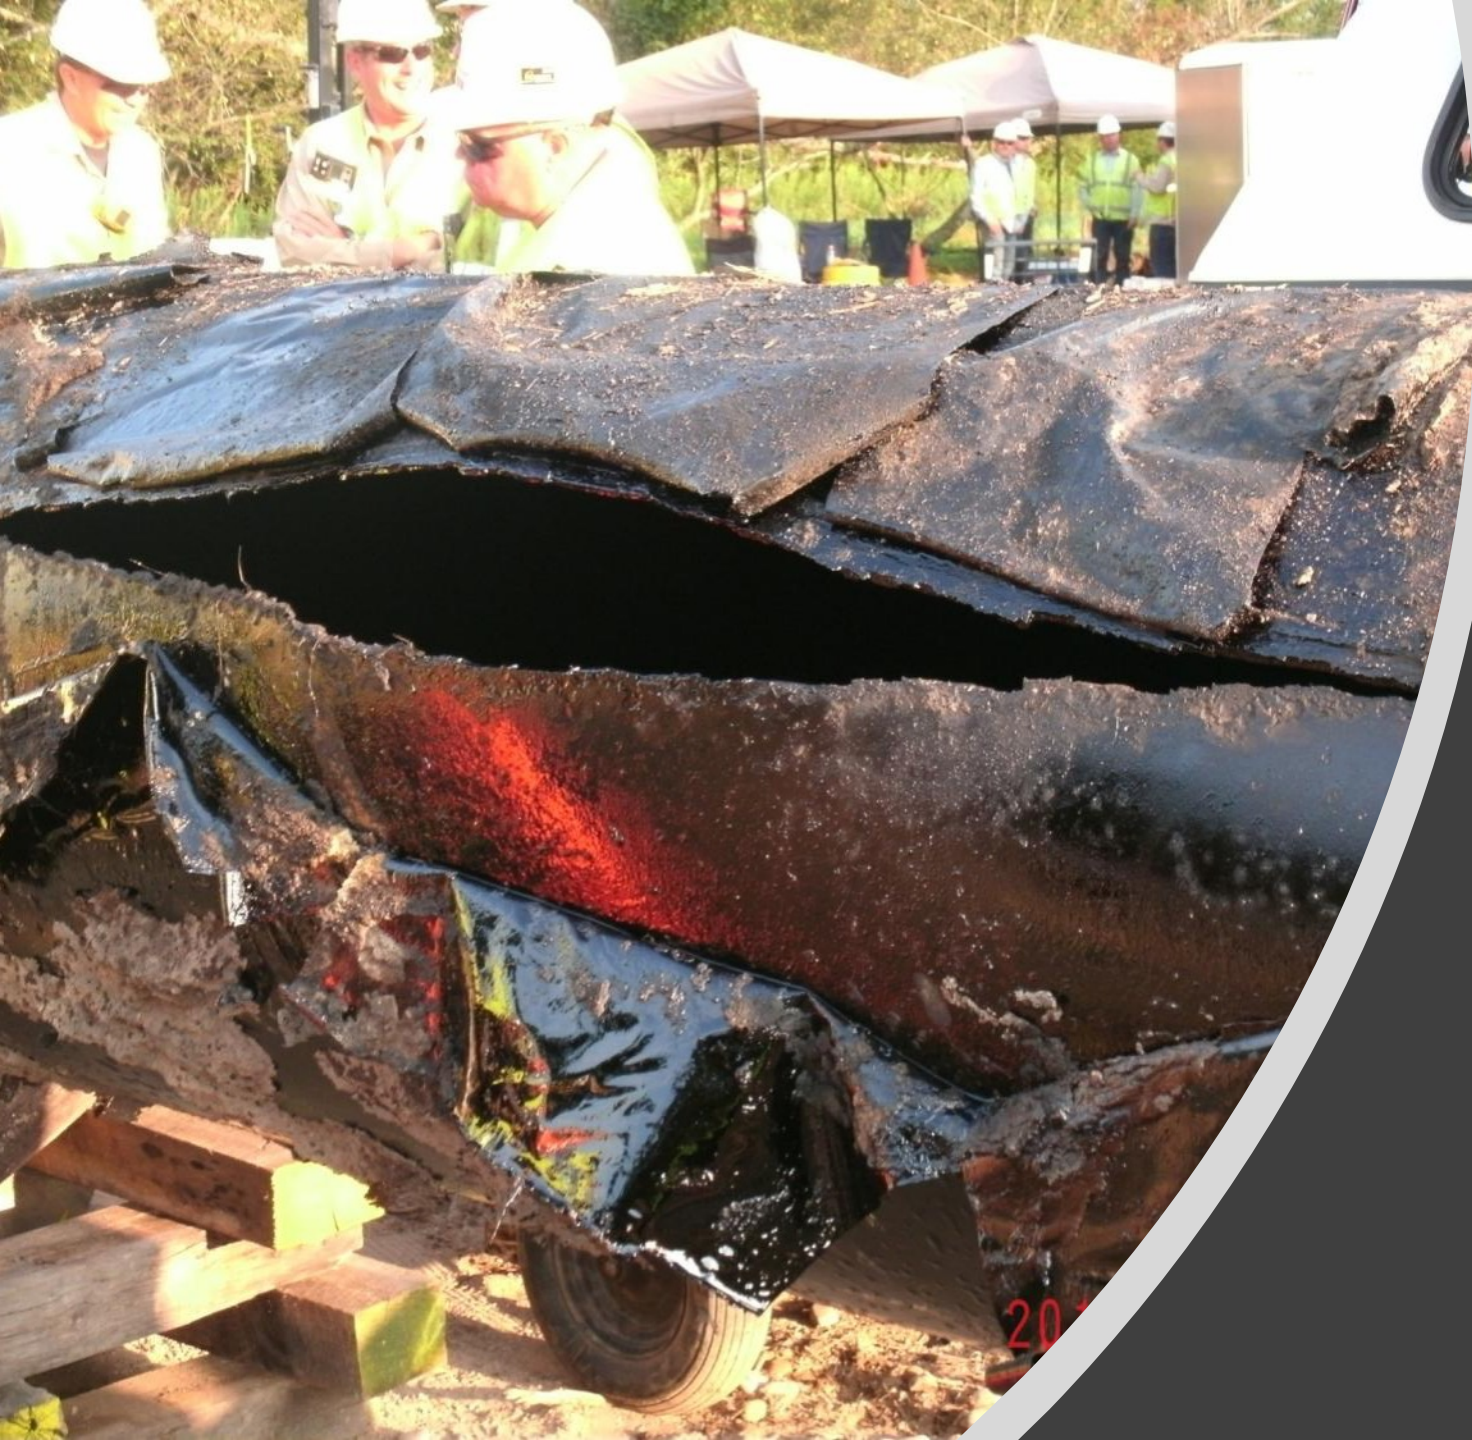
Enbridge line 6b – carrying DilBit

6 foot rupture

Where EPA first responded

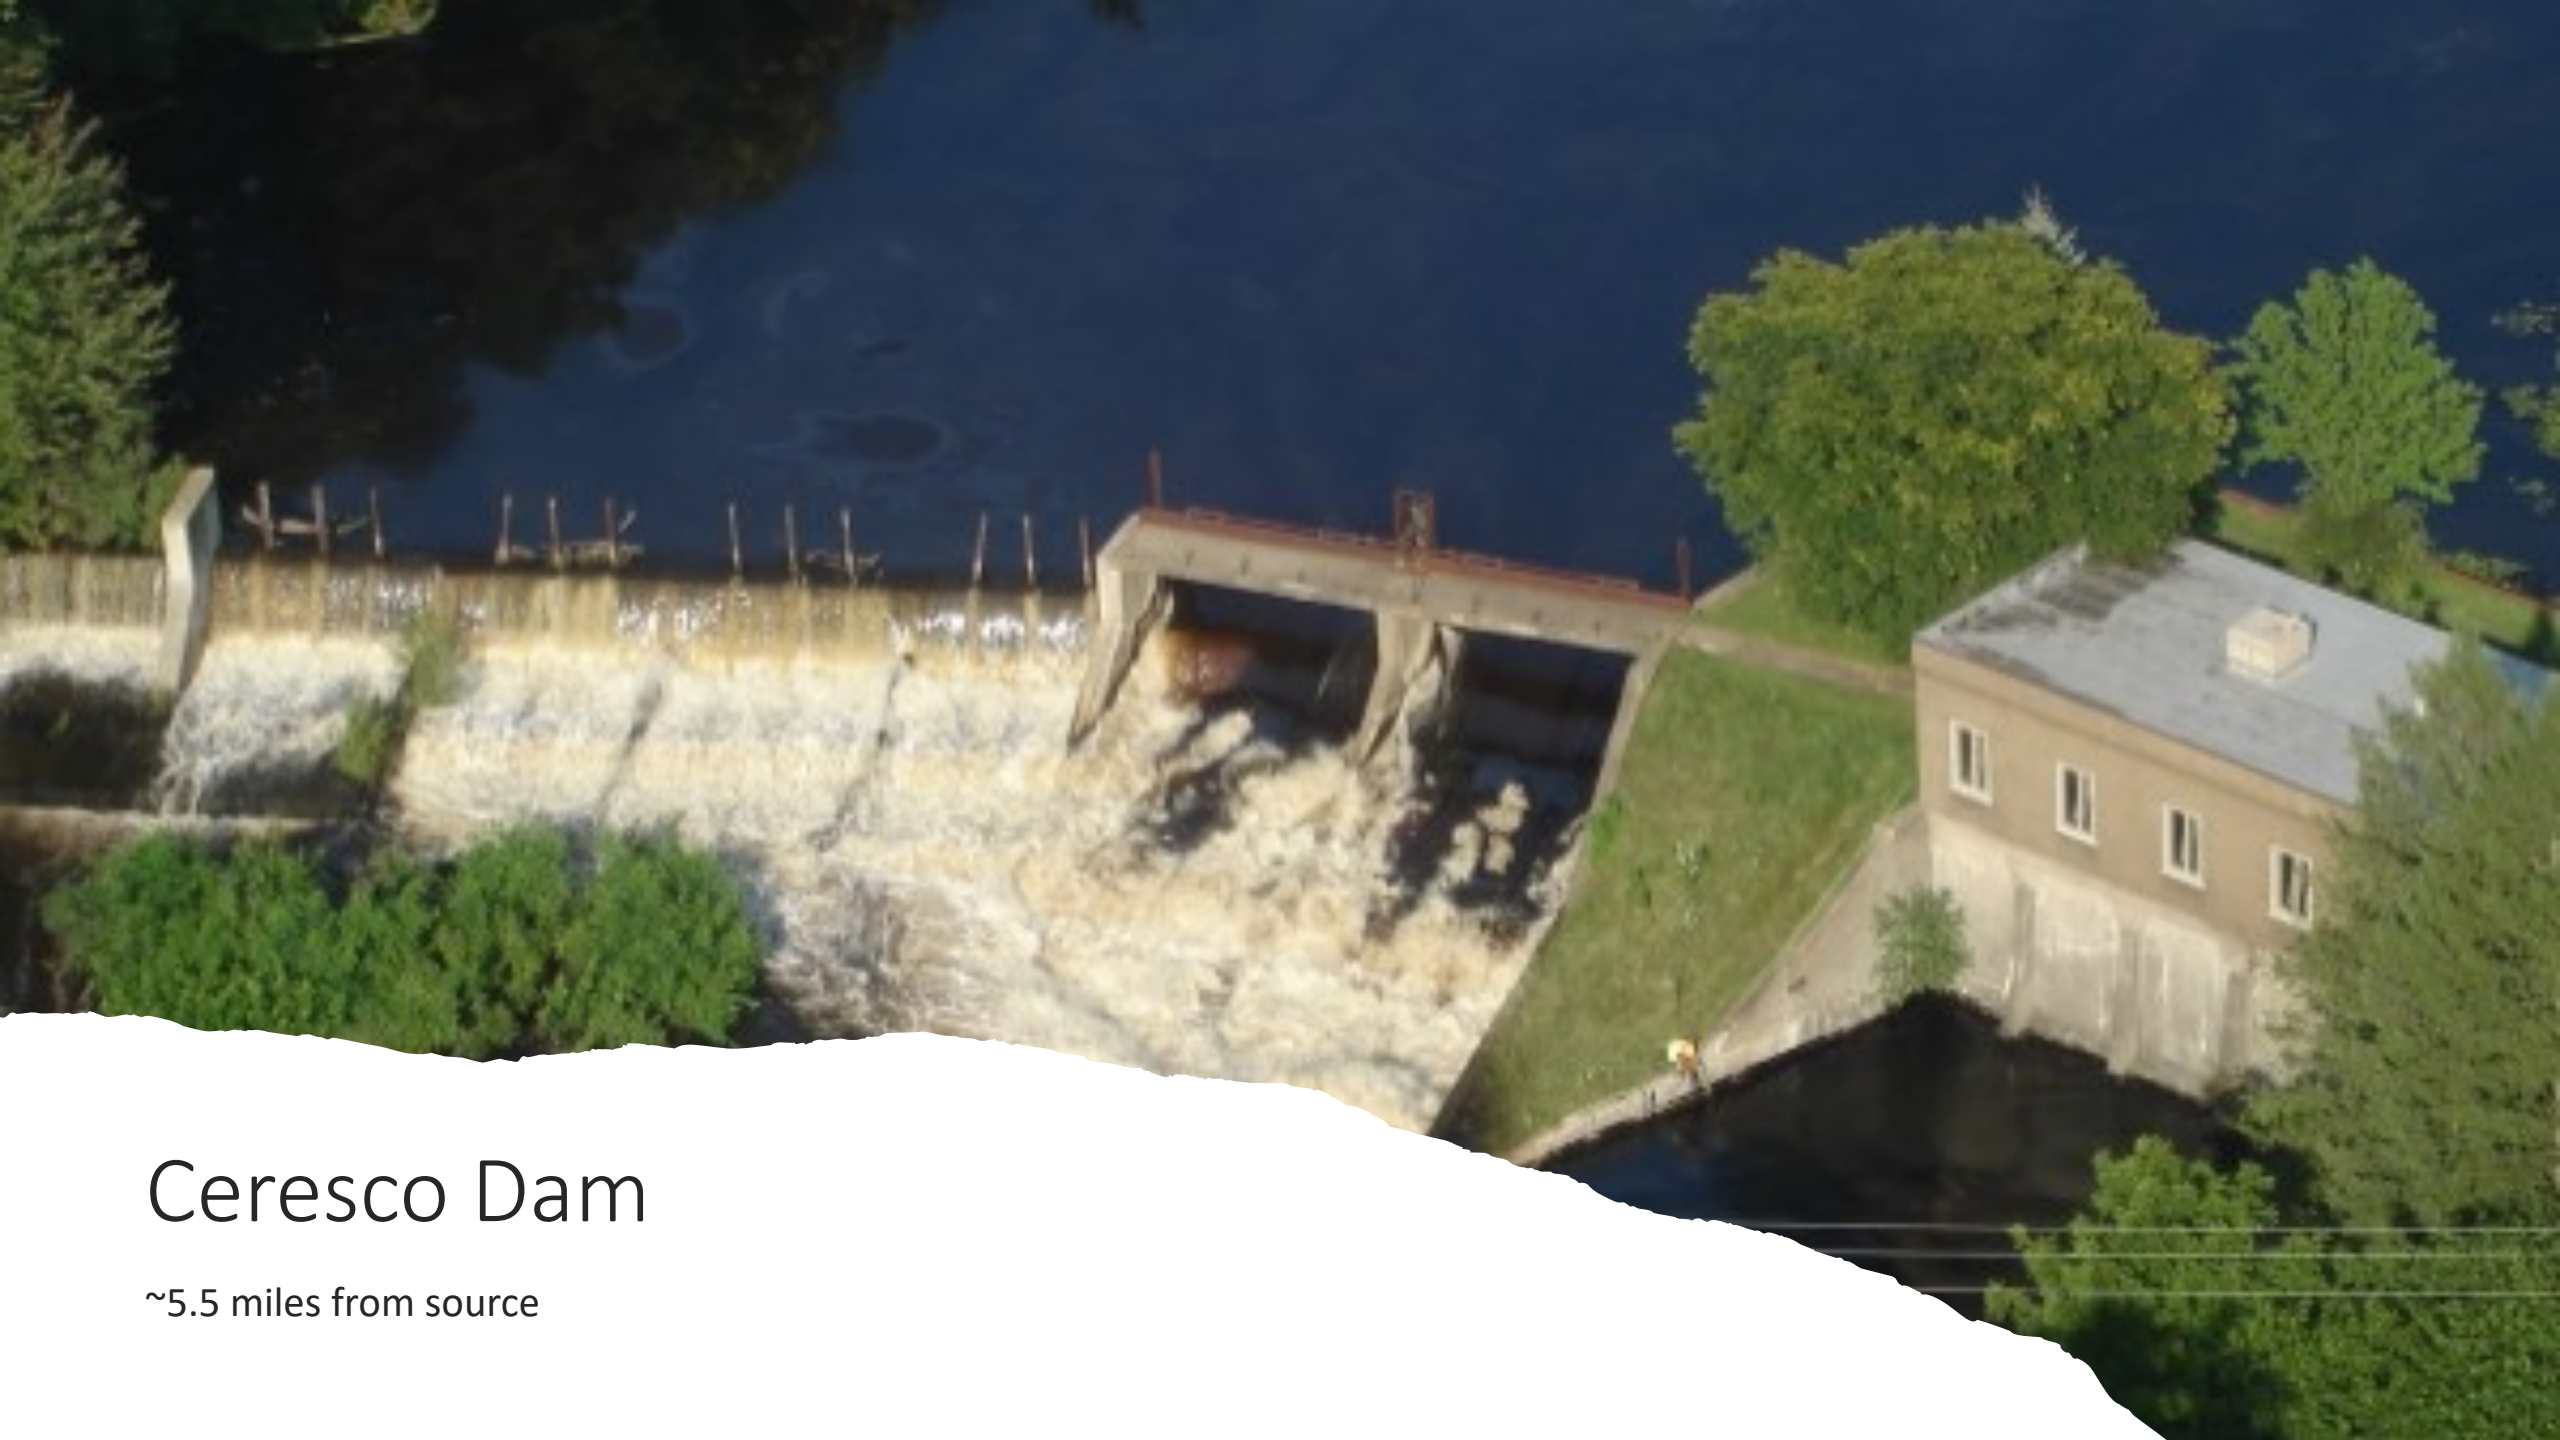
Ceresco Dam

~5.5 miles from source

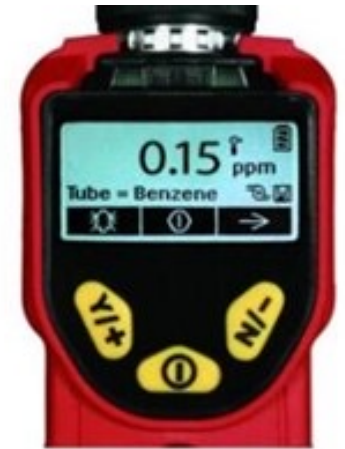
UltraRAE 3000

- Area RAEs are mobile air monitoring devices that will screen the air for pollutants – can be remotely monitored
- Handheld mobile air monitoring devices screen the air for benzene, LEL, CO, O₂, and VOCs.
- Handheld mobile air monitoring devices and area RAEs were deployed the night of the spill and were used to make Personal Protective Equipment (PPR) decisions.

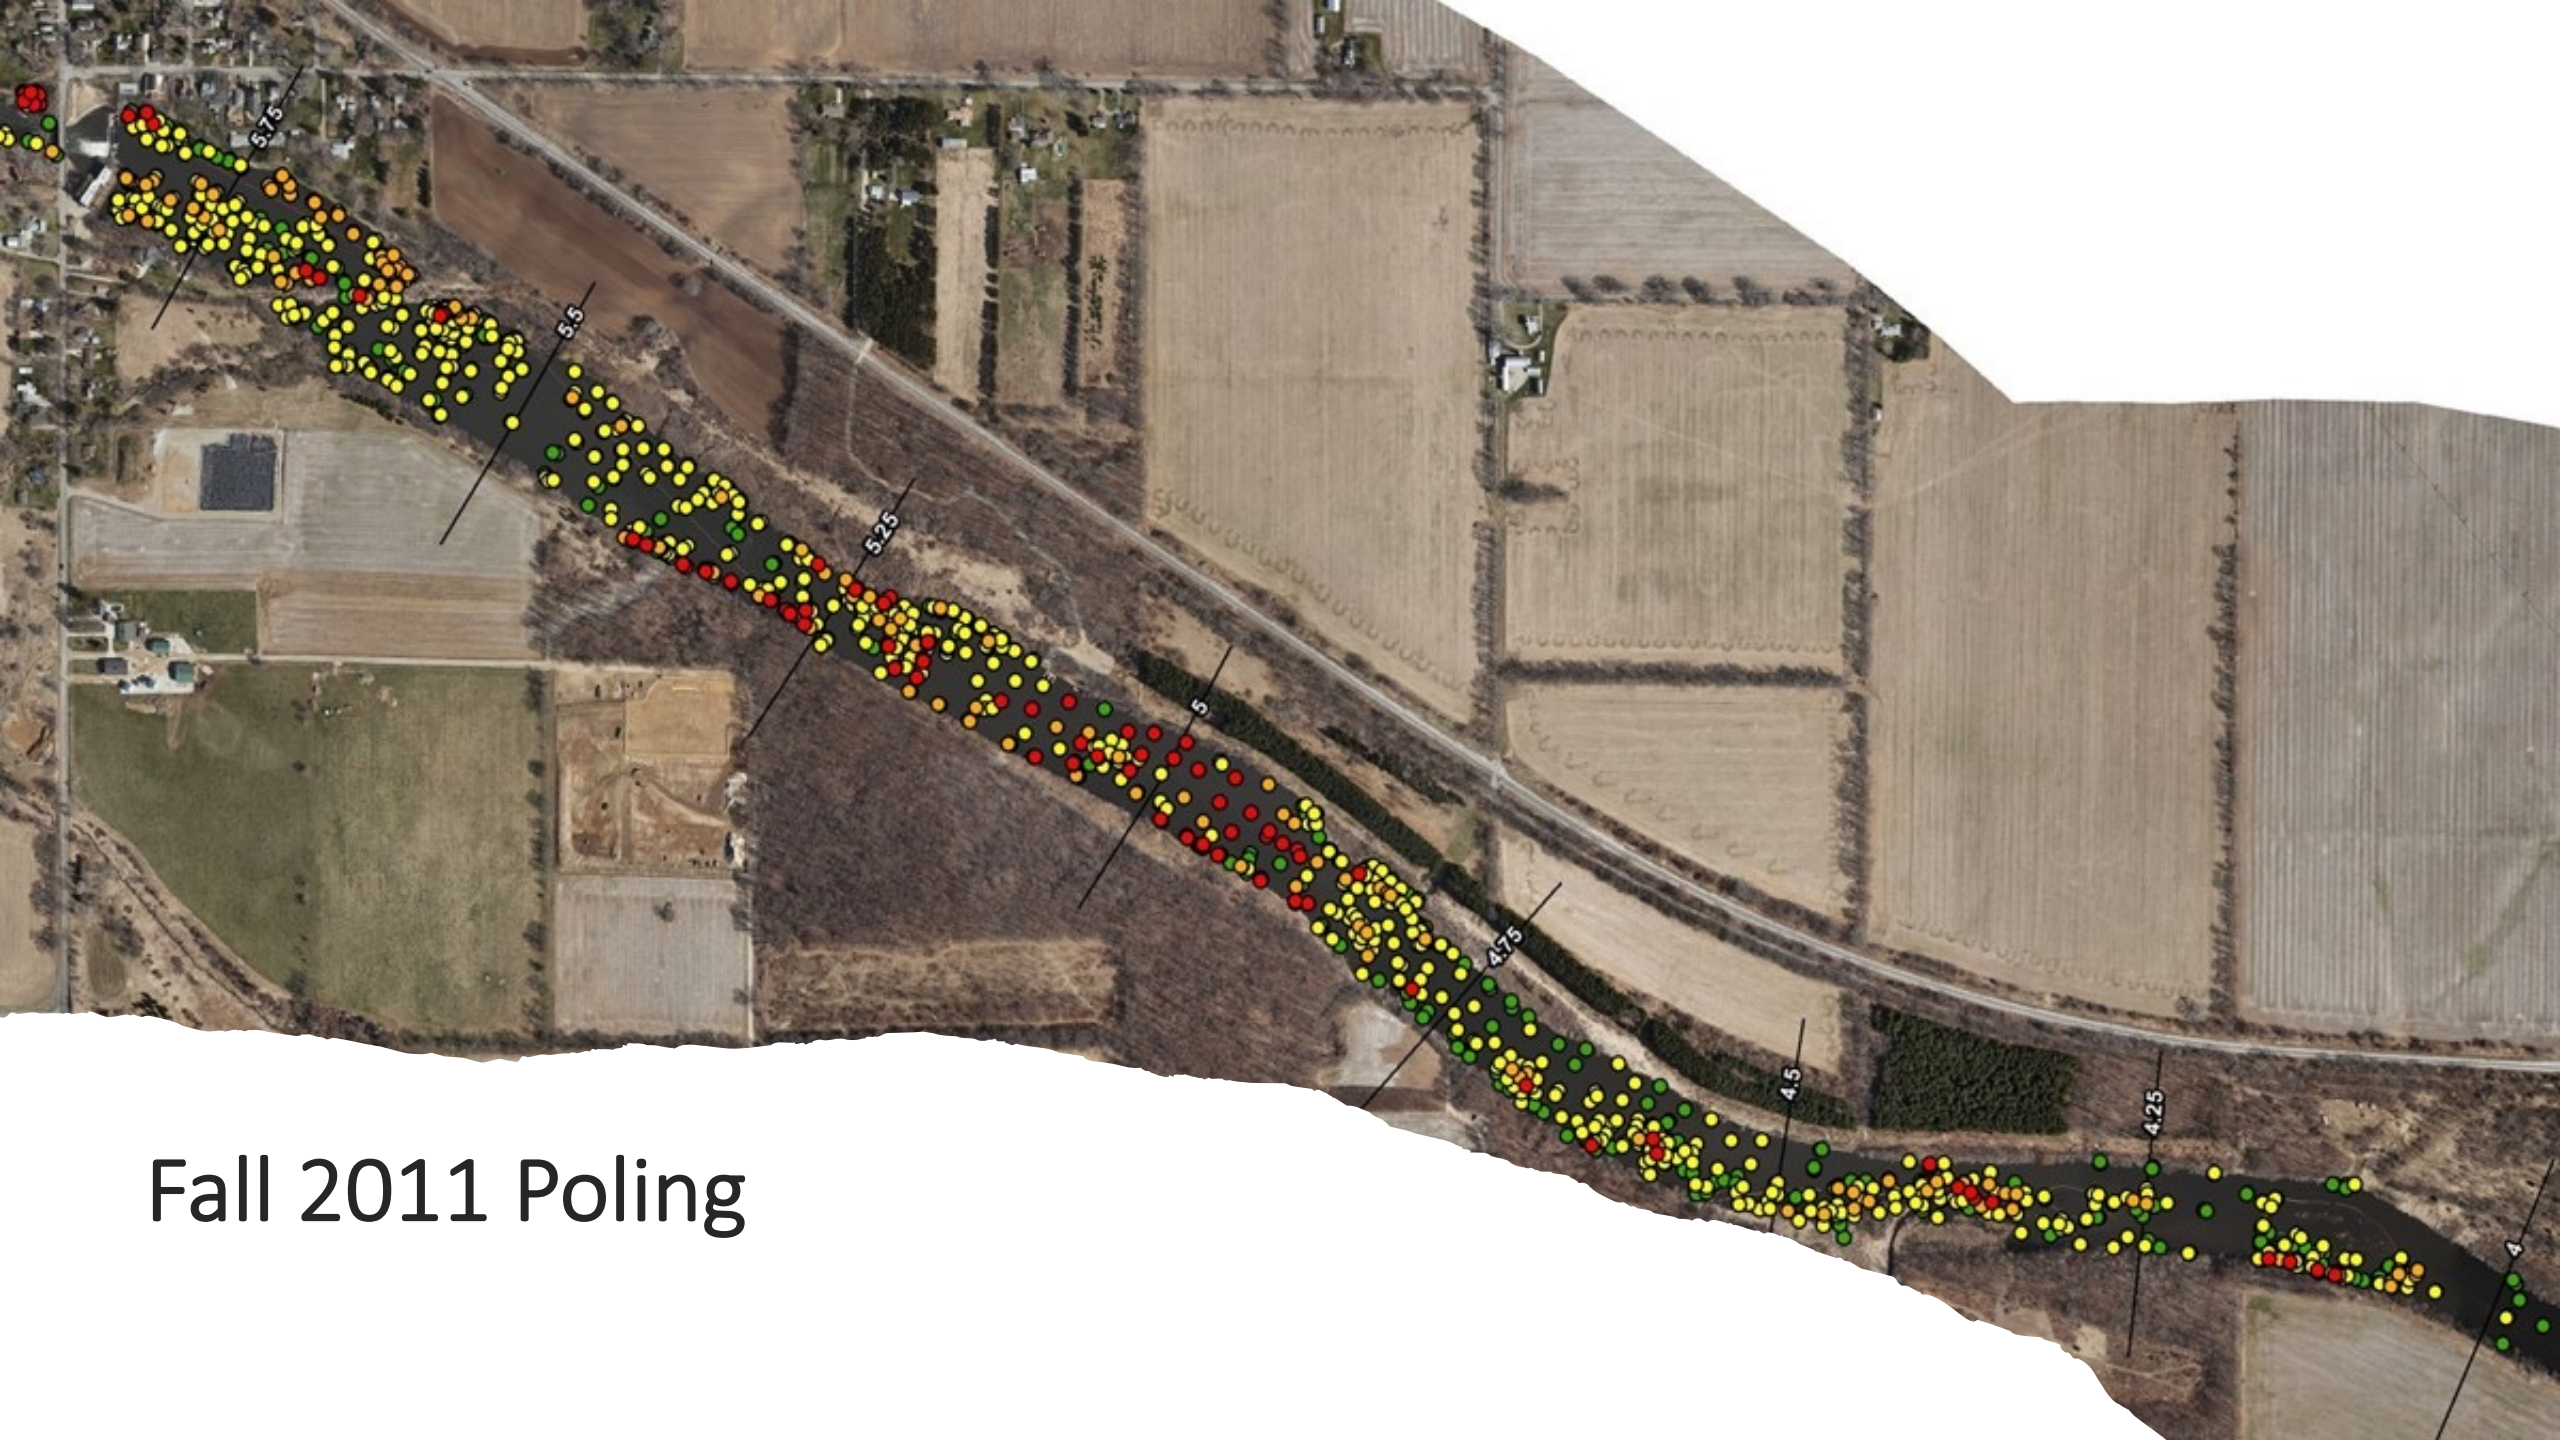
Fall 2011 Poling

Poling to support
dredge
operations
