Composite Material in U.S Coast Guard Aids to Navigation

LT Jon Benvenuto, P.E.

U.S. Coast Guard

Collins Engineers, Inc.

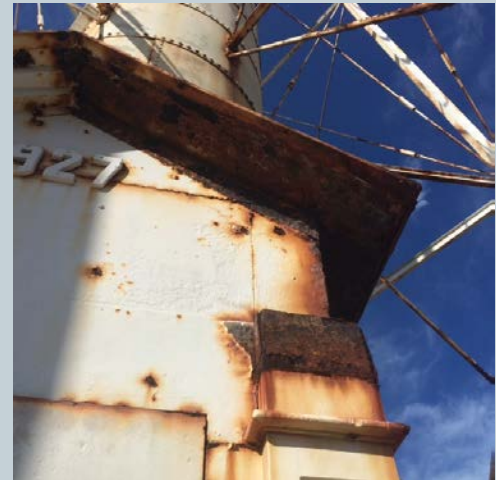
Corrosion

- Advancements in FRP = corrosion resistant, strong, lightweight and cost effective
- Structural material degradation from corrosion – large factor in engineering design
- 2014 - estimated worldwide corrosion cost to be \$2.2 trillion (>3% of the world's GDP)

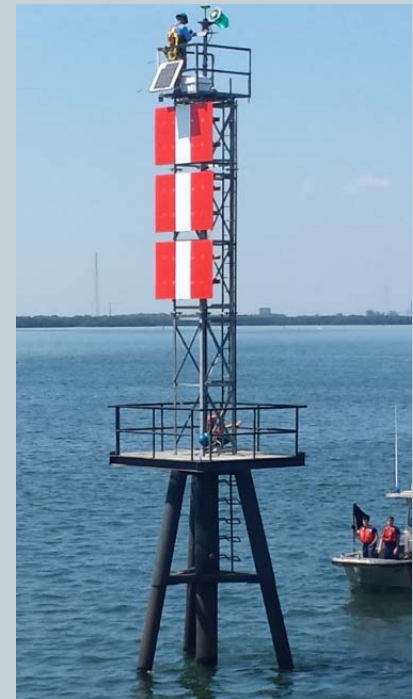
Steel

- Steel used in ATON structures for many years
- An ideal candidate for large ATON structures; rigid and abrasion resistant
- Steel is not as cost effective as in the past

- **Protection from Corrosion**
 1. Cathodic Protection
 2. Alloyed Metals
 3. Coatings

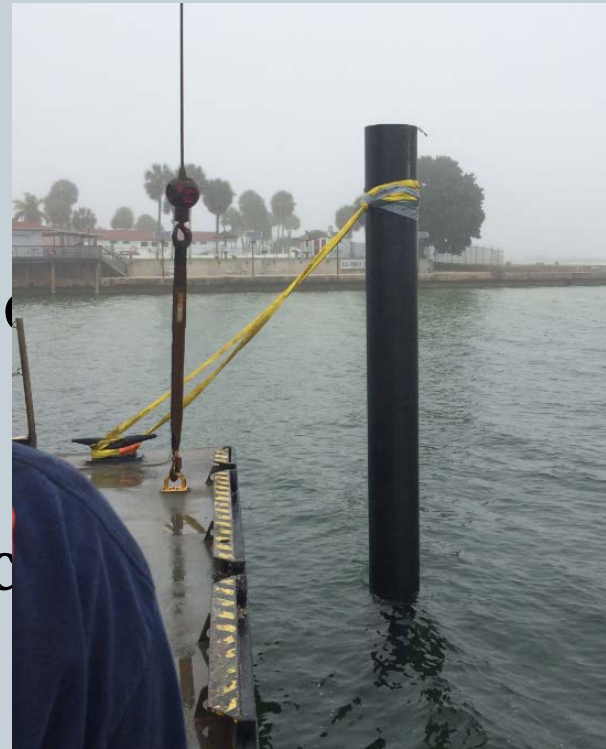
Bending Stiffness

- If design requires minimizing deflection, FRP bending stiffness may require use of a hybrid design to reduce the deflection
- FRP has about one-fifth the bending stiffness as compared to steel
- FRP is an anisotropic material; direction of the force applied has much to do with how the material bends
