# TRB Webinar: Bridge Preservation Using Non- Destructive Testing on T1 Steel

# Kentucky T-1 NDE and Remediation

## NDE and Remediation Plans for T-1 Steel Members

# Commodore Barry Bridge

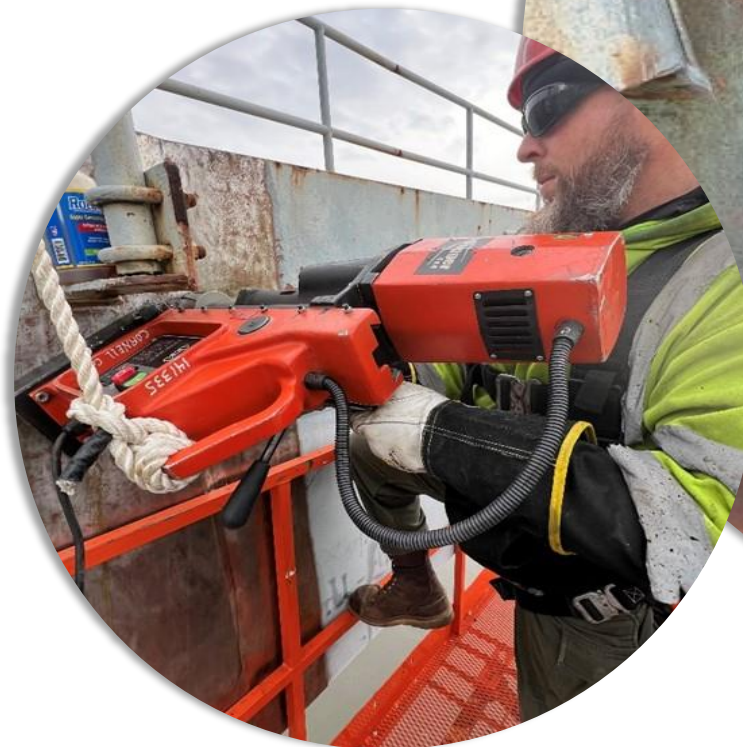
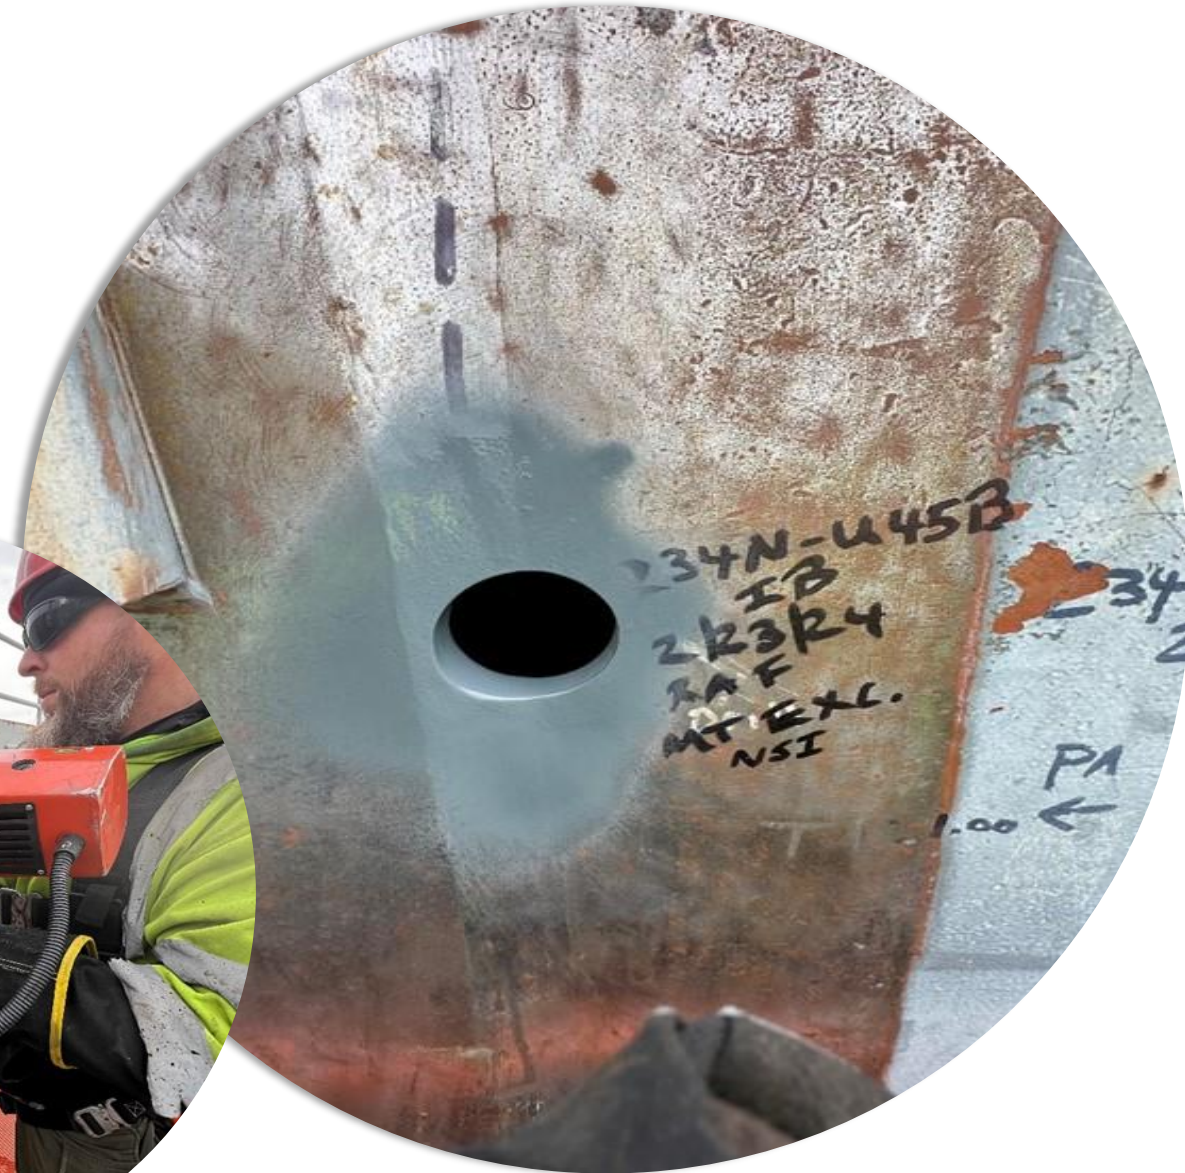
## Typical Coring Remediation

- Coring remediation locations (1.5" and 3" cores typical, 54 locations)

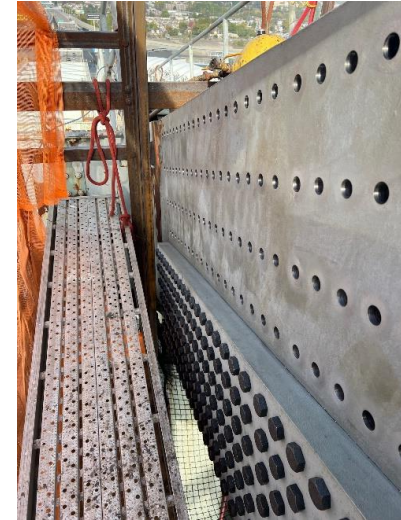
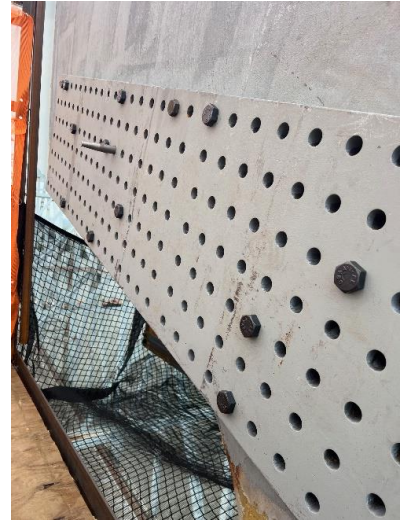
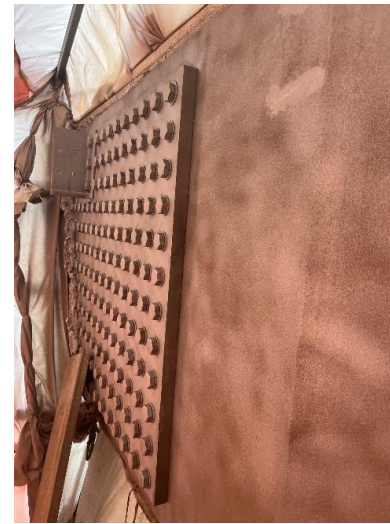
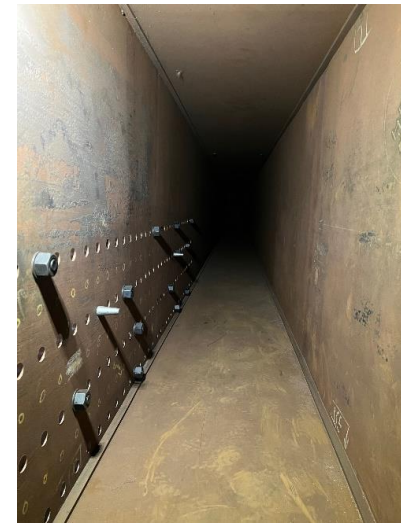
# Typical Plate Repairs

- Plating repair locations (42 total)

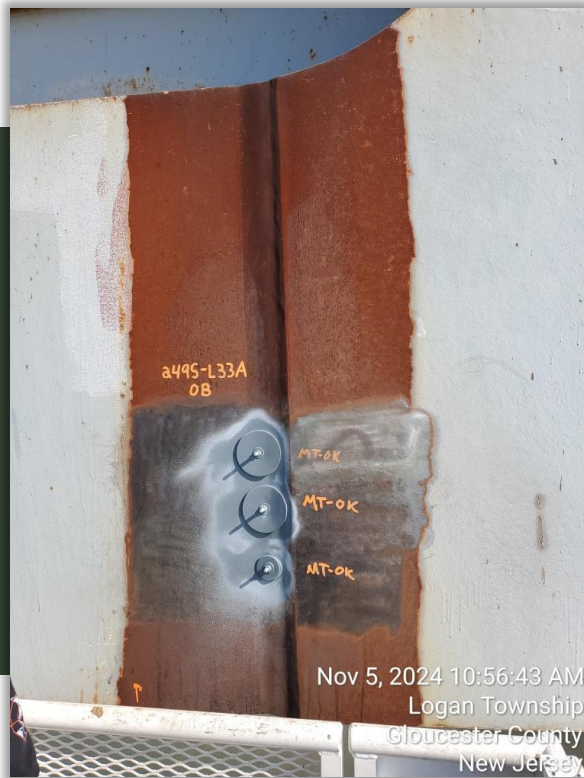
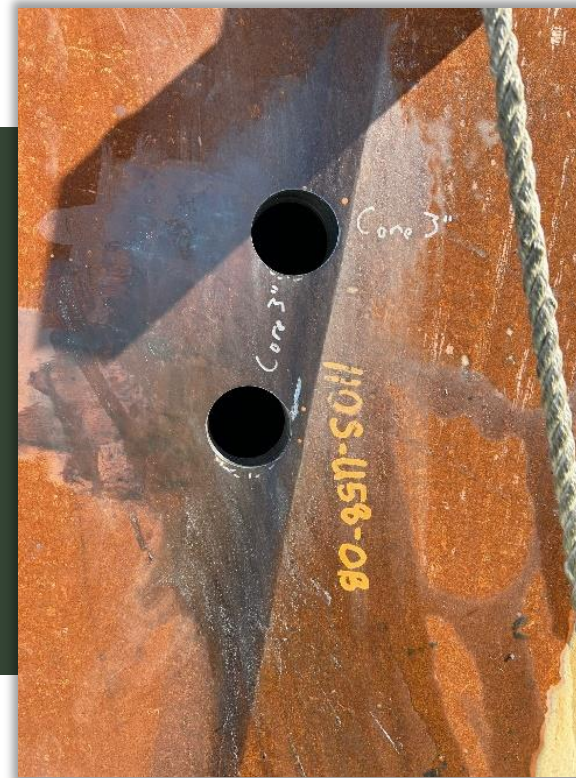
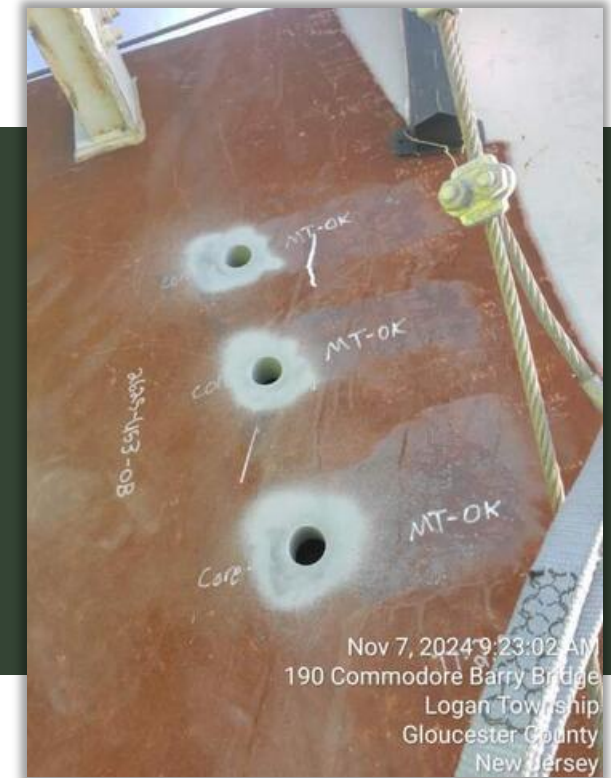
# Typical Intermediate Repairs

- Intermediate repairs (multiple cores, cores with slots, 13 locations)
