Dosimetry During the Radiological Accident in Goiânia

CHALLENGES IN INITIATING AND CONDUCTING LONG-TERM HEALTH MONITORING OF POPULATIONS FOLLOWING NUCLEAR AND RADIOLOGICAL EMERGENCIES IN THE UNITED STATES A WORKSHOP

LA-UR-19-21929

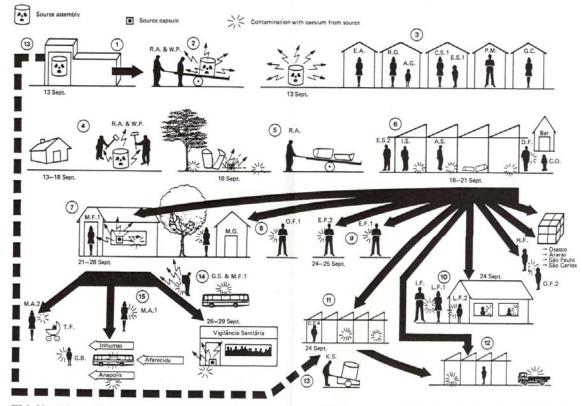
Schematic Diagram of the Dispersal of Cs-137

FIG. 8. Schematic diagram of the dispersal of caesium-137 in the accident in Golânia. The diagram is based on a drawing made shortly after the discovery of the accident in attempting to reconstruct what had happened. It is reproduced in the format in which it was originally drawn even though it differs in minor details from what is now considered to be the best description of events (see the text of the report). Key: (1) the derelict clinic of the IGR; (2) removal of the rotating source assembly from an abandoned telehterapy machine by R.A. and W.P.; (3) source assembly placed in R.A.'s yard near houses rented out by R.A.'s mother E.A.; (4) R.A. and W.P. break up source wheel and puncture source capsule; (5) R.A. sells pieces of the source assembly to lankyard 1; (6) Lunkyard 1: the caesium

chloride is fragmented and dispersed by I.S. and A.S. via public places; (7) D.F.'s house: contamination is further dispersed; (8) visitors and neighbours, e.g. O.F.I, are contaminated; (9) E.F.I and E.F.2 contaminated; (10) I.F.'s house; other arrows indicate dispersion via visitors and contaminated scrap paper sent to other towns; (11) contamination is spread to Junkyard II; (12) contamination is spread to Junkyard III; (13) K.S. returns to the IGR clinic to remove the rest of the teletherapy machine to Junkyard II; (14) M.F.I and G.S. take the source remnants by city bus to the Vigilfacia Sanidria; (15) contamination transferred to other towns by M.A.I. (By courtesy of CNEN, Brazil.)

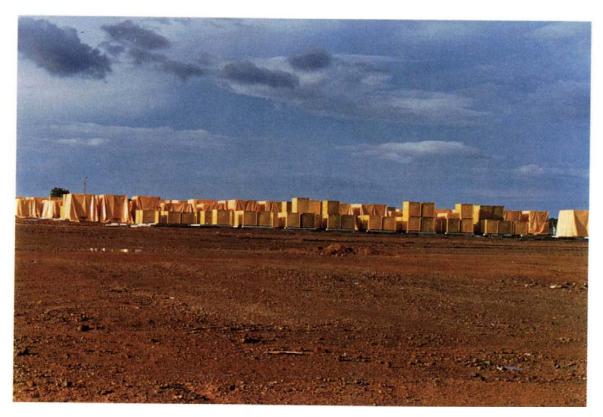
100 g of CsCl \rightarrow 3500 m³ Waste

3800 metal drums (200 L), 1400 metal boxes (5 tons), 10 shipping containers (32 m³) and 6 sets of concrete packaging. It took 275 truck loads.

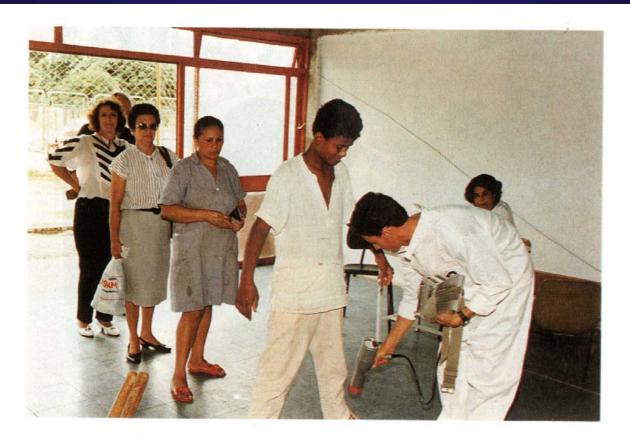
5. Monitoring people for contamination at the Olympic stadium.

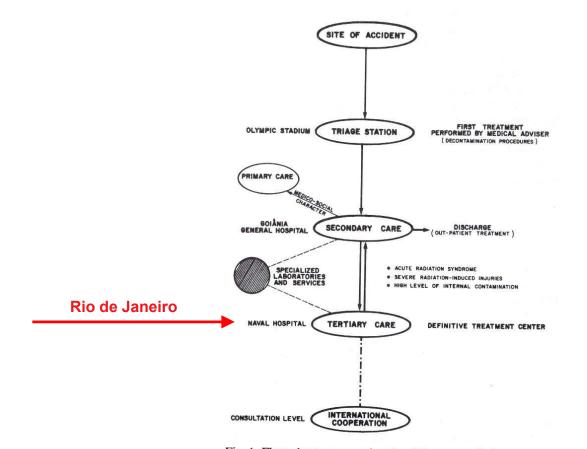
Fig. 1. Flow chart representing the different medical care levels.

Levels of Patient Care

- Primary care level: The dispensary of the Institute for Protection of Minors (IPM).
 Patients presenting external contamination and slight internal contamination, warranting decontamination measures impossible to implement elsewhere.
 Also those who had their homes and properties interdicted, which added a medicosocial character to this level.
- Secondary care level: Goiania General Hospital.

Patients with first- and second-degree local radiation injuries, or those who had received doses capable of causing a slight-to-moderate impairment (1 to 2 Gy) of the hematopoietic system but who would not require special isolation measures or replacement therapy (platelet transfusions, for example).

Also those with moderate-to-severe internal contamination. They could benefit from ¹³⁷Cs removal procedures.

• Tertiary care level: Naval Hospital, Rio de Janeiro.

Patients with severe impairment of the hematopoietic system, as well as those presenting third-degree local skin radiation injuries.

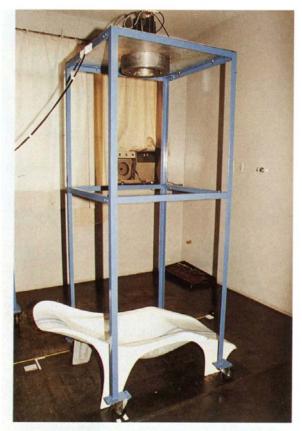
- Improvised at the General Hospital of Goiânia.
- 20cm x 10cm Nal(TI) detector, 5 cm Pb shielding.
- Detector positioned at 2 m from the floor.
- System proved adequate: MDA = 9 kBq (243 nCi) for 2 min counting

^{32.} The improvised whole body counter used in Goiânia.

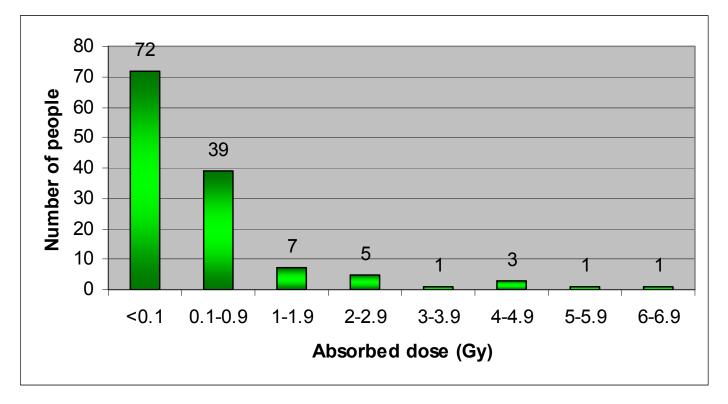
Dose Distribution for Exposed People

Patients and Their Families: 129 People
