U.S. Department  
of Transportation  
**Federal Railroad  
Administration**

RR 20-03 | February 2020

## FULL-SCALE SHELL IMPACT TEST OF A DOT-113 TANK CAR

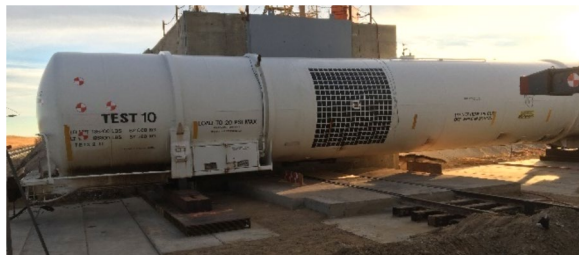
On November 19, 2019, the Federal Railroad Administration (FRA) conducted a full-scale shell impact test of a DOT-113C120W (DOT-113) tank car at the Transportation Technology Center (TTC) in Pueblo, CO. A DOT-113 is a tank within-a-tank designed to transport specified cryogenic materials by rail. The outer tank is carbon steel and the inner tank is stainless steel with insulation and vacuum in between the tanks, in order to keep the lading cold. The shell of the outer tank was struck by a 297,000 pound ram car equipped with a 12-inch by 12-inch impactor at its mid-height and longitudinally offset 11 feet towards the A-end, because a centered impact would have fouled a track adjacent to the impact wall due to the DOT-113's length. [Figure 1](#) shows the tank car in its pre-test position against the impact wall at the TTC.

**Figure 1. Pre-test Photo of DOT-113 Tank Car**

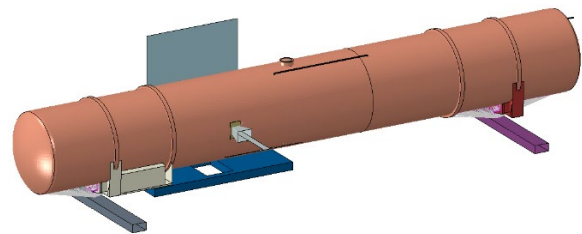
An FEA was performed in conjunction with the test. A schematic of the FE model is shown in [Figure 3](#). This model featured simplified modeling of the water and the air within the tank. The water was modeled using a hydraulic cavity approach, and the air was modeled as an ideal gas using a pneumatic cavity. The tanks were modeled using shell elements, except in the impact zone. The impact zones of both the inner and outer shells were modeled using solid elements, with elastic-plastic and ductile failure material properties defined. This combination of shell and solid element types allowed puncture of the tank car to be modeled while reducing the model's run-time.

**Figure 3. DOT-113 FE Model**
