# Arecibo Observatory: *Failure Event Sequence*

Presentation Requested by  
*The Committee on Analysis of Causes of Failure and Collapse of the  
305-Meter Telescope at the Arecibo Observatory*

January 25, 2022

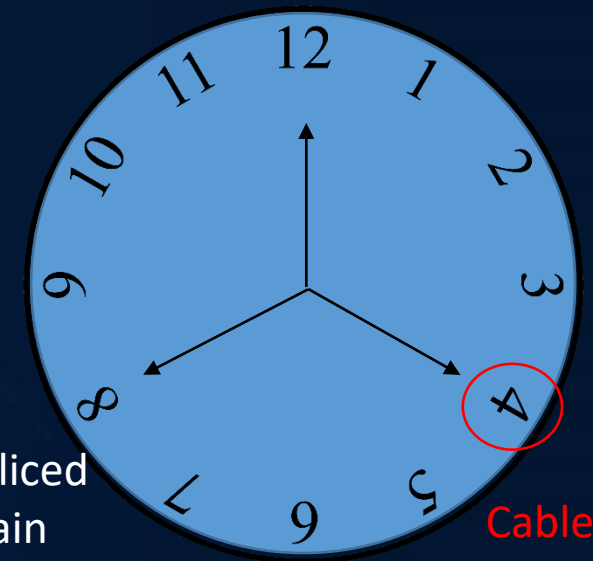
Spliced  
main  
cable

Cable  
failures

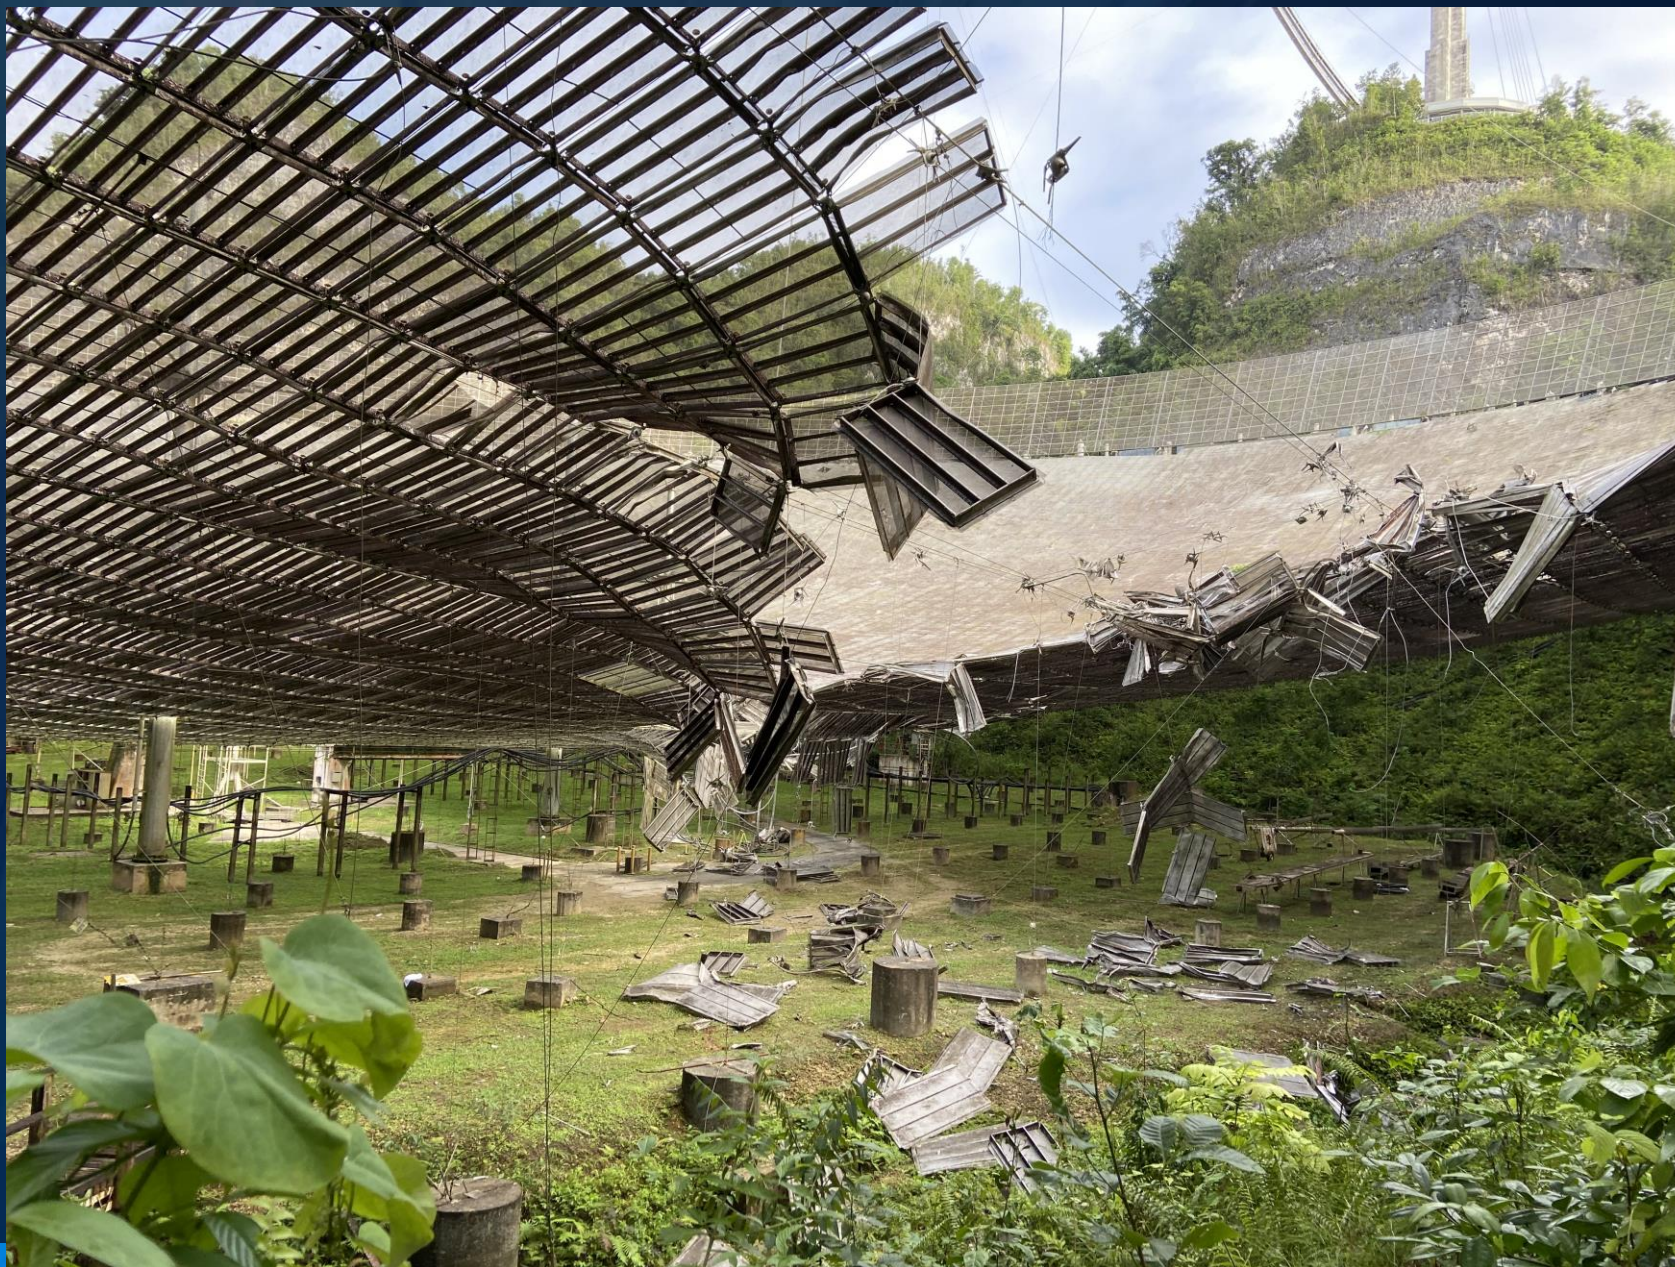
Failed  
socket

-described by  
structural  
engineers to  
have failed  
“suddenly and  
without  
warning”

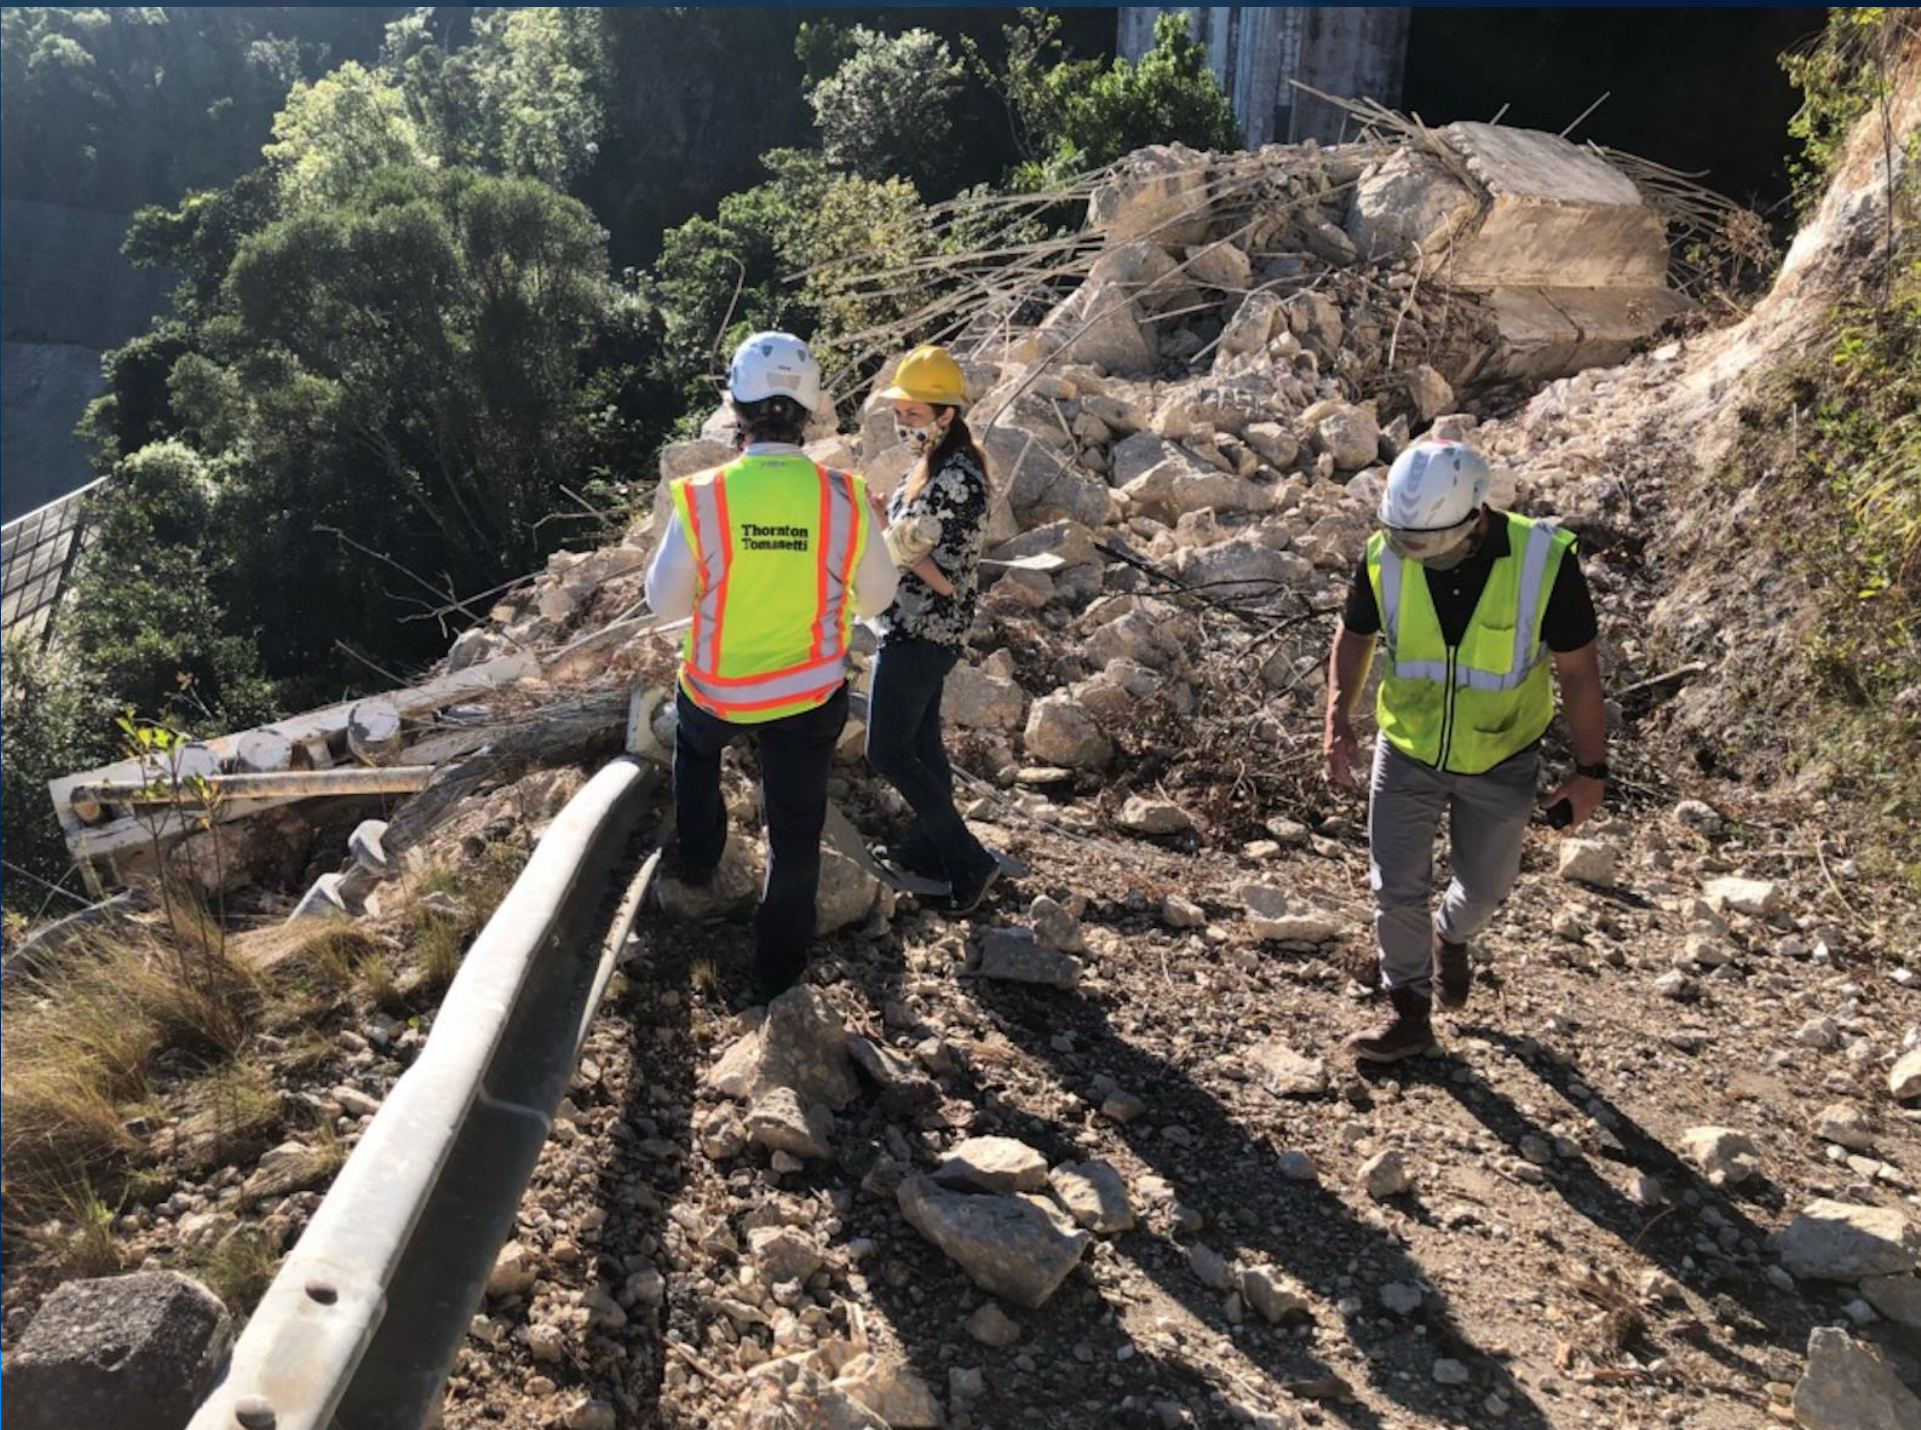
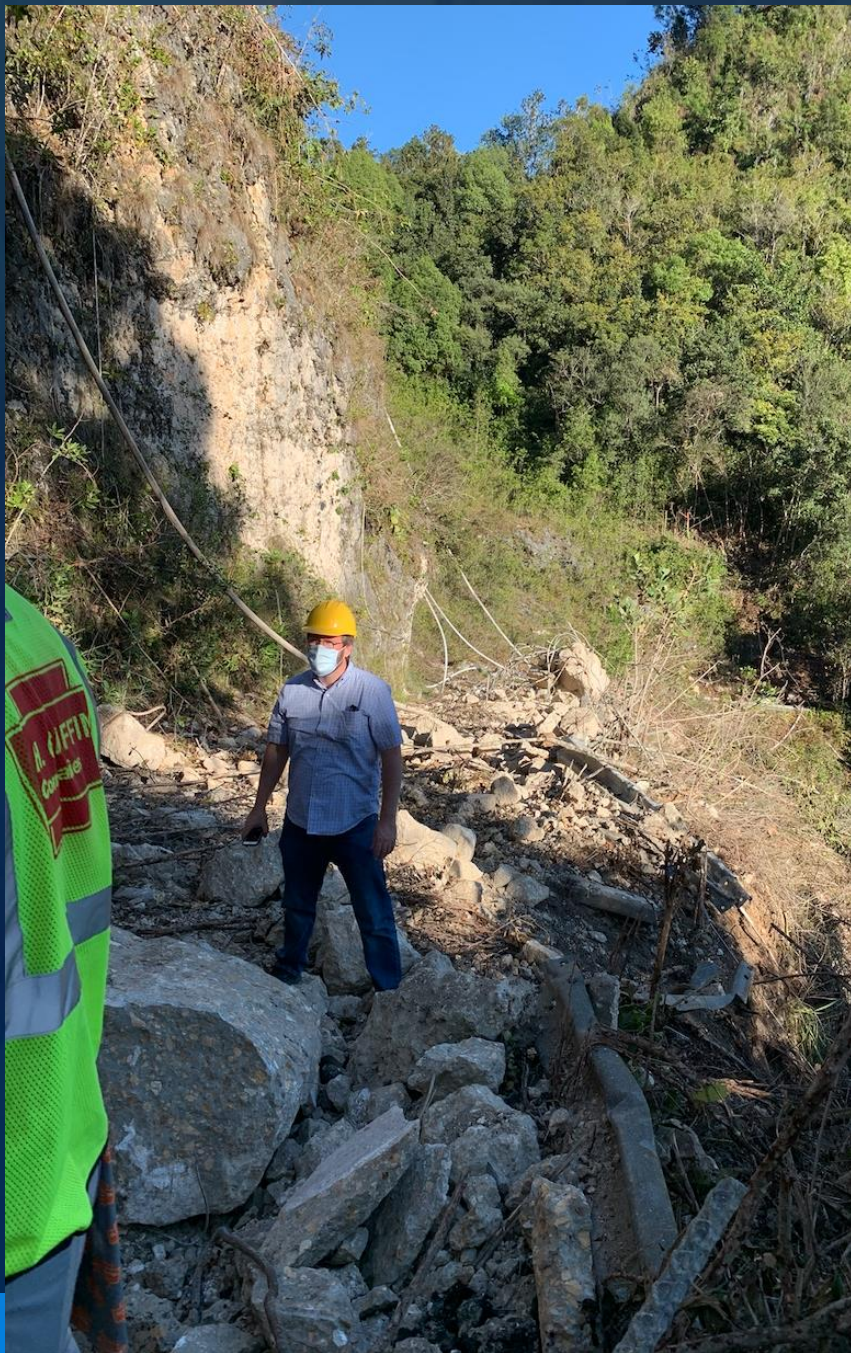
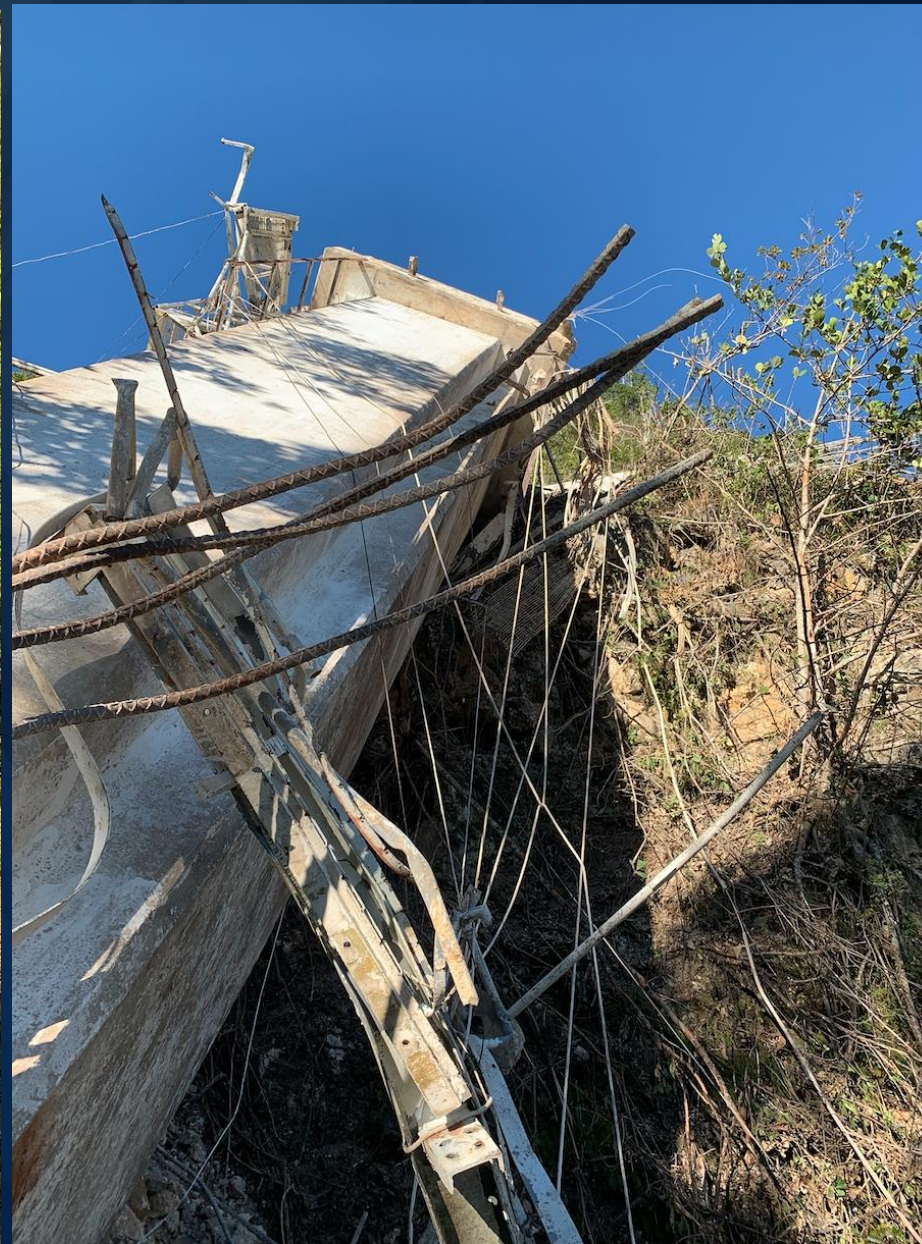
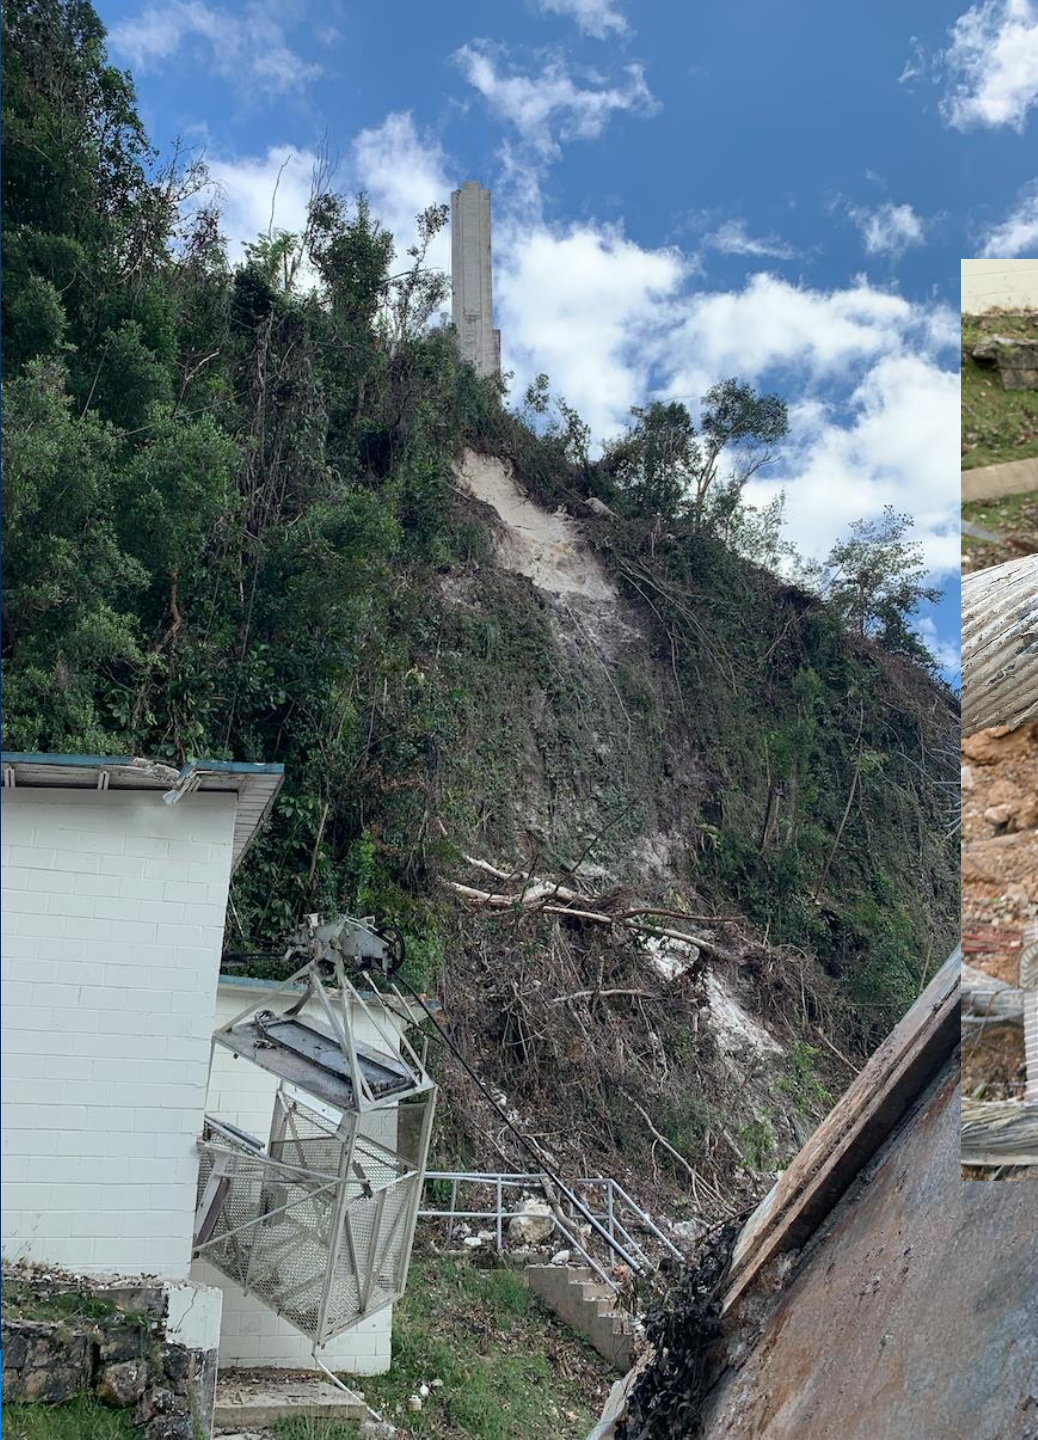
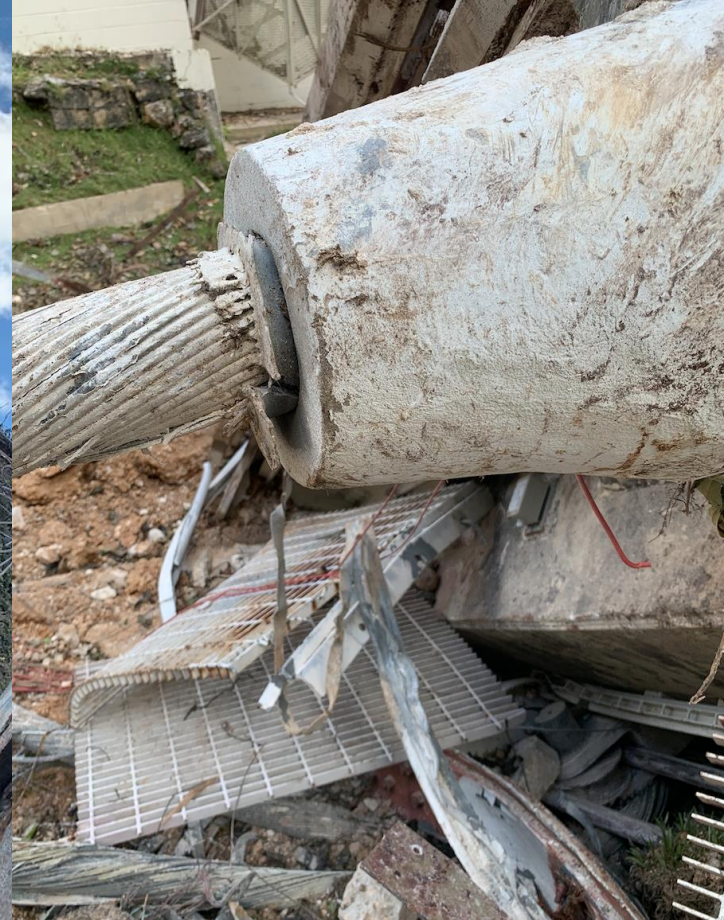
- Photos and videos after collapse
- 3D model prepared by Thornton Tomasetti
  - Chain-of-command established, hardware gathered

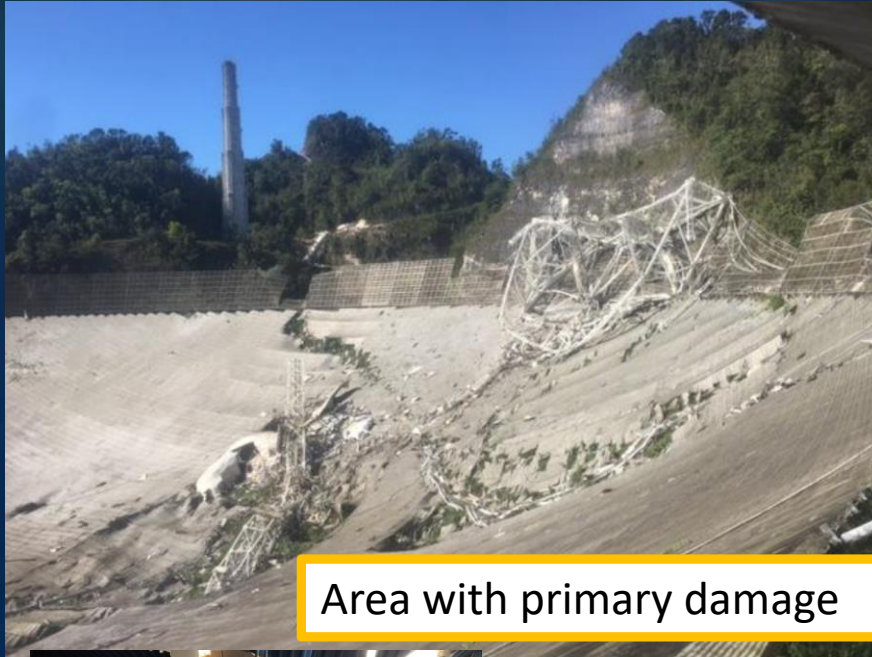
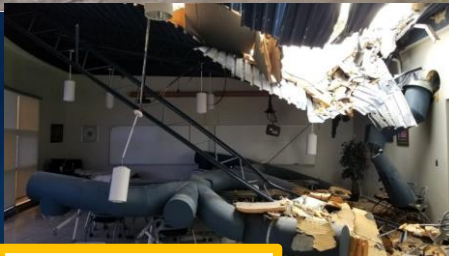
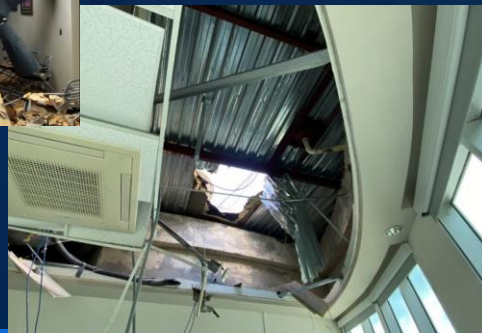
# Damage Assessment

- Platform, azimuth arm, Gregorian with instrumentation, reflector panels, cables
- Tops of towers
- EPO trailer
- Learning Center
- Cable car shed
- Minimal damage to:
  - Visitor's Center
  - Bldg #1
- 3/6 HF dipoles
