WHY MINE WASTE IMPOUNDMENTS EXPERIENCE STABILITY FAILURES

**Committee on Geological and Geotechnical Engineering
Board on Earth Sciences and Resources
National Academies of Sciences, Engineering, and Medicine**

September 5, 2019

W. Allen Marr

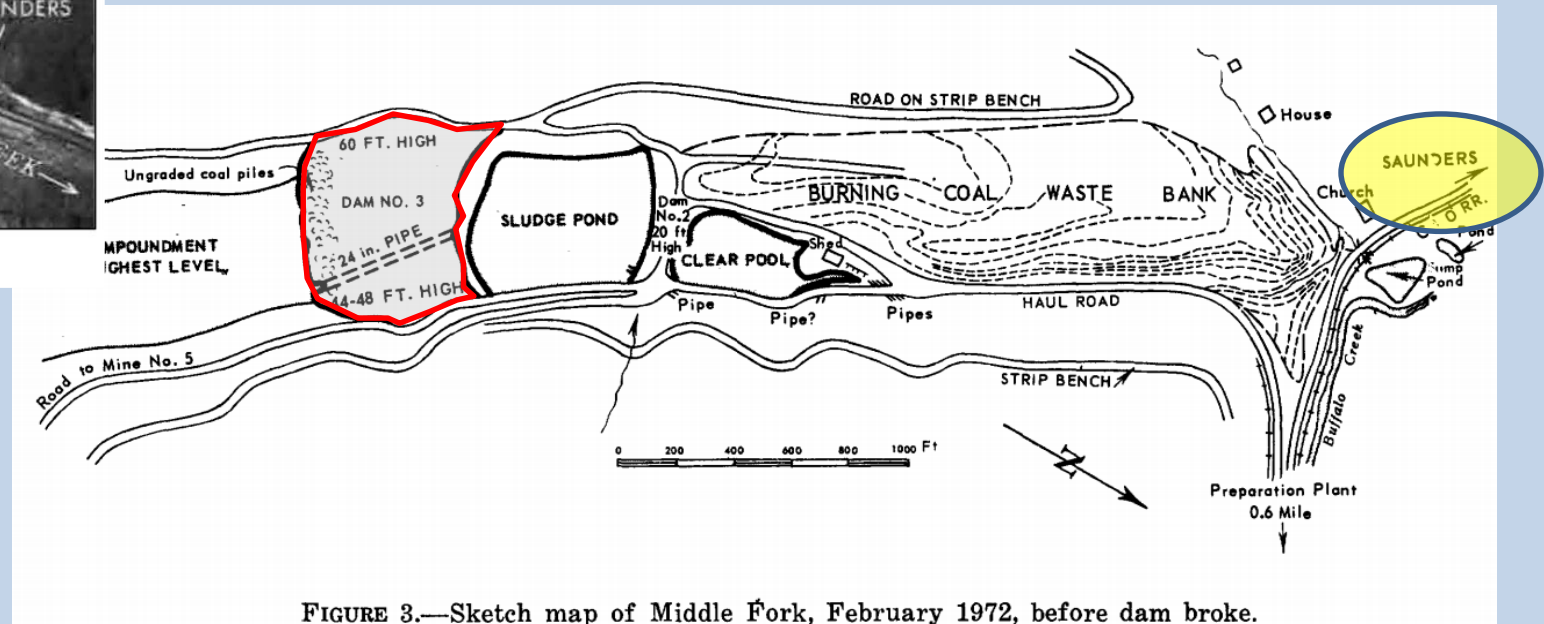
FIGURE 3.—Sketch map of Middle Fork, February 1972, before dam broke.

Buffalo Creek, West Virginia, USA (1972)

Date:	Feb 26, 1972, sudden, no warning
Type:	14 m embankment of coal waste built on coal refuse slurry retaining coal wash tailings for coal mine
Failure Mode:	Collapse of dam by slumping and sliding of downstream after heavy rain (<u>water flow through the dam</u>)
Volume Spilled:	500,000 cubic meters
Consequences:	Tailings traveled 27 km downstream average 2 m/sec, 125 people died, 1121 injuries , 507 homes destroyed, 30 businesses. Property and highway damage exceeded \$65 million. Led to US Dam Safety Act giving US Army Corps of Engineers responsibility to conduct nationwide safety inspections of dams.

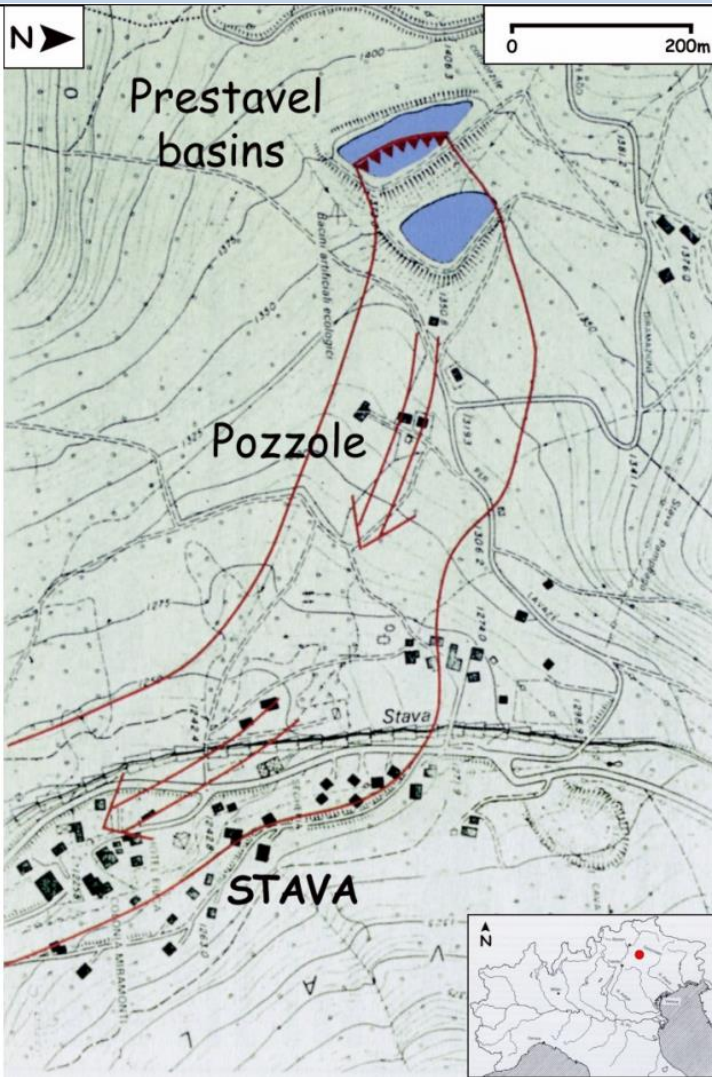
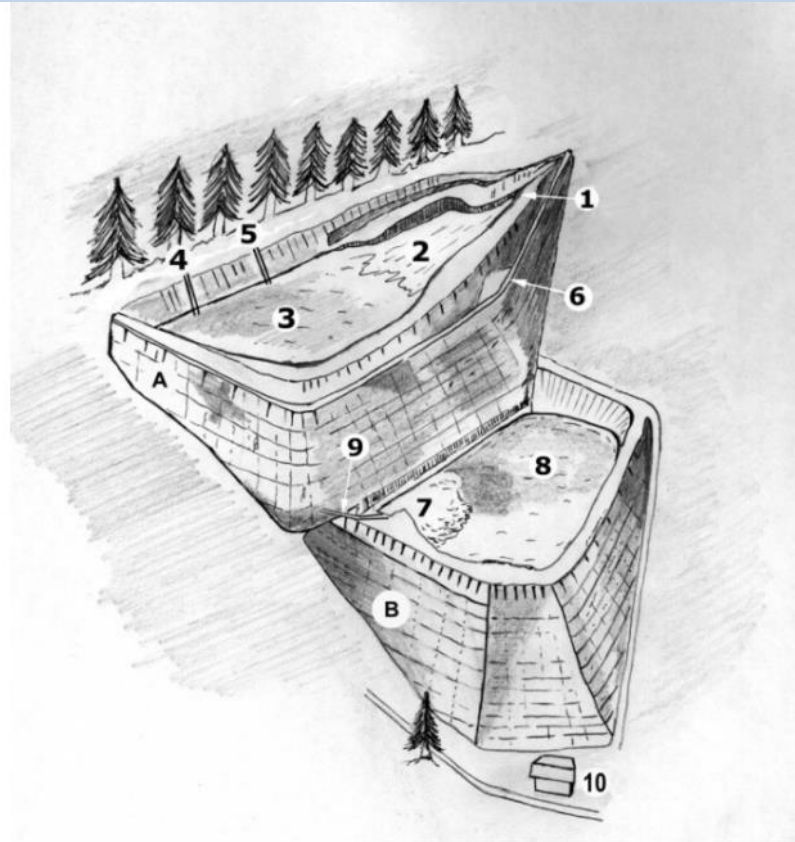
Fig. 2. Graphical representation of the Prestavel basins: (A) upper basin; (B) lower basin; (1) cyclone, (2) sandy deposit, (3) silty deposit, (4) drainage service, (5) emergency drainage, (6) service road, (7) sand cone, (8) silty deposit, (9) drainage from the upper basin, (10) caretaker's house.

Stavia Mudflow, Trento, Italy (1985)

Date:	July 19, 1985, sudden, no warning
Type:	30 m upstream tailings dam for fluorite mine
Failure Mode:	<u>Failure through silt foundation</u> followed by mud flow
Volume Spilled:	200,000 cubic meters of liquefied tailings flowed 4.2 km at 25 m/sec
Consequence:	Mud flows killed 268 people, destroyed 82 buildings

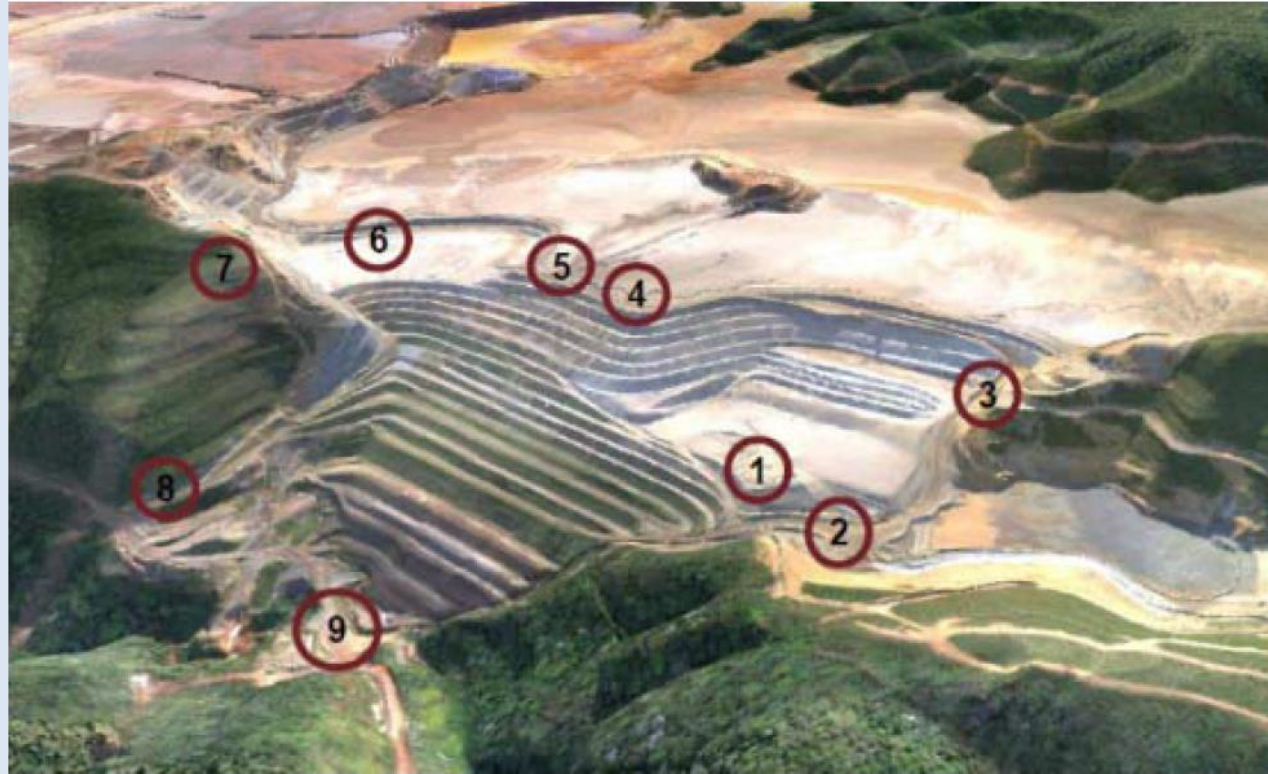
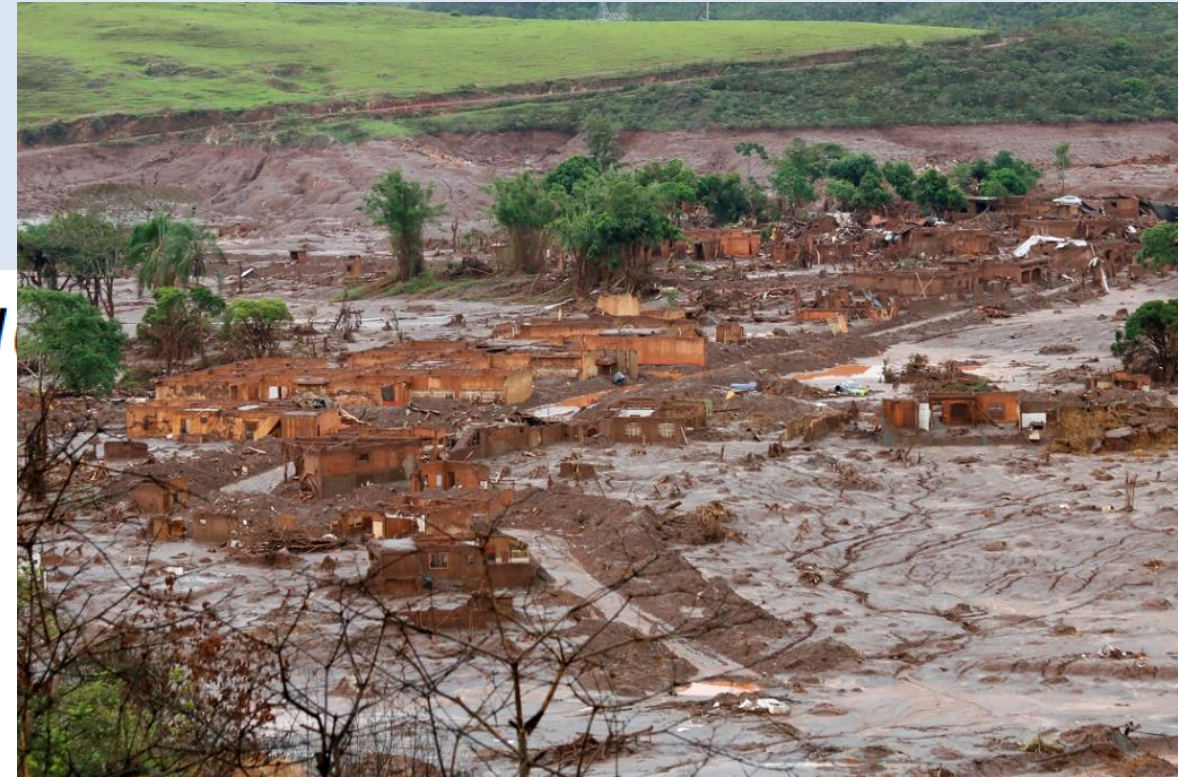
Figure 2-17 Eyewitness locations on the afternoon of November 5, 2015

Fundão, Brazil (2015)

Date:	Nov 15, 2015 sudden no warning, inspected shortly before
Type:	39-100 m upstream method dam tailings from iron ore
Failure Mode:	<u>Undrained failure of containment dam built over tailings from rapid filling</u> , leading to liquefaction of stored tailings, followed by mud flow
Volume Spilled:	43.7 million cubic meters of liquefied tailings flowed 620 km, initially at 11 m/sec
Consequence:	Mud flows killed 19 people, destroyed 375 homes, other structures. Worst environmental disaster in Brazilian history to that time. Damages and lawsuits of billions of dollars against owners.
