# HM-264 LNG by Rail Technical Briefing

## PHMSA OHMS 6/7/2021

U.S. Department of Transportation  
Pipeline and Hazardous Materials  
Safety Administration

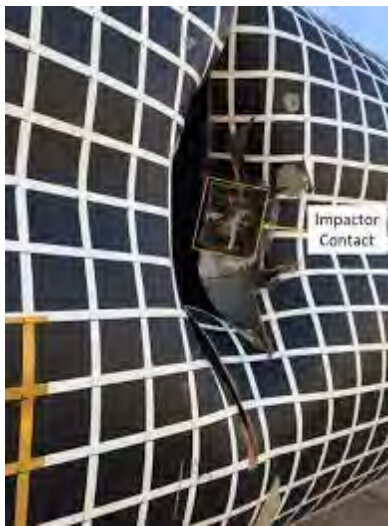
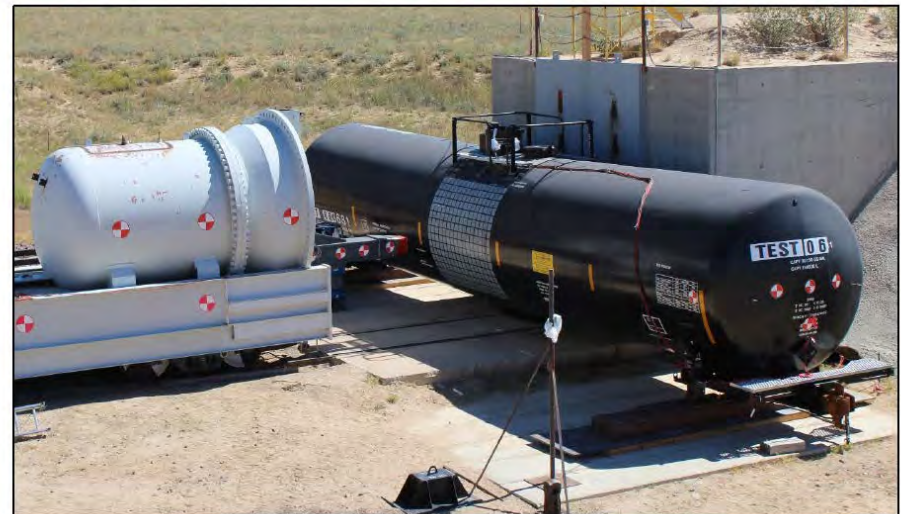
# DOT-117 and Legacy DOT-113 Impact Tests

- Impact tests and finite element analysis

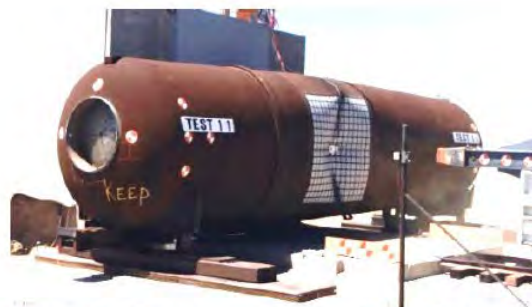
Figure 2. Post-test Photo of the Surrogate

# DOT-113 9/16 Inch Surrogate Impact Test
