# TRB Webinar: Integrating Non- Destructive Evaluation in Bridge Preservation and Management

*February 25, 2025*

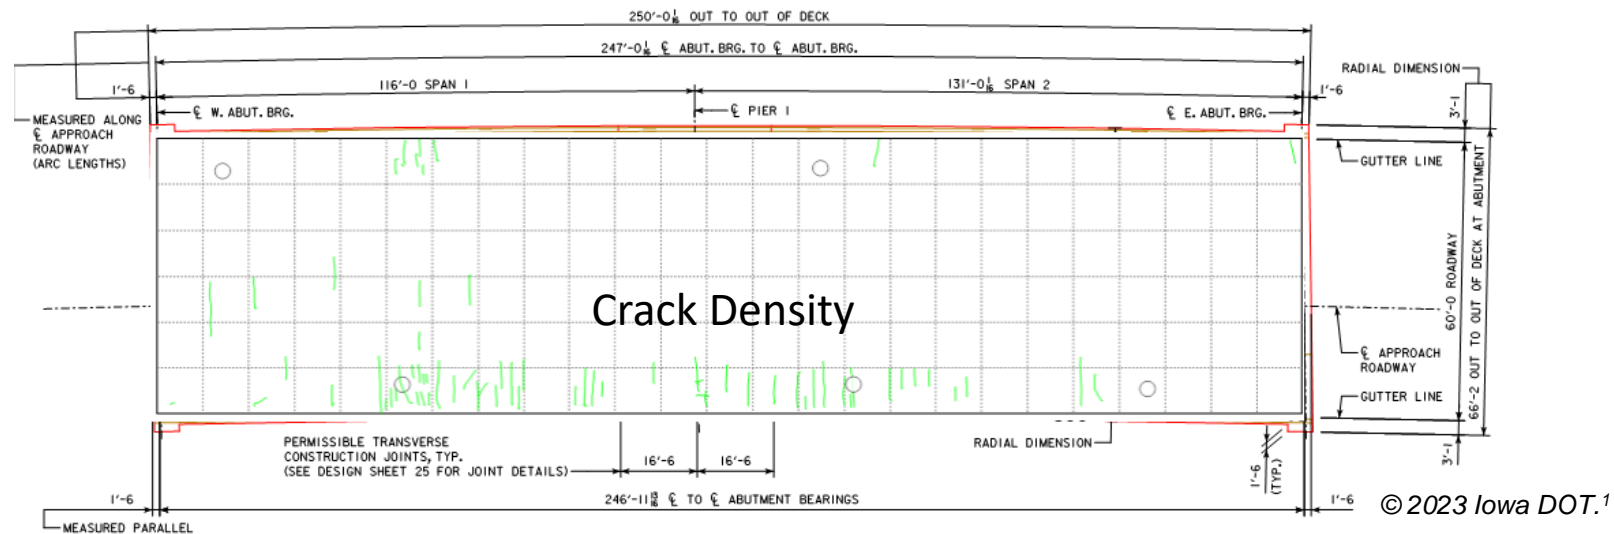
# High Resolution Imagery (Crack Assessment)

High-resolution imagery:

- ▶ Potential for use as a QA/QC method for crack mapping of newly constructed bridge decks.
- ▶ Information related to crack density and width can be used to guide the selection of preservation techniques.

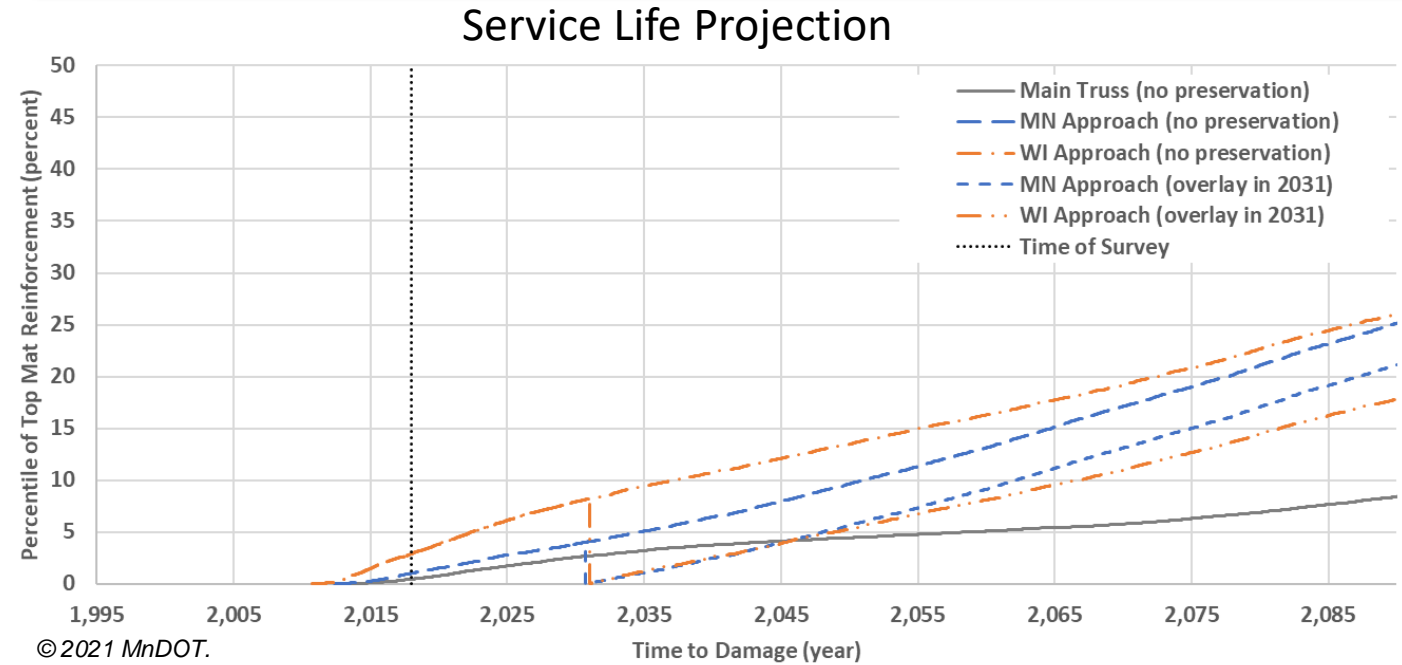
Deck is currently in good condition, despite abundant surface cracking in sacrificial wearing course. Previous treatment of cracks appears effective in slowing chloride ingress. Average chloride concentration is 1.2 lb./yd<sup>3</sup> (300ppm) at top bar. Approaches are expected to require major preservation within 20 yr, whereas the main truss deck, with greater cover, may last longer with periodic patching.

RECOMMENDATION—A properly placed new structural overlay in the near term would eliminate cracking and remove chloride contamination that is driving diffusion. The life of the deck could easily be extended 20 to 30 yr longer.

- ▶ Eight of 77 cores had  $\text{Cl}^- > 500\text{ppm}$  at reinforcement depth.
- ▶ Carbonation – negligible to 0.3 inch.
- ▶ GPR: 3.2-inch average cover depth.
- ▶ GPR: 7.8 percent deck area attenuation.
- ▶ IR: 1.4 percent deck area delaminated.
- ▶ DAR: 1.7 percent deck area degraded.
- ▶ HRV: 0 percent deck patching.

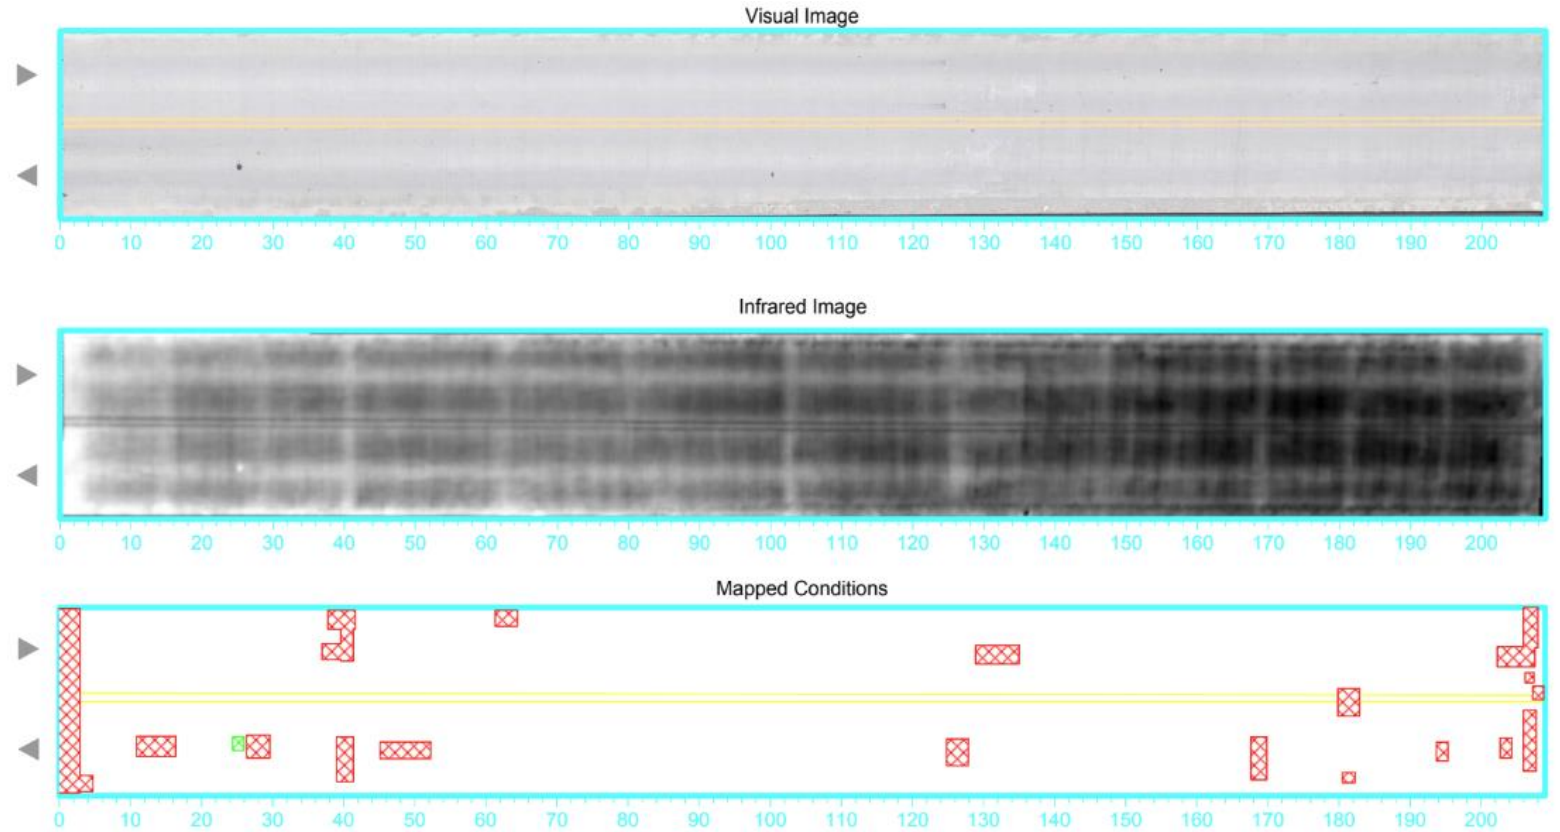
I69-323-04603

Quantity Summary	
Delamination %	5.1
Delamination (ft <sup>2</sup> )	284
Patching %	<1
Patching (ft <sup>2</sup> )	3
Spalling %	0.0
Spalling (ft <sup>2</sup> )	0

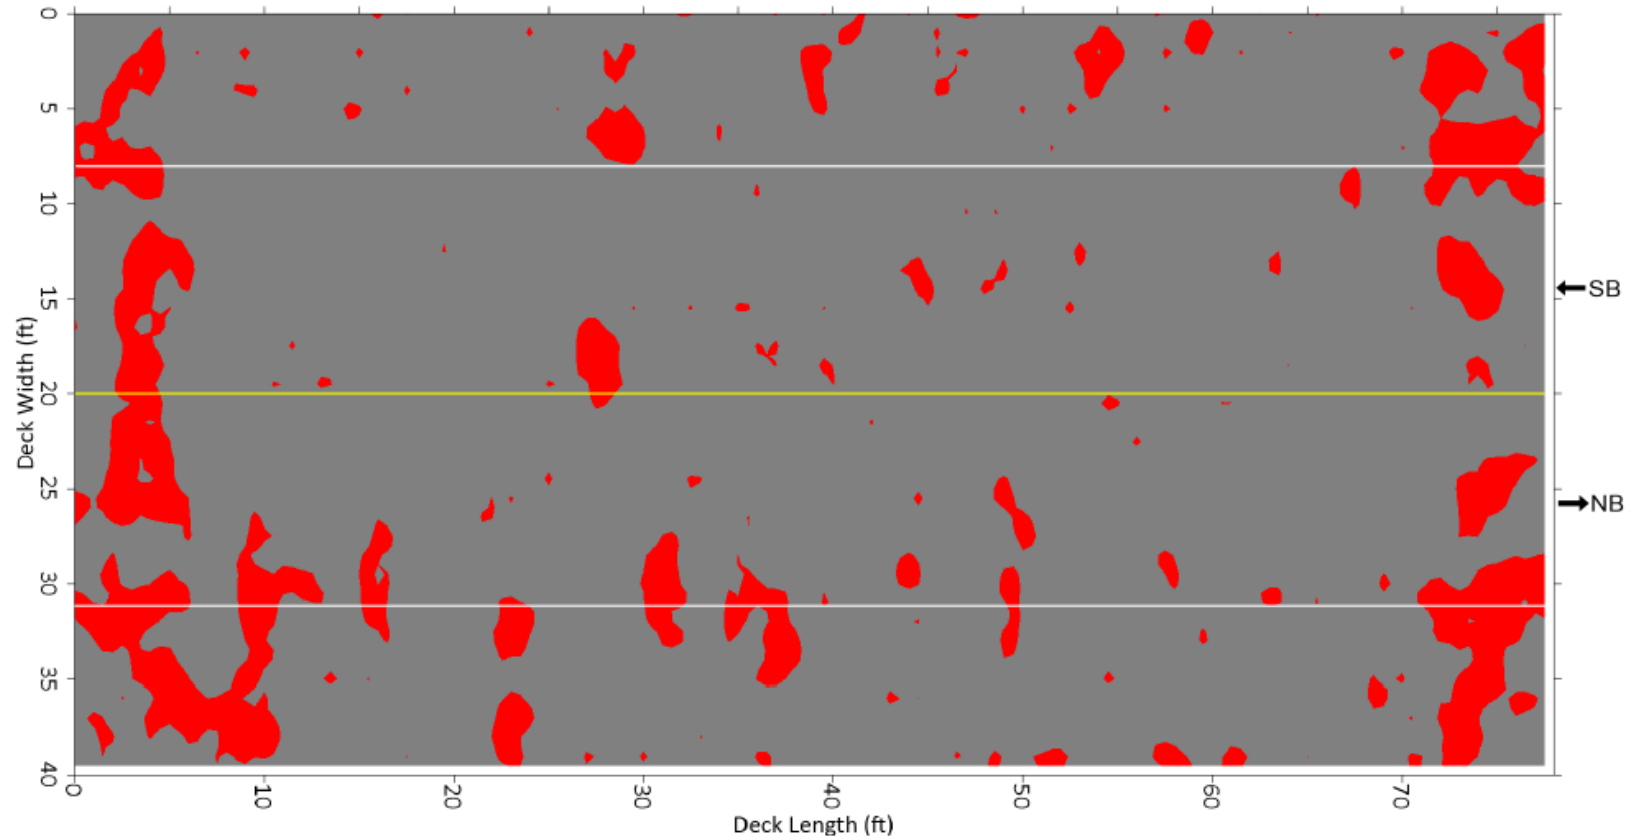
NBI 490 Bridge 001-17-06097, SR 1 over Sol Shank Ditch

DELAMINATION

9.1%

DECK CONDITION RATING = 6

WEARING SURFACE CONDITION RATING = 6

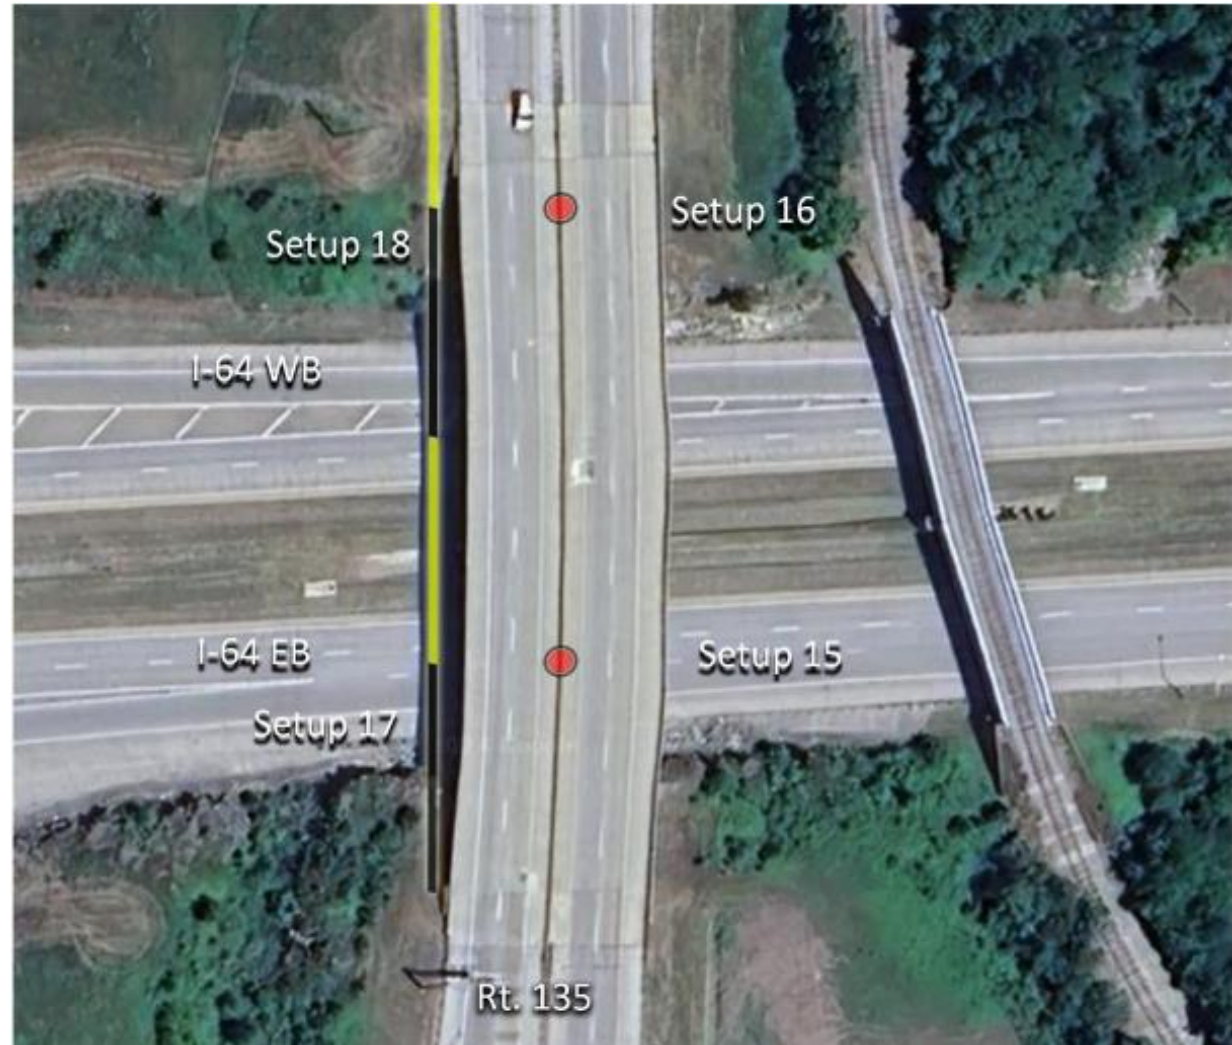
Setup Locations

NBI 26370 SR 135 over I-64  
EB/WB

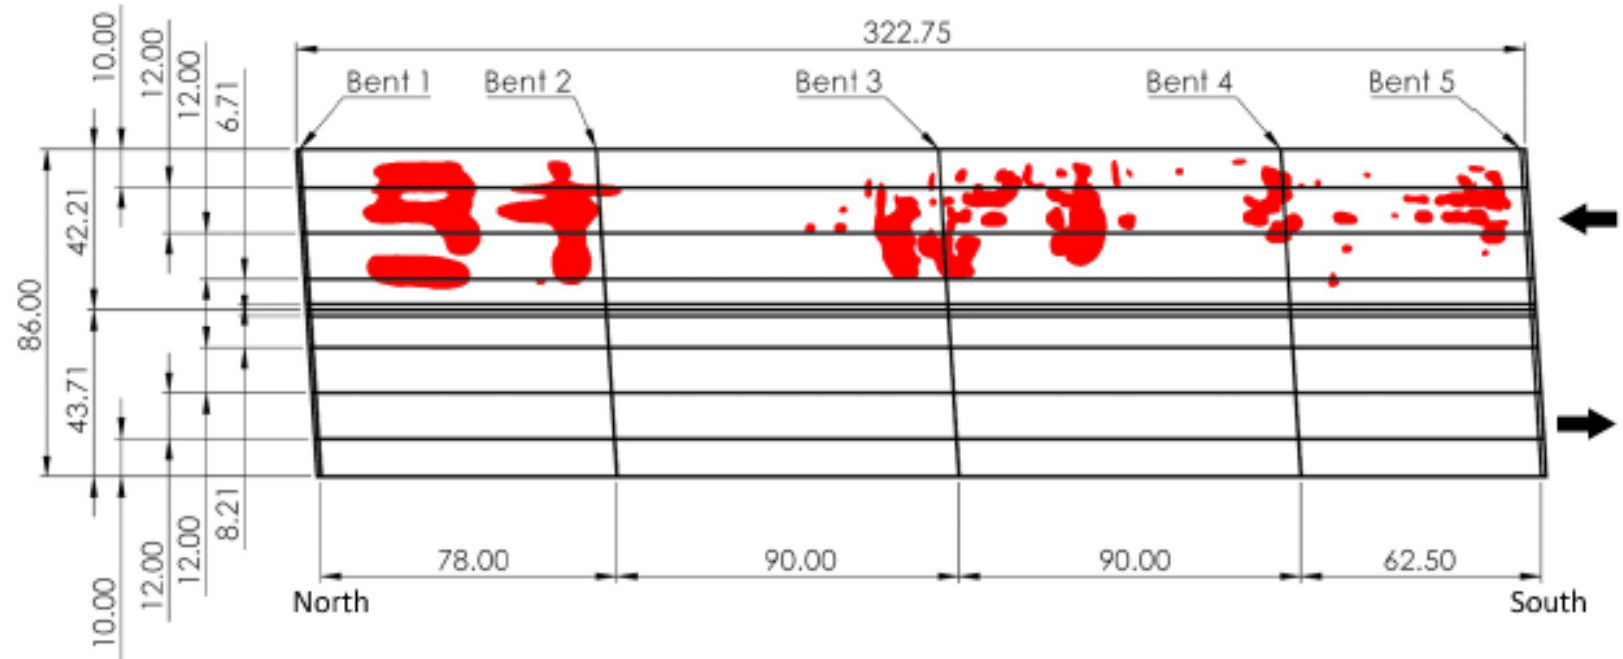
Defect Indications

NBI 26370 SR 135 over I-64  
EB/WB

Setup #	Positions	Defect Indication Area (sq. ft.)	Measurement Area (sq. ft.)	Percent Defect Indication
15	3	1251.0	7,007	17.9%
16	2	793.3	4,117	19.3%
		<b>2,044.3</b>	<b>11,124</b>	<b>18.3%</b>

Setup #	Positions	Defect Indication Area (sq. ft.)	Measurement Area (sq. ft.)	Percent Defect Indication
17	3	0.0	6,210	0.0%
18	2	0.0	4,044	0.0%
		<b>0.0</b>	<b>10,254</b>	<b>0.0%</b>

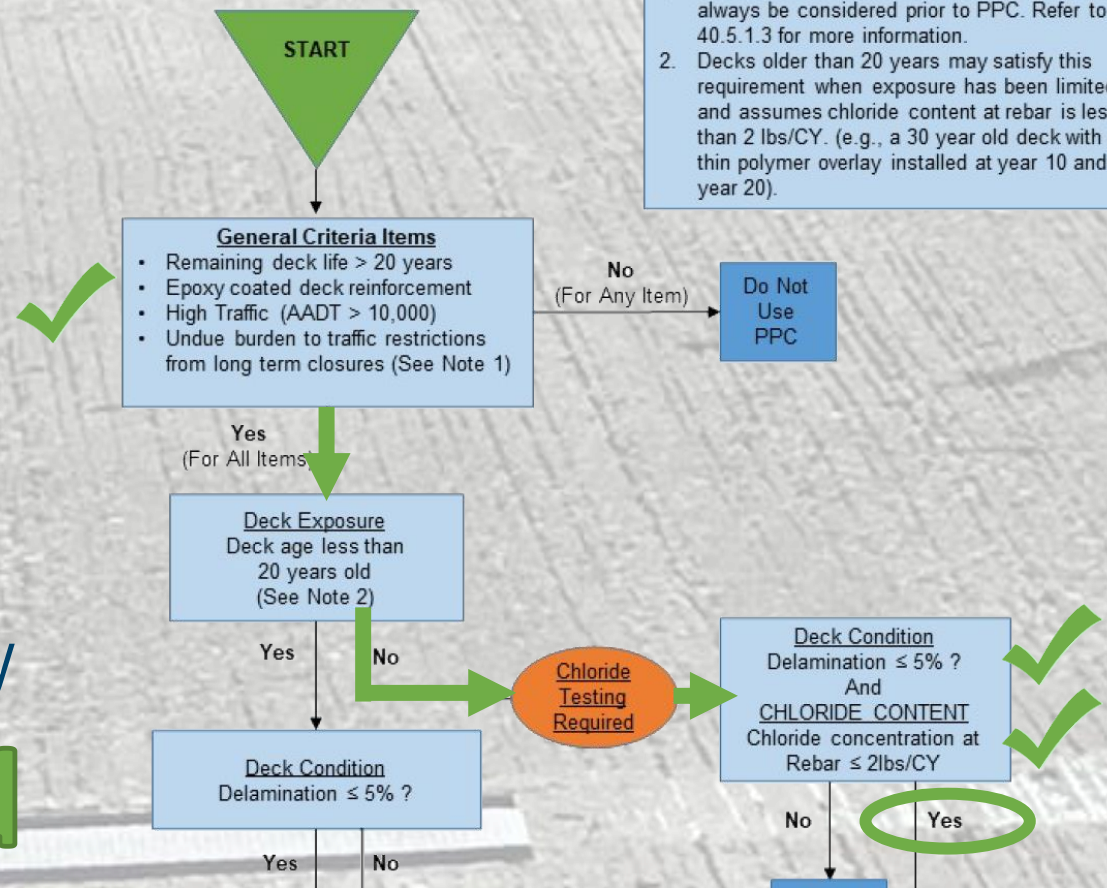
Figure 40.5-2

1. Lower cost preservation treatments should always be considered prior to PPC. Refer to 40.5.1.3 for more information.
2. Decks older than 20 years may satisfy this requirement when exposure has been limited and assumes chloride content at rebar is less than 2 lbs/CY. (e.g., a 30 year old deck with a thin polymer overlay installed at year 10 and year 20).

Polyester Polymer Concrete Overlay Usage Flowchart

**Note: PPC overlays are expensive and new to WisDOT. As a result, use of PPC overlays should be limited to preservation projects that meet the requirements outlined in [Figure 40.5-2](#) or as approved by the Bureau of Structures.**

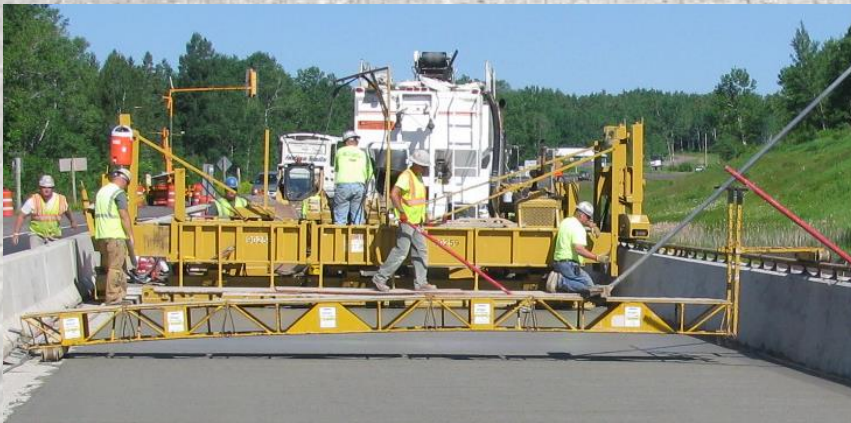
## B-11-8 STH 13

- Visual only inspection
  - No work action
- Visual with IRT results
  - 2035 concrete overlay

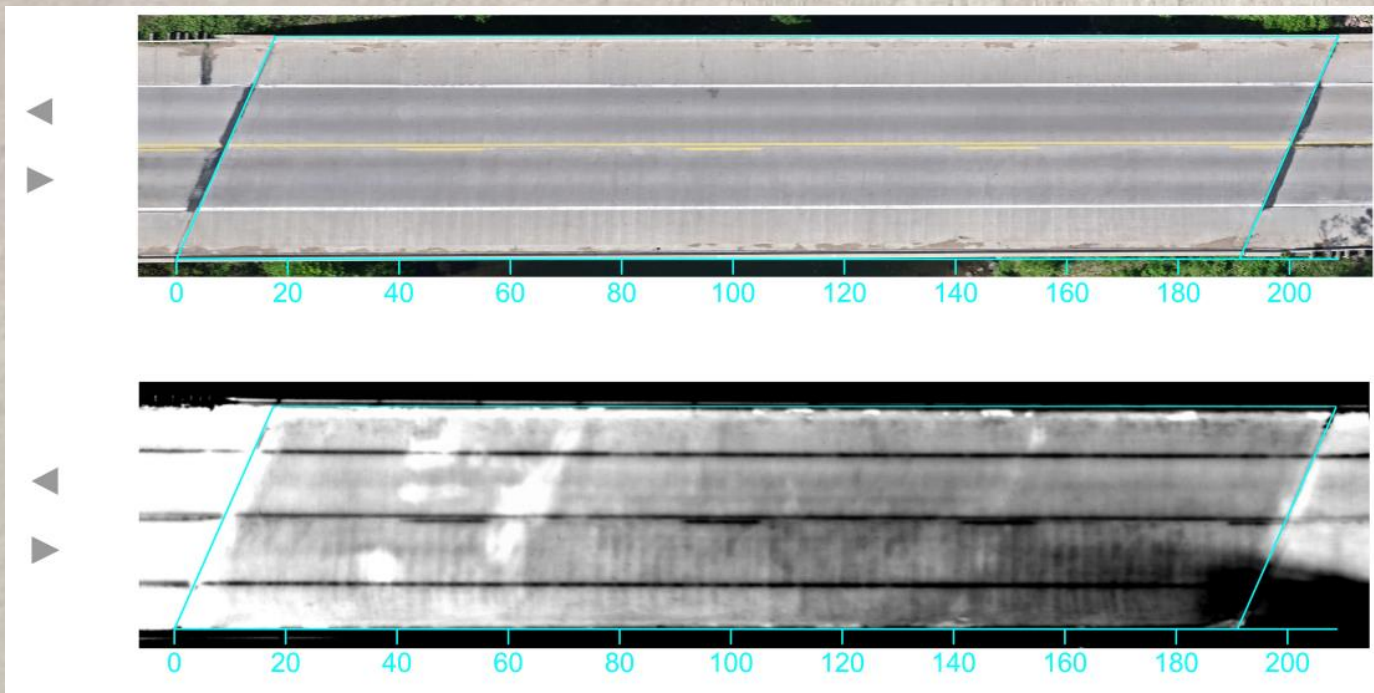
## B-65-18 STH 48 over Red Cedar Narrows

- April 2021 – Inspector only recorded 154 SF delamination estimated by partial chaining
- June 2021 – Aerial IRT recommends adding 657 SF CS2 delamination

Quantity Summary	
Delamination Quantity (%)	11
Delamination Quantity (ft <sup>2</sup> )	811

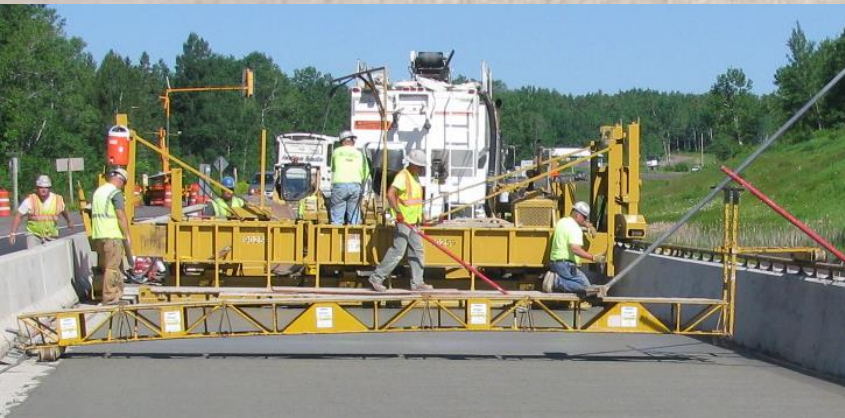
## B-65-18 STH 48

- Visual/partial chaining
  - No work action
- Visual with IRT results
  - 2030 concrete overlay

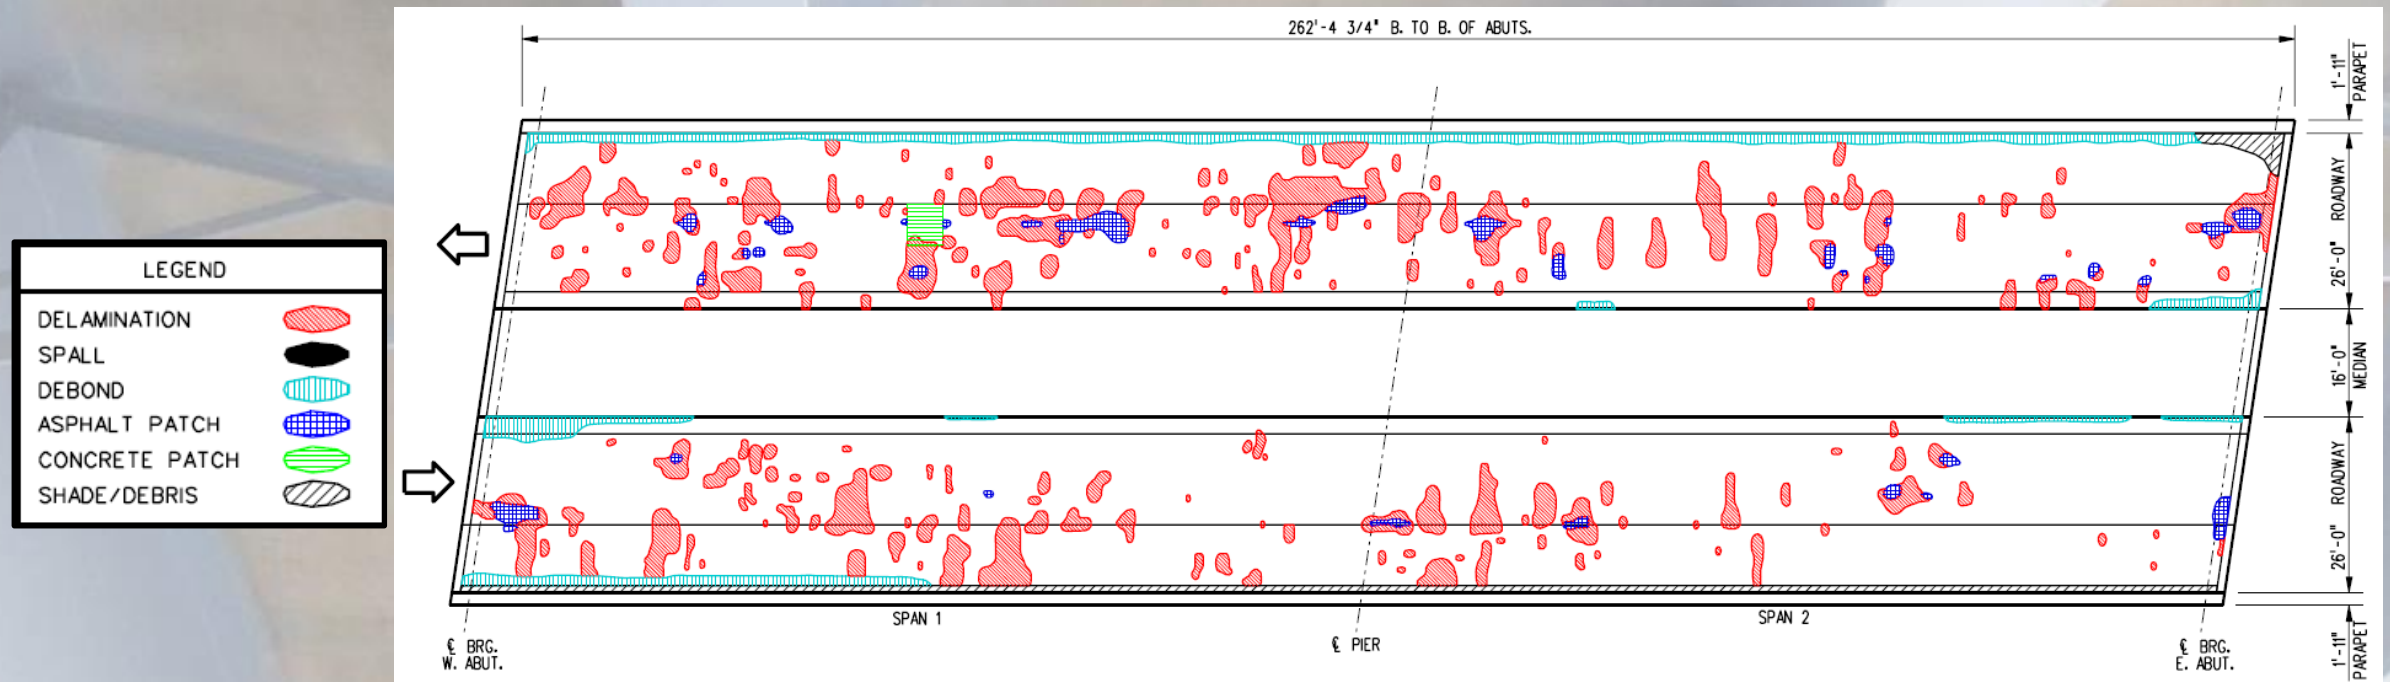
## B-45-55 CTH D over IH 43

- 2019 – Wearing surface IRT estimates 17.2% debond/delam/patch

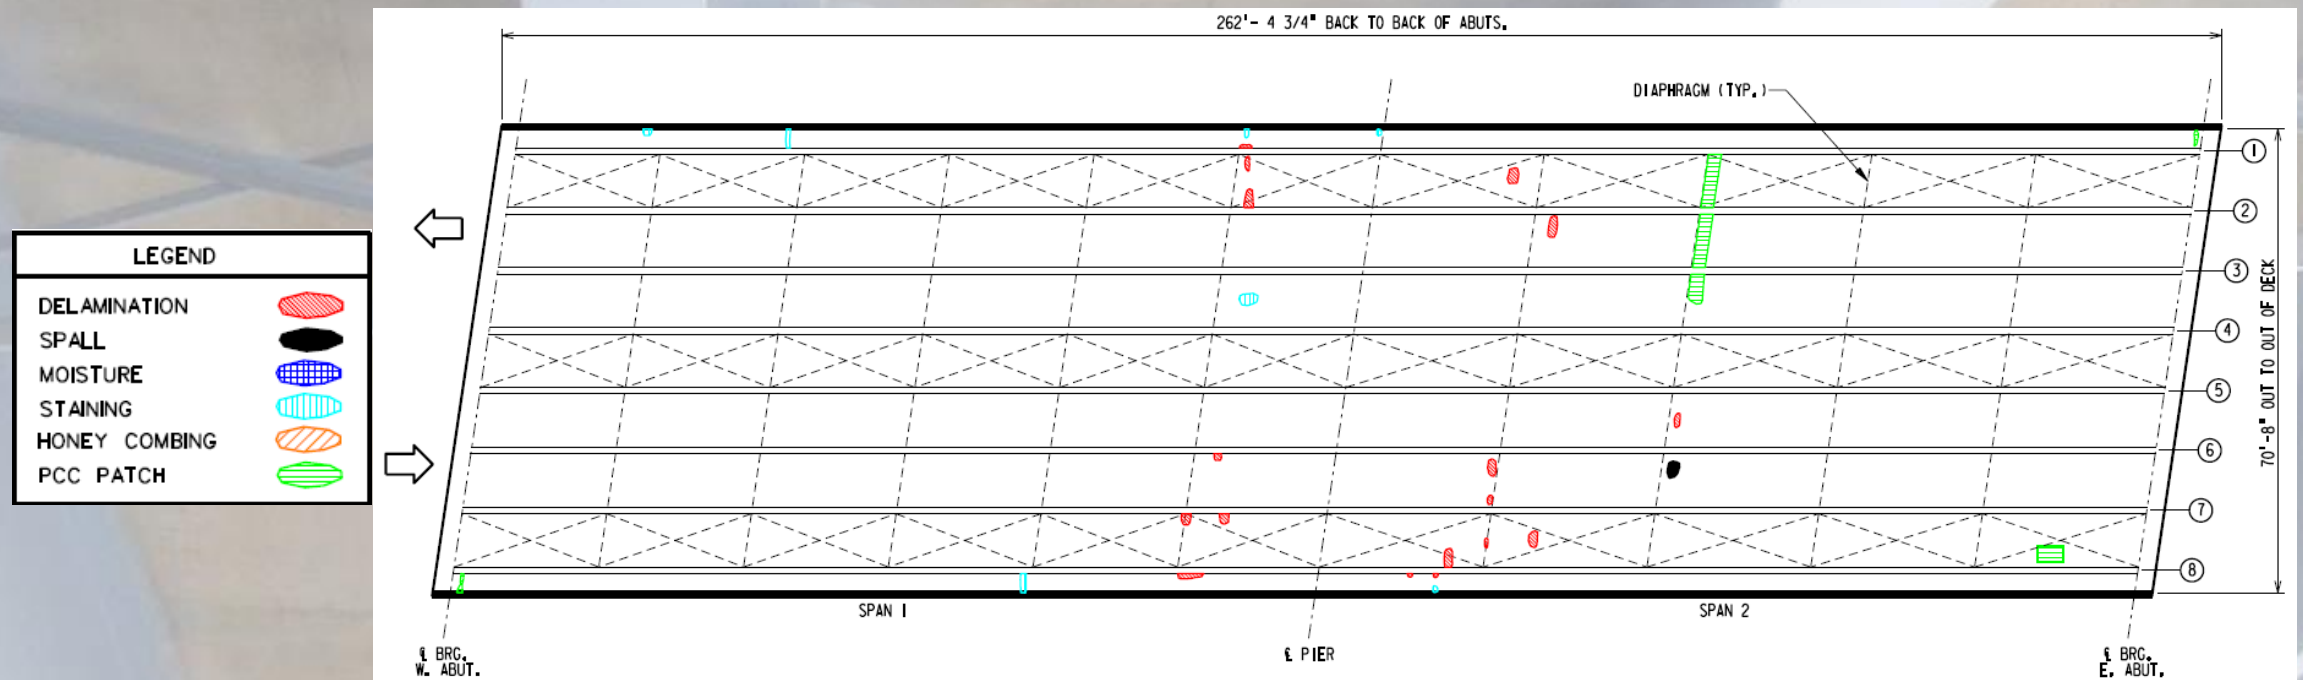
## B-45-55 CTH D over IH 43

- 2022 – Underside IRT estimates 0.5% delam/spall/patch
